# Your Inspection Report

123 Main Street  
Anytown, IL 60100

**INSPECTION DATE:**  
Wednesday, August 12, 2015

RE: Report No. 6165, v.2  
123 Main Street  
Anytown, IL  
60100

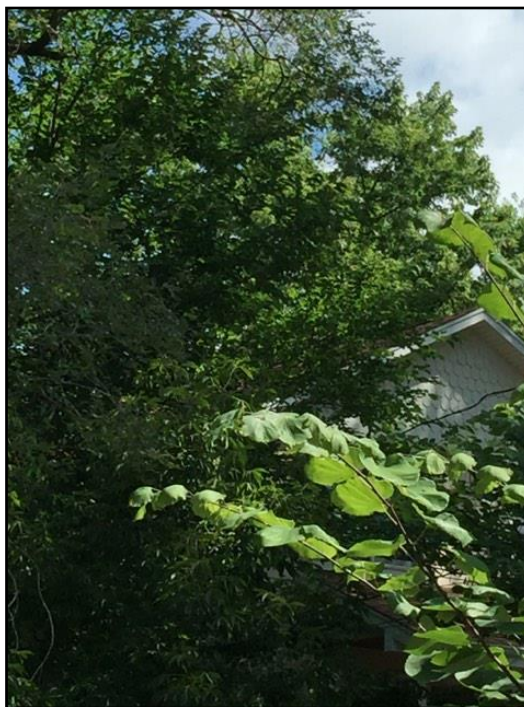
*Note:* The west portion of the roof was not visible as a result of tree coverage from the next door home.

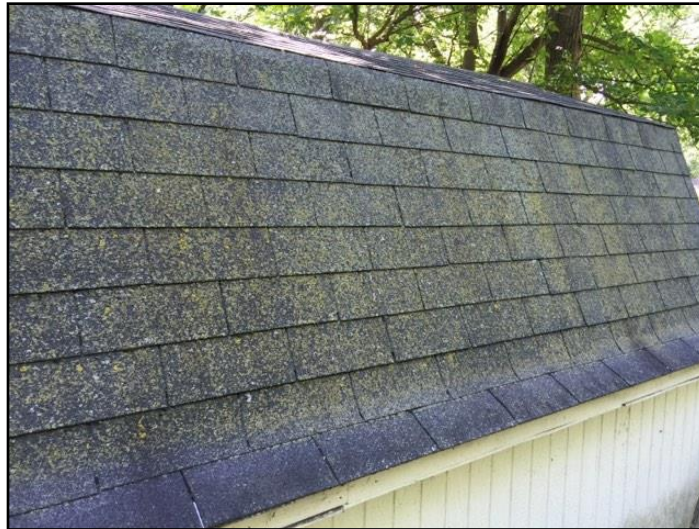
**1. Condition:** • [Vulnerable areas](#)

Moss growth noted on the shed roof.

**Implication(s):** Chance of water damage to contents, finishes and/or structure

**Task:** Clean

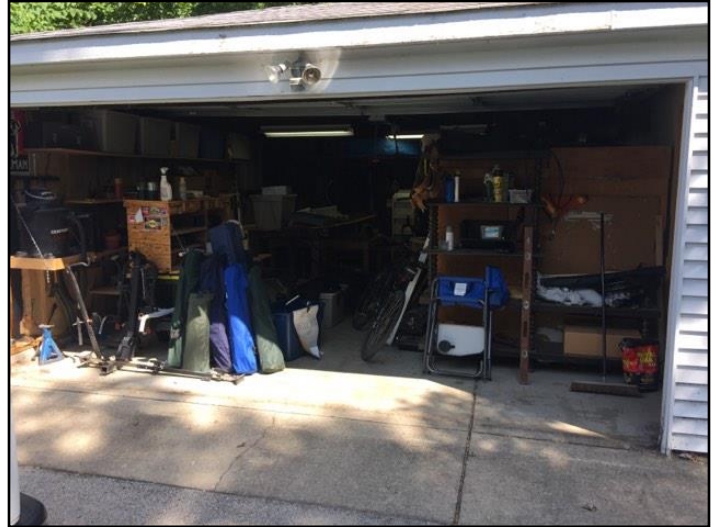
Storage limited the visual access to the garage interior.

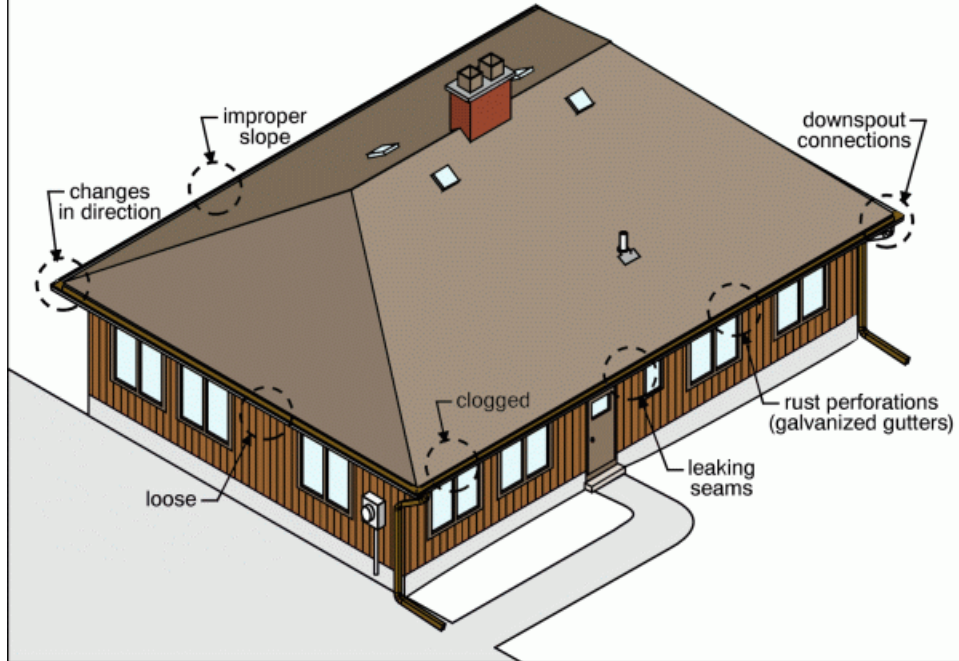
**3. Condition:** • [Clogged](#)

**Implication(s):** Chance of water damage to contents, finishes and/or structure

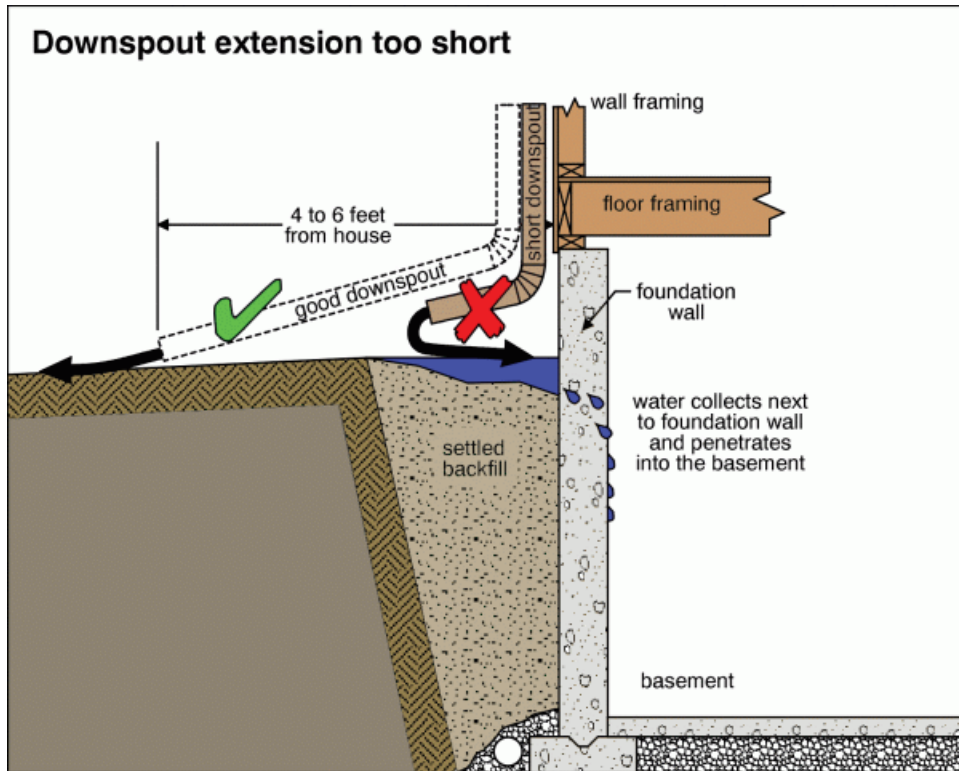
**5. Condition:** • [Downspouts end too close to building](#)

**Implication(s):** Chance of water damage to contents, finishes and/or structure

**Task:** Improve

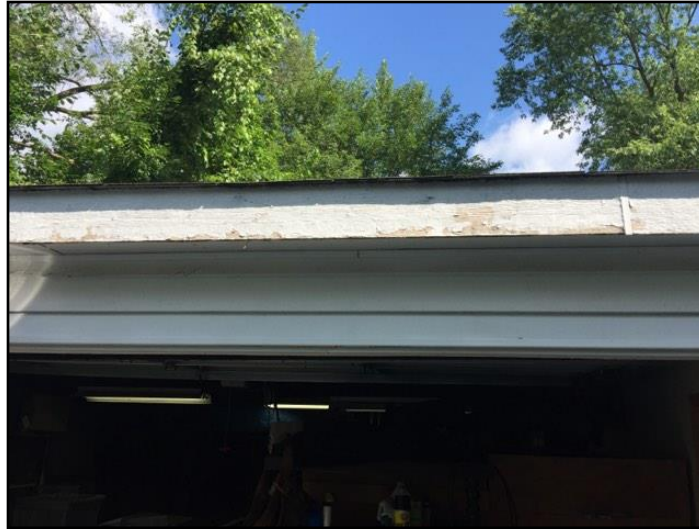
**6. Condition:** • [Paint or stain needed](#)

**Implication(s):** Cosmetic defects | Chance of water damage to contents, finishes and/or structure | Shortened life expectancy of material

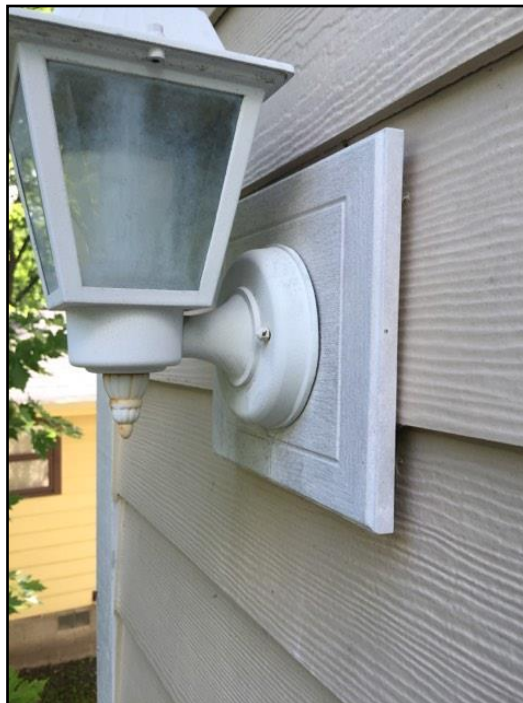
7. Condition: • [Caulking missing or ineffective](#)

Implication(s): Chance of water damage to contents, finishes and/or structure

Task: Improve

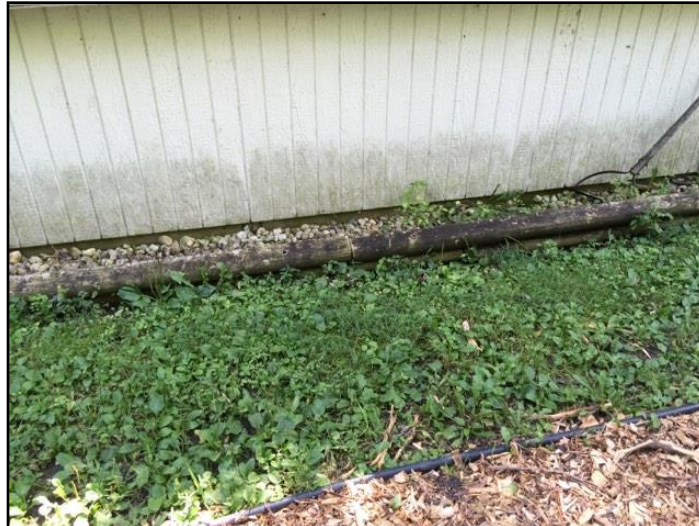
8. Condition: • [Paint or stain - needed](#)

**Task:** Improve

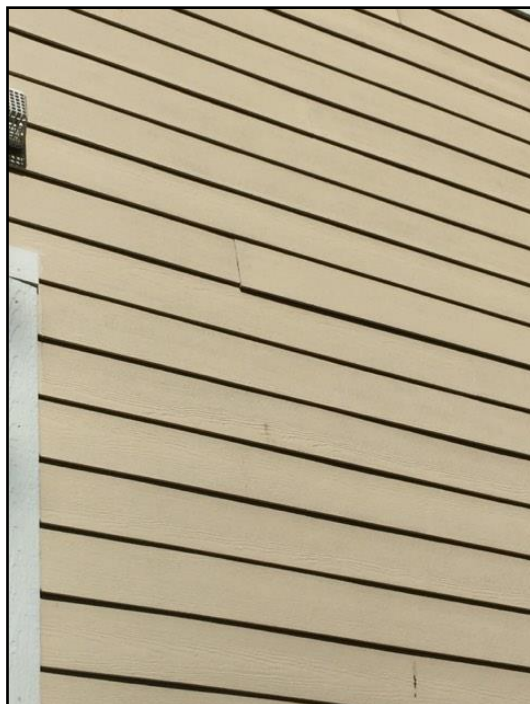
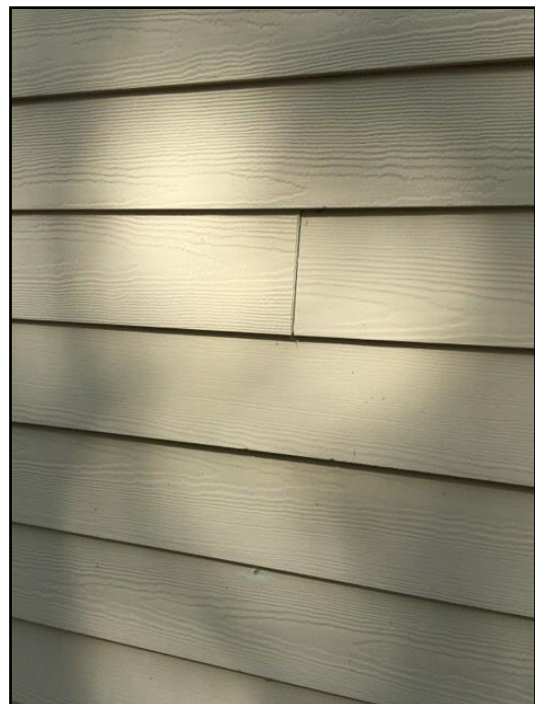
**9. Condition:** • [Loose](#)

The east wall has more sun and weather exposure which has caused movement of the hardboard siding.

**Implication(s):** Cosmetic defects | Chance of water damage to contents, finishes and/or structure | Material deterioration

**Task:** Repair

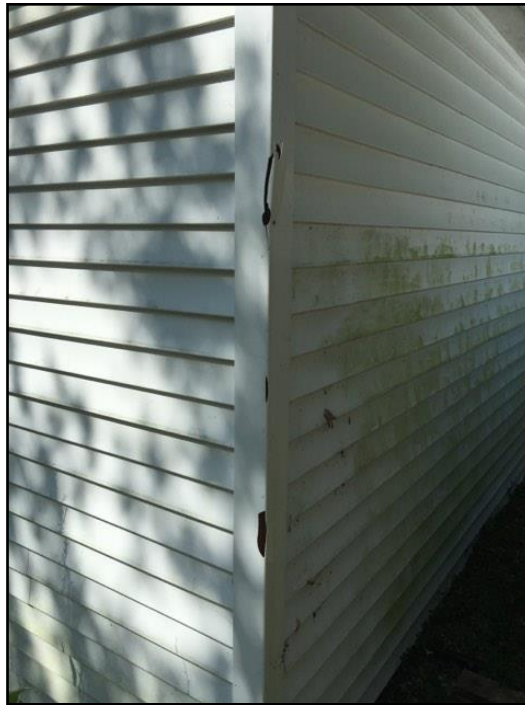
**10. Condition:** • [Mechanical damage](#)

**Implication(s):** Cosmetic defects | Chance of water damage to contents, finishes and/or structure

**Task:** Repair or replace

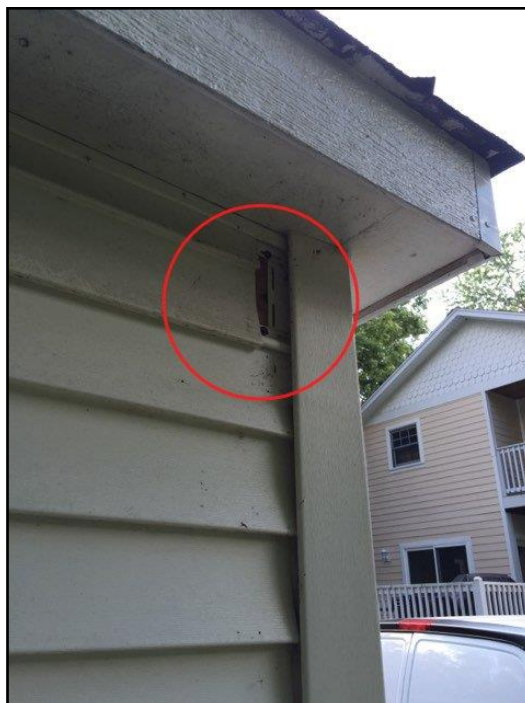
**11. Condition:** • [Loose or missing pieces](#)

**Implication(s):** Cosmetic defects | Chance of water damage to contents, finishes and/or structure

**Task:** Repair

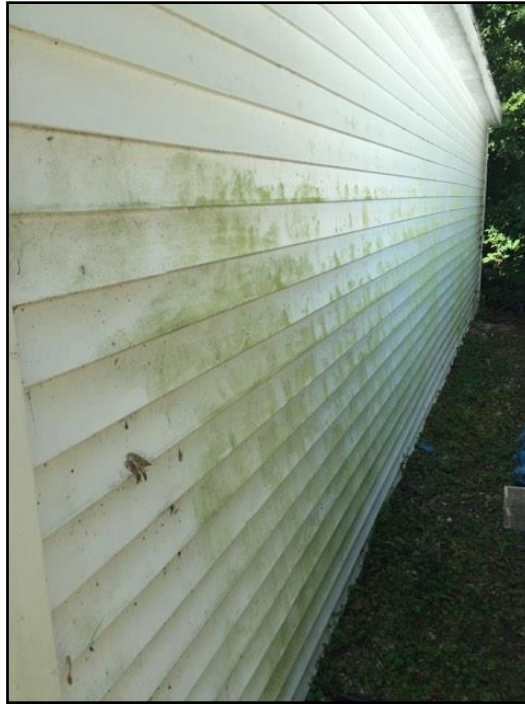
**12. Condition:** • [Discolored](#)

**Implication(s):** Cosmetic defects

**Task:** Clean

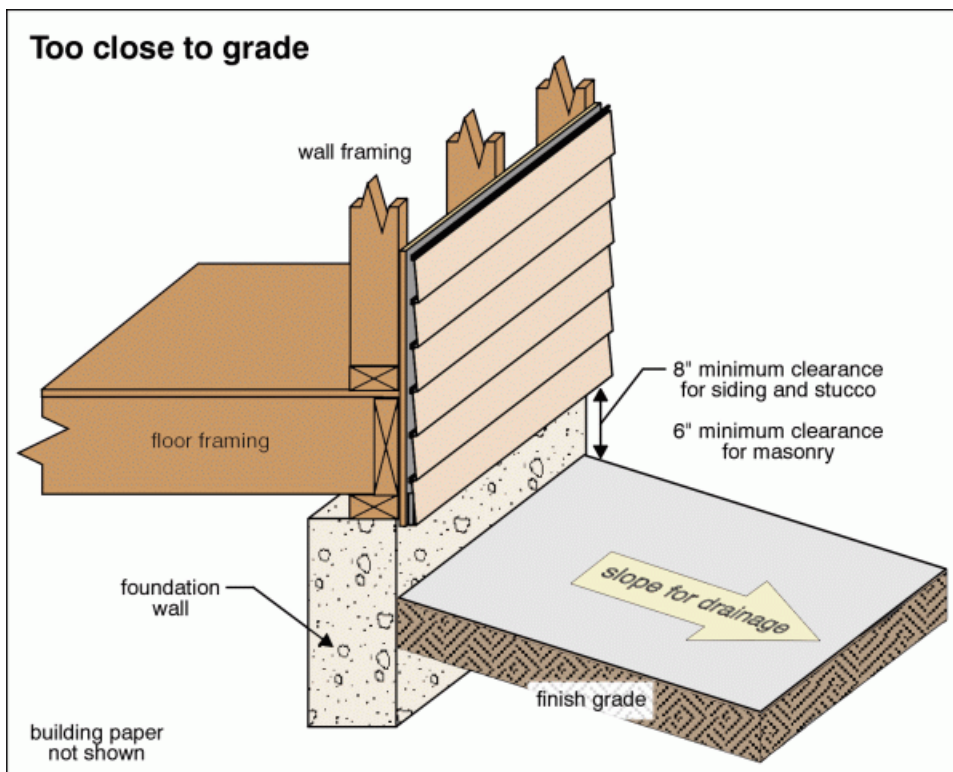
**13. Condition:** • [Too close to grade](#)

**Implication(s):** Chance of water damage to contents, finishes and/or structure

**Task:** Improve

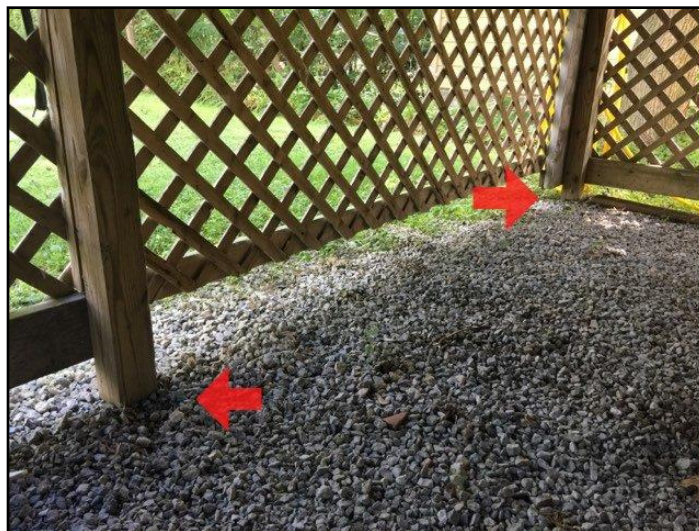
### 14. Condition: • [Wood/soil contact](#)

**Implication(s):** Weakened structure | Chance of movement | Rot | Insect damage

**Task:** Further evaluation

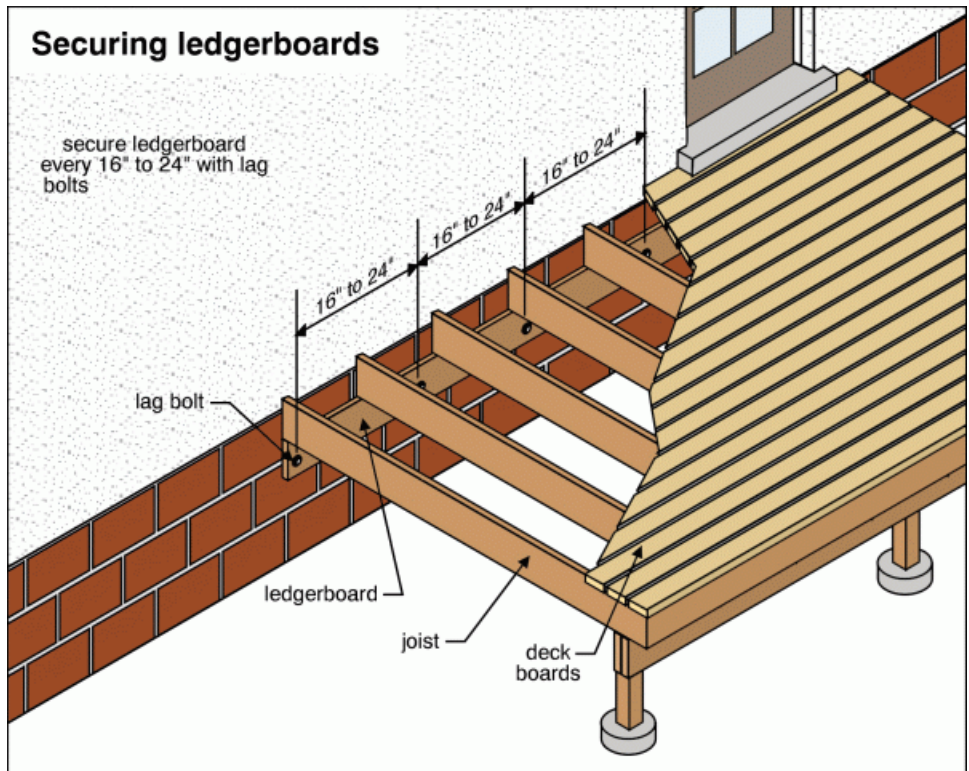
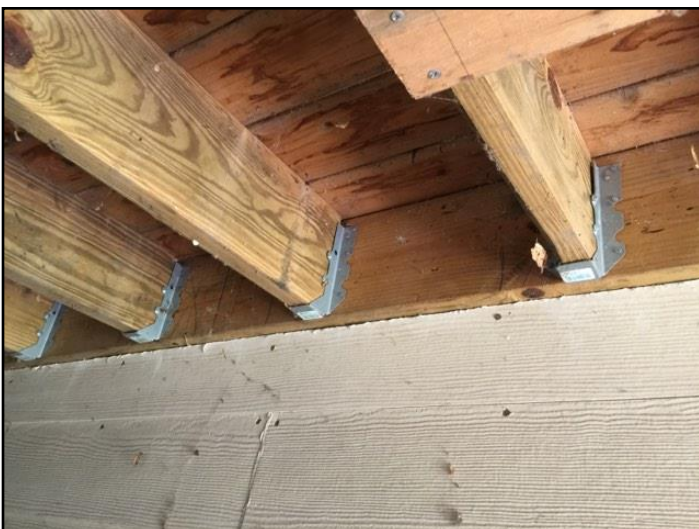
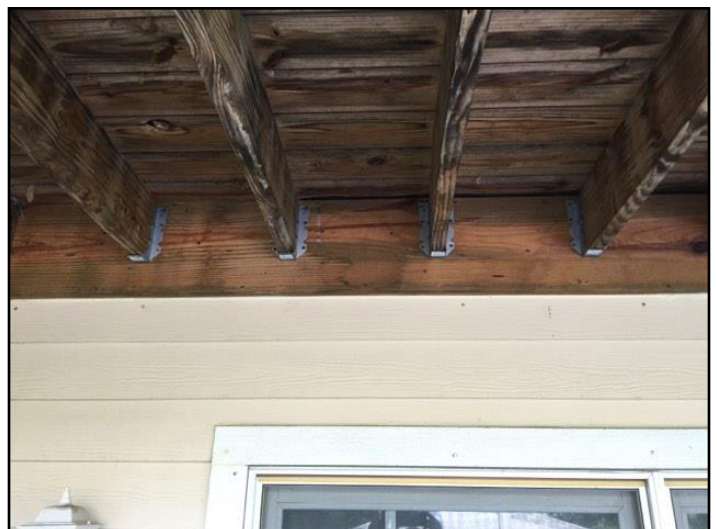
The ledgerboard should be lagbolted to the house for structural integrity. For further info, please view:

**Implication(s):** Weakened structure | Chance of movement

**15. Condition:** • [Ledgerboard problems](#)

**Task:** Further evaluation by a deck contractor

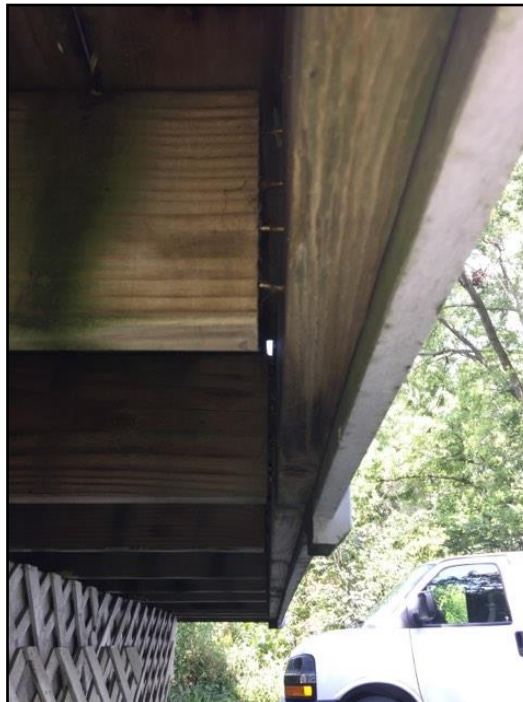
The joists are pulling away from the deck header board. Joist hangers are needed for a secure connection.

**Implication(s):** Weakened structure | Chance of movement

## 16. Condition: • [Fastener problems](#)

**Task:** Repair by a deck contractor

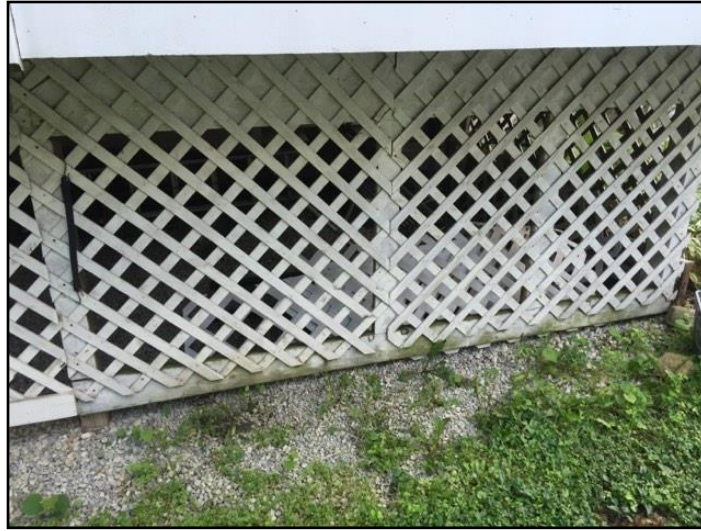
### 17. Condition: • [Paint or stain needed](#)

**Implication(s):** Cosmetic defects | Shortened life expectancy of material

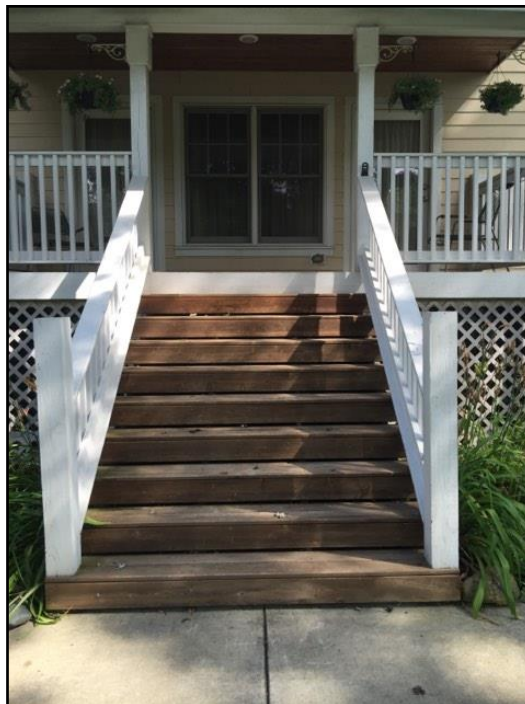
The concrete pad under the front porch has settled which has undermined the support for the front porch steps.

**18. Condition:** • [Steps springy, loose or sagging](#)

**Implication(s):** Trip or fall hazard

**Task:** Repair

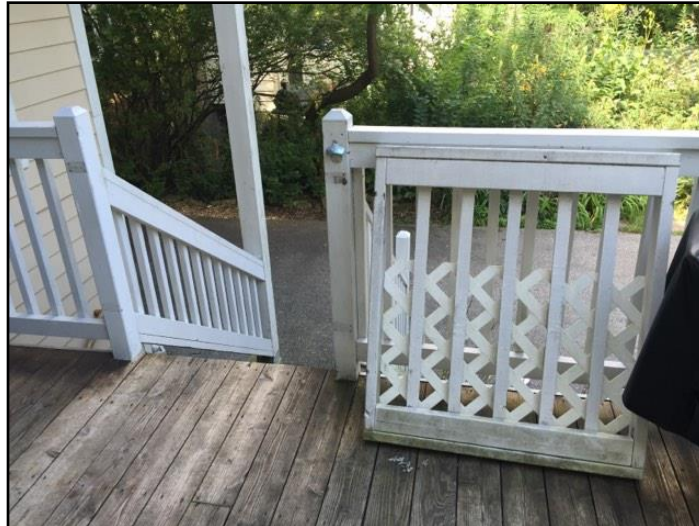
**19. Condition:** • The gate was not installed at the time of the inspection.

**Task:** Repair

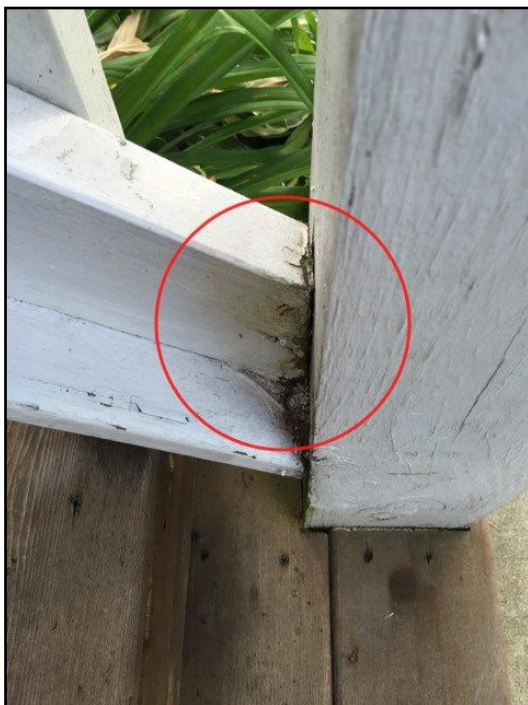
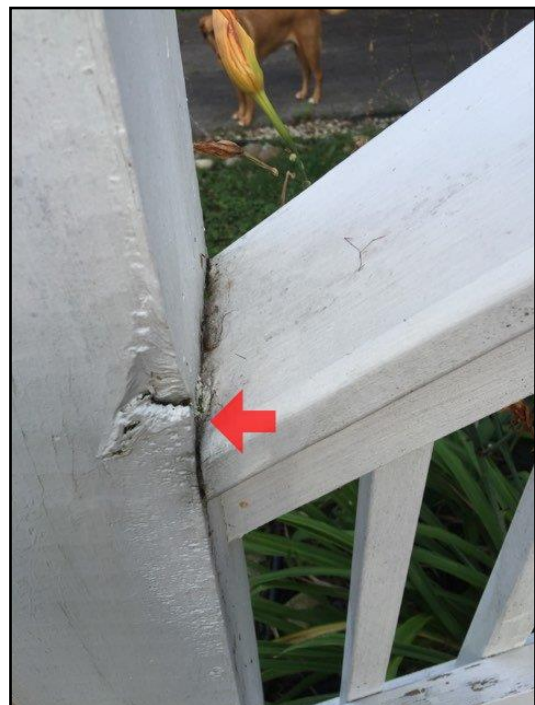
**20. Condition:** • [Rot or insect damage](#)

**Implication(s):** Fall hazard

**Task:** Repair or replace

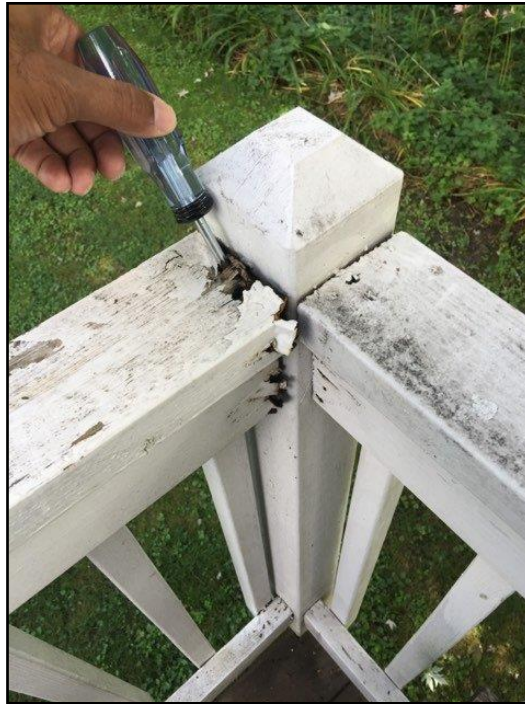
**21. Condition:** • [Rot or insect damage](#)

The guardrail is rotted and extremely loose.

**Implication(s):** Fall hazard

**Task:** Repair or replace

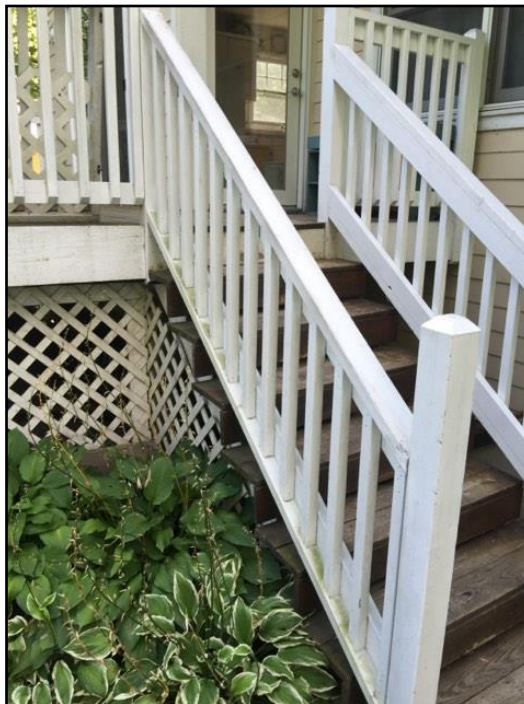
**22. Condition:** • [Loose](#)

The left handrail is loose.

**Implication(s):** Fall hazard

**Task:** Repair

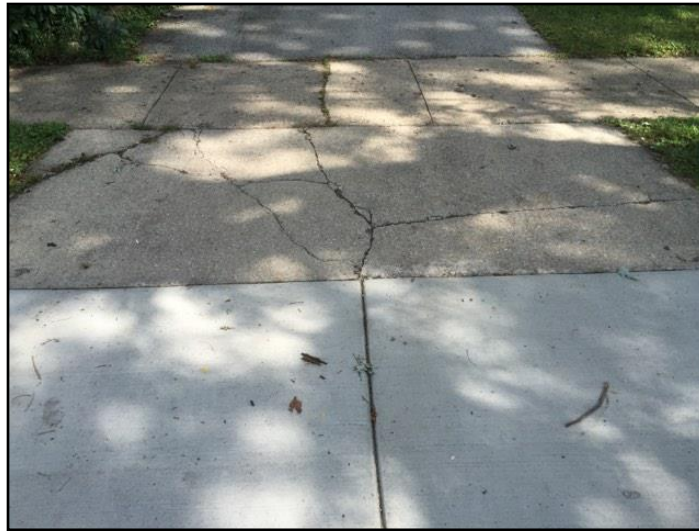
**25. Condition:** • [Cracked or damaged surfaces](#)

**Implication(s):** Trip or fall hazard

**Task:** Repair

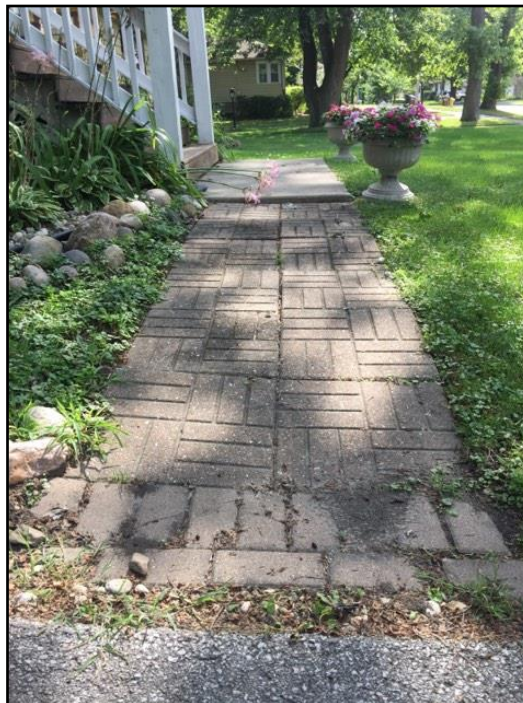
26. Condition: • [Uneven \(trip hazard\)](#)

Task: Repair or replace

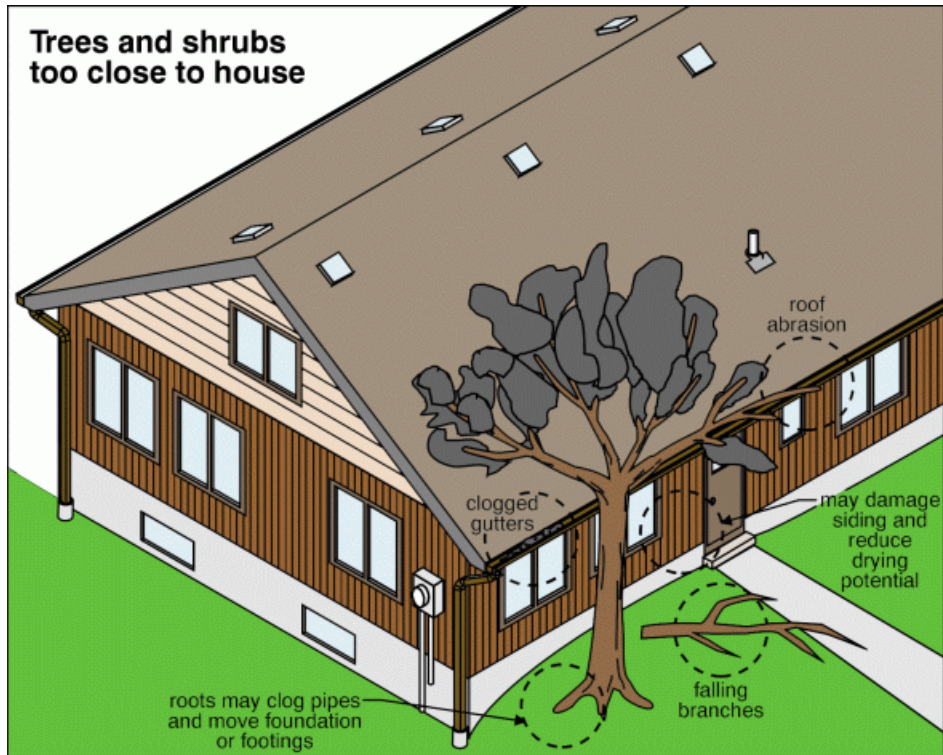
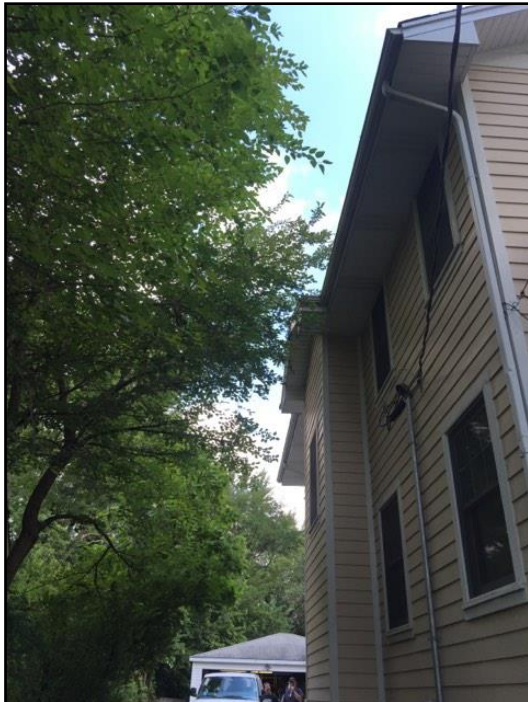
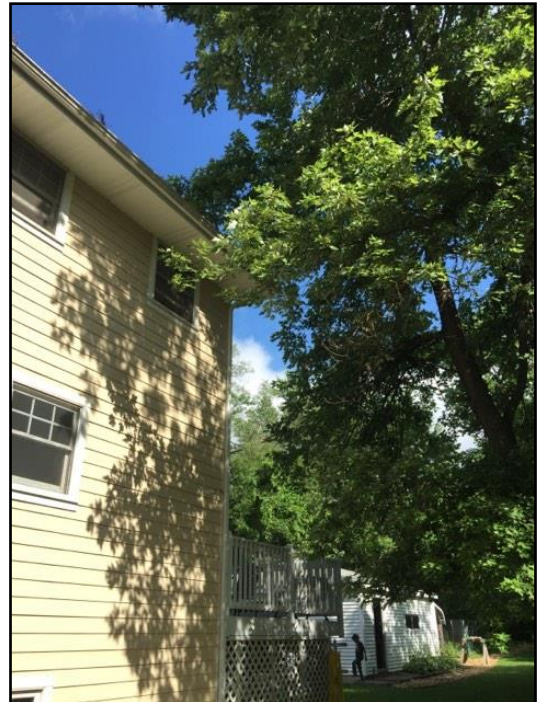
27. Condition: • [Trees or shrubs too close to building](#)

Tree limbs overhanging the roof may cause abrasion damage to roofing materials if allowed to come into contact. Leaves will collect in and possibly clog the gutters and/or downspouts.

**Implication(s):** Chance of water damage to contents, finishes and/or structure | Chance of pests entering building | Material deterioration

**Task:** Improve

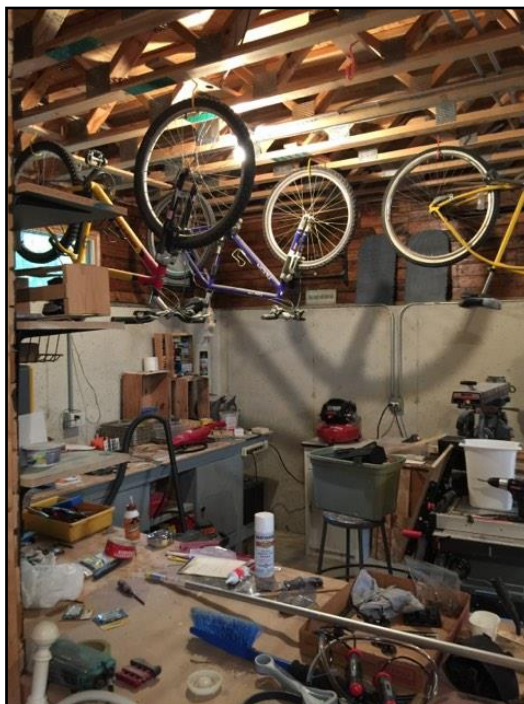
Excessive basement storage significantly limited visual access to the basement walls and floors.

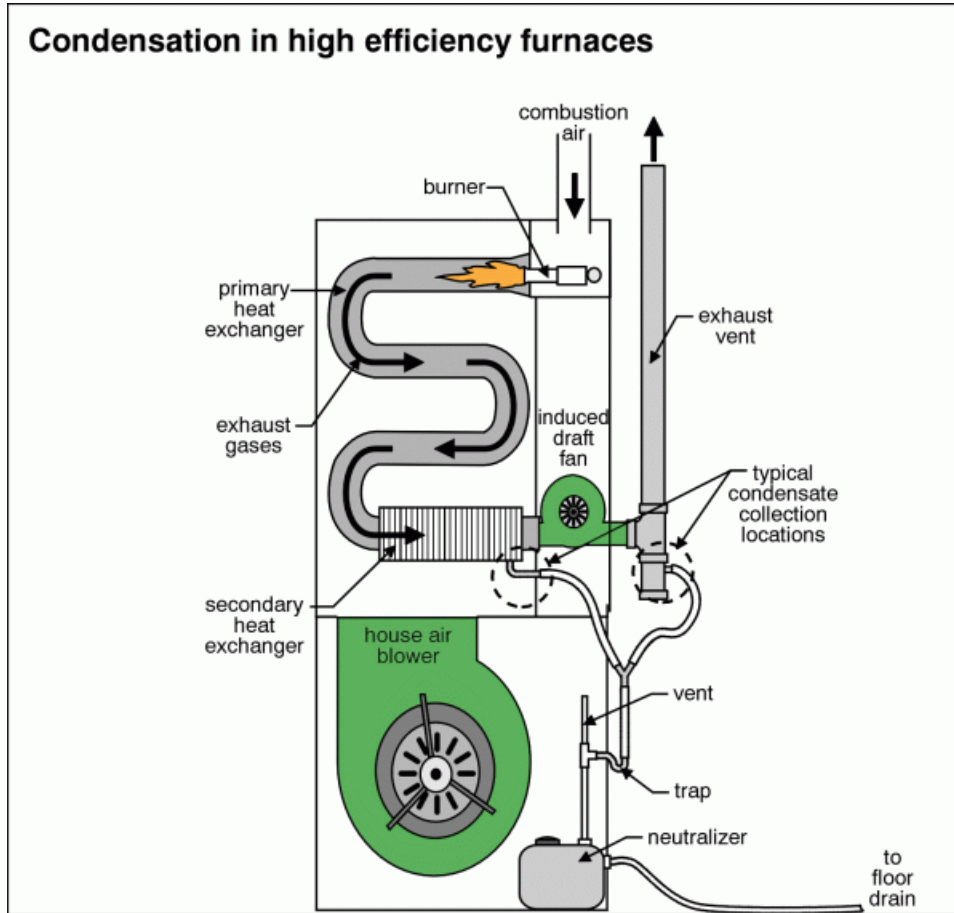
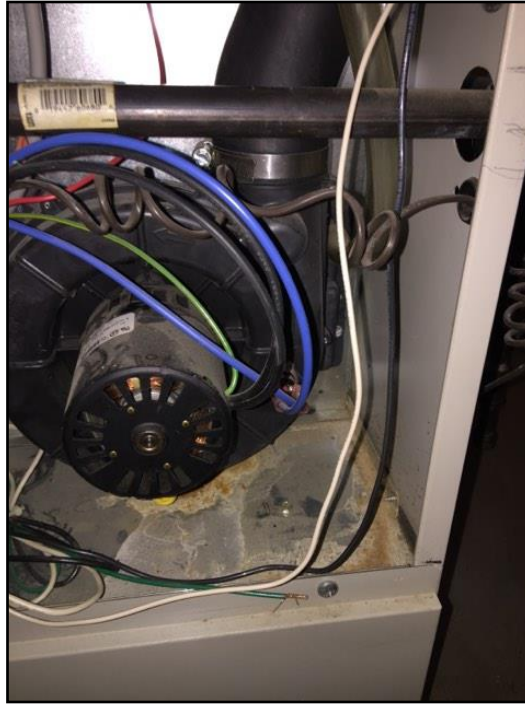
### 30. Condition: • [Condensate problems](#)

Signs of past condensate leakage noted inside the unit as evidenced by rust.

**Implication(s):** Chance of water damage to contents, finishes and/or structure | Reduced system life expectancy

**Task:** Further evaluation

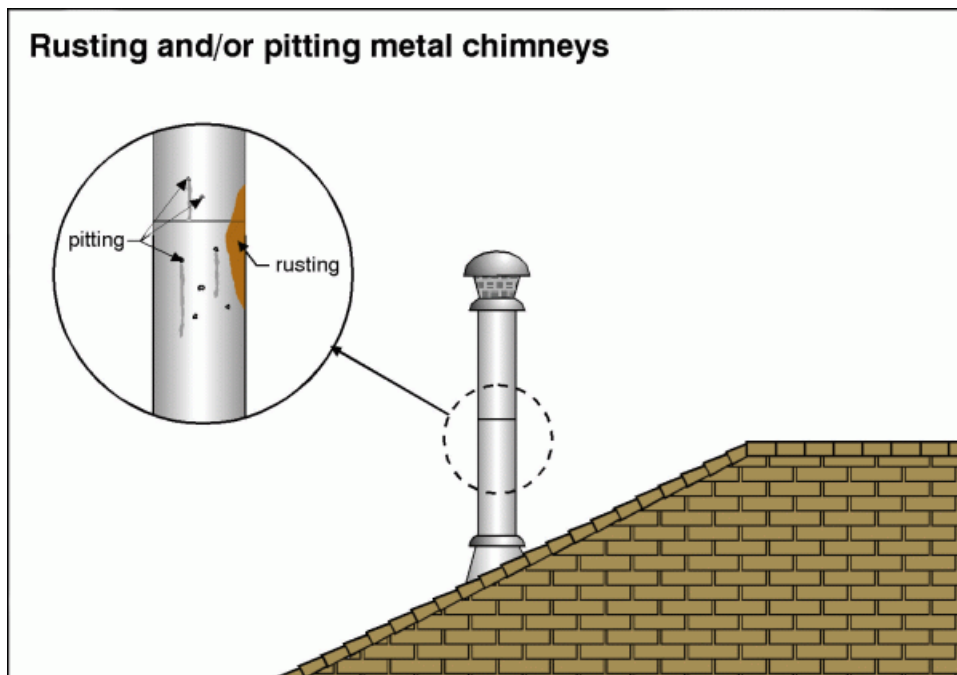
31. Condition: • [Chimney walls rusting or pitting](#)

Implication(s): Chance of movement | Hazardous combustion products entering home

Task: Replace

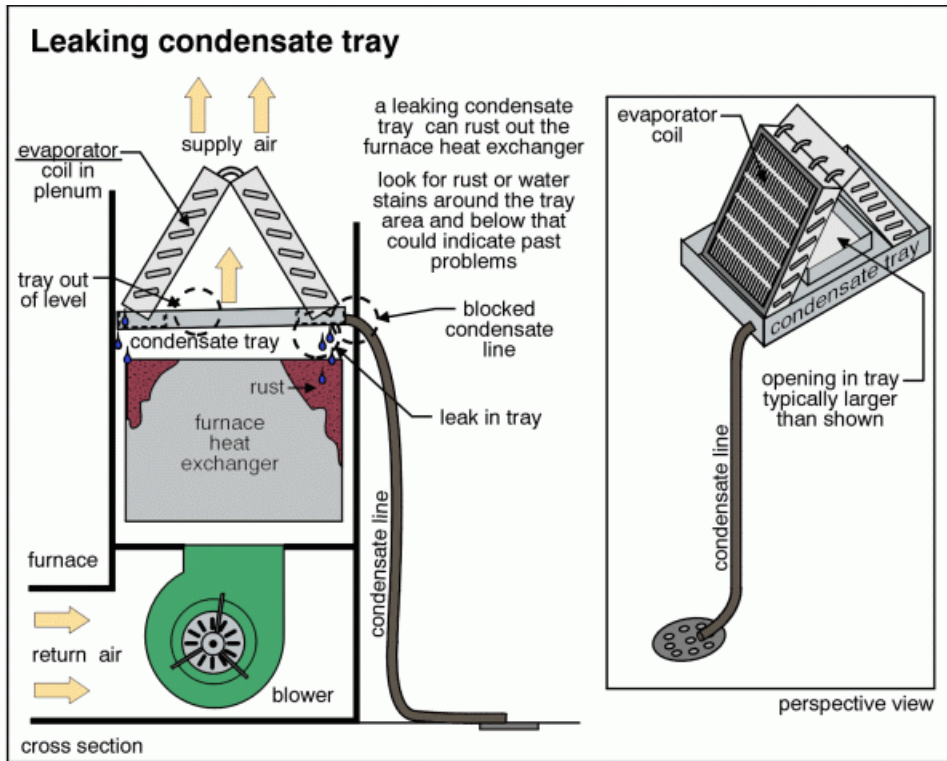
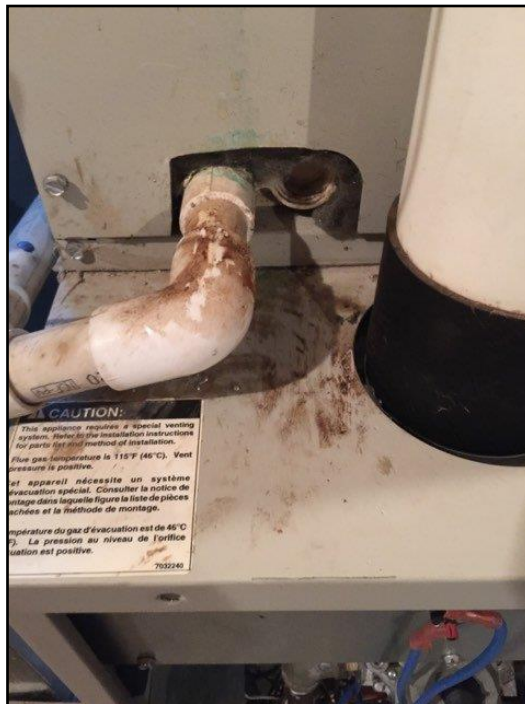
**32. Condition:** • [Pan leaking](#)

Signs of past leakage noted from the evaporator coil onto the furnace unit compartment.

**Implication(s):** Chance of water damage to contents, finishes and/or structure | Damage to equipment

**Task:** Further evaluation

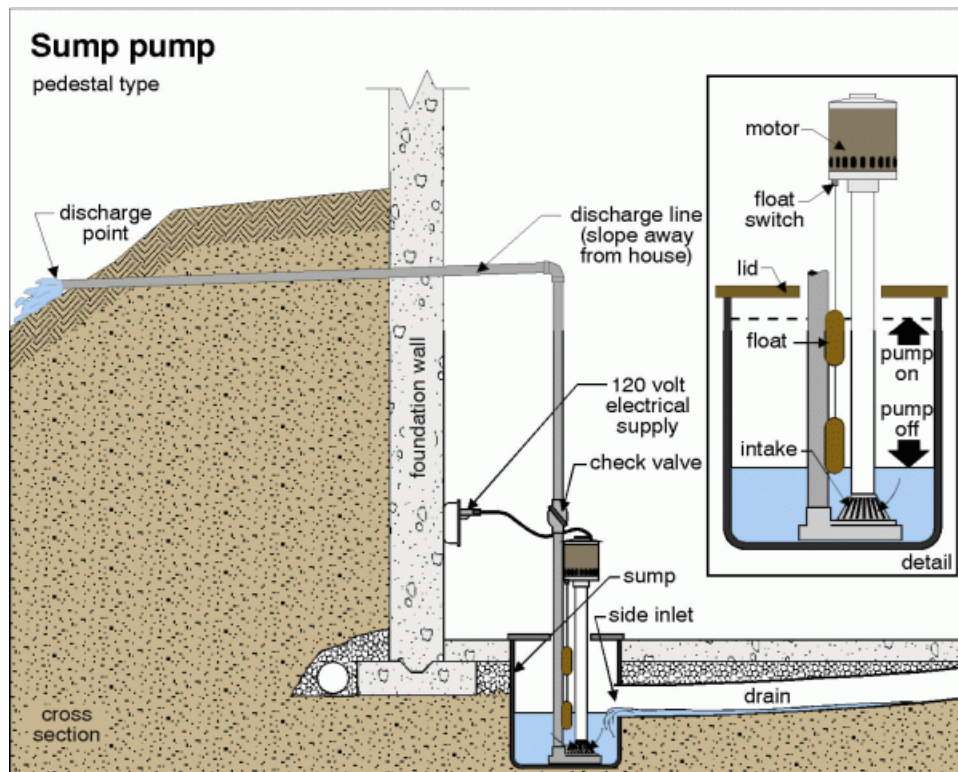
**35. Condition:** • [Discharge pipe problems](#)

**Implication(s):** Chance of water damage to contents, finishes and/or structure

**Task:** Improve

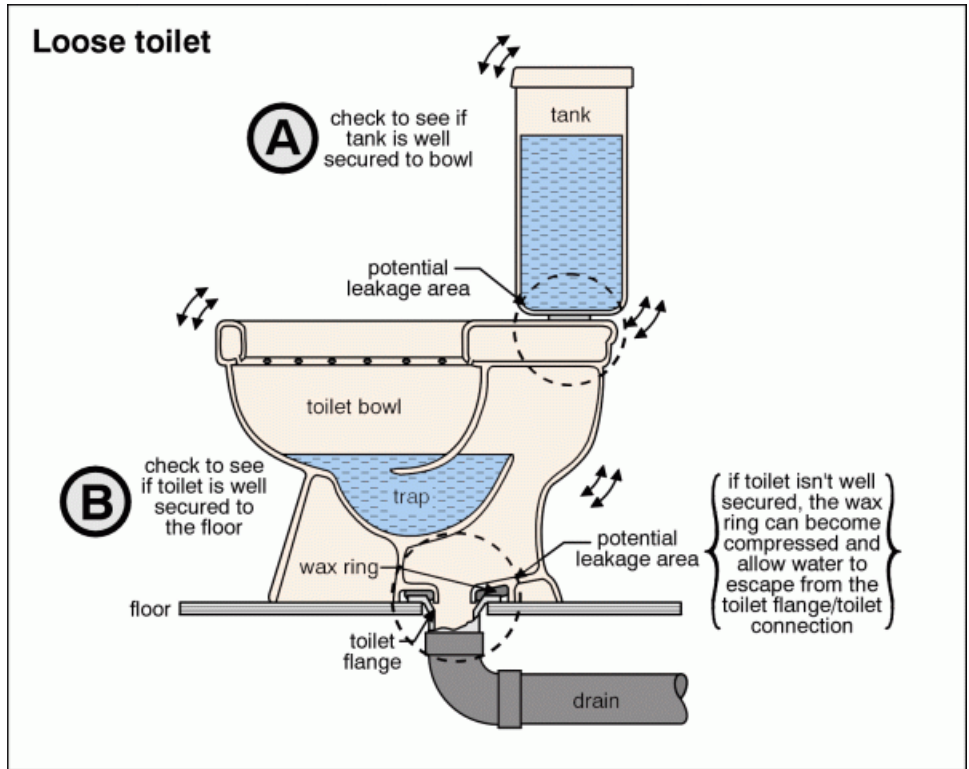
**Loose toilet**

**36. Condition:** • [Loose](#)

**Implication(s):** Chance of water damage to contents, finishes and/or structure | Sewage entering the building

**Task:** Repair

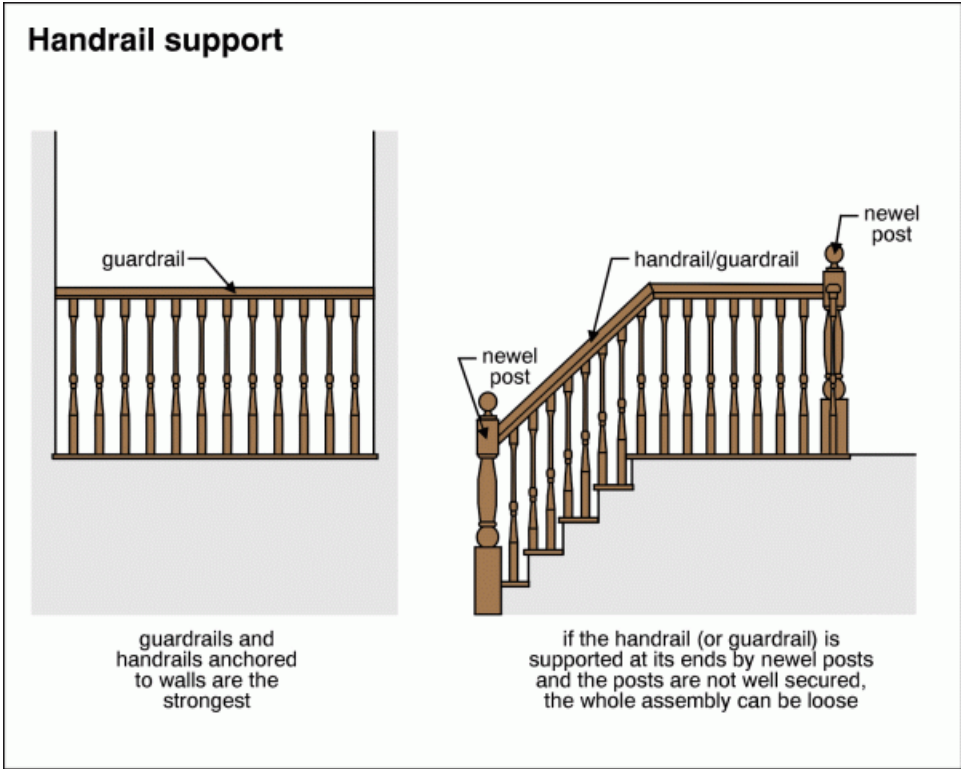
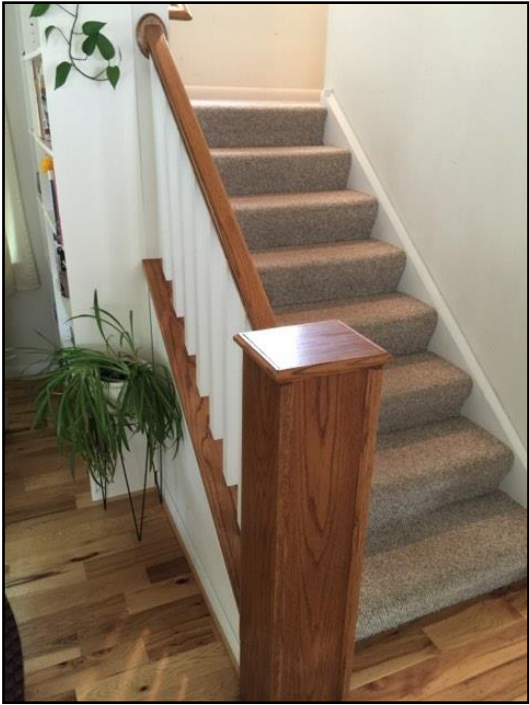
**39. Condition:** • [Loose](#)

**Implication(s):** Fall hazard

**Task:** Repair
