# Your Inspection Report

14242 Summerfield Dr  
New Lenox, IL 60451

Saturday, January 16, 2016

Report No. 6673

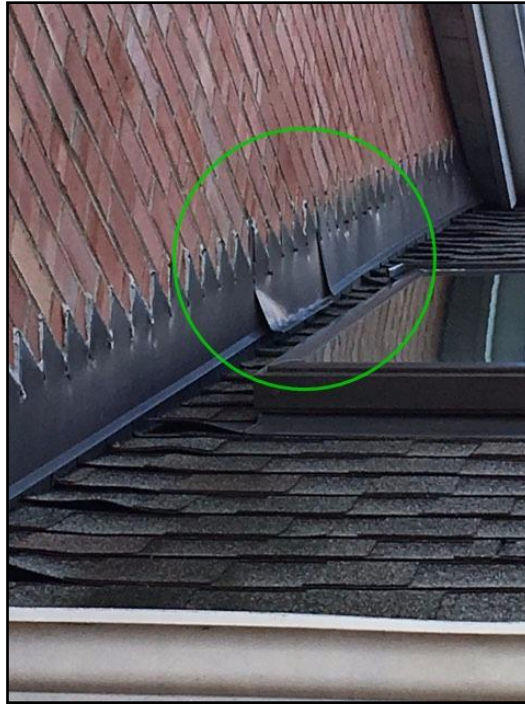
**2. Condition:** • [Loose, damaged, patched, open seams](#)

*Loose sidewall flashing*

**Task:** Repair

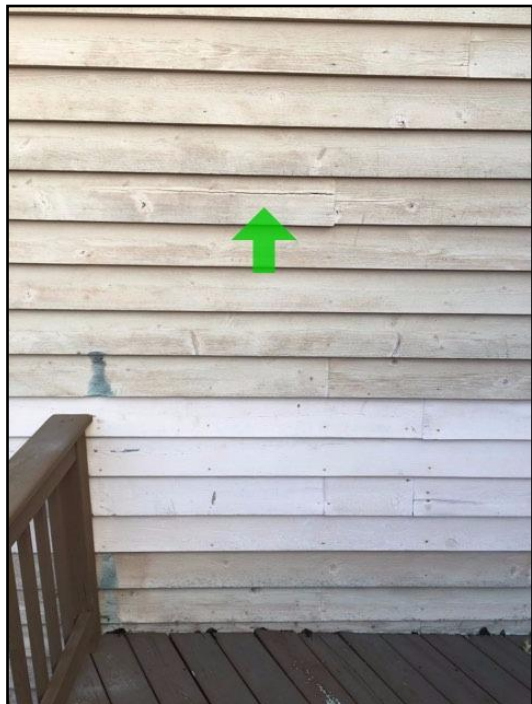
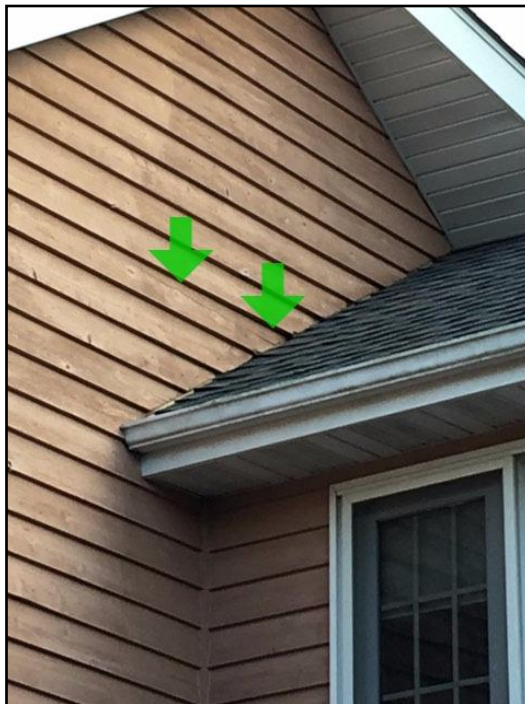
**6. Condition:** • [Cracked, split or broken](#)

*Cracked, split or broken*

**Task:** Repair or replace

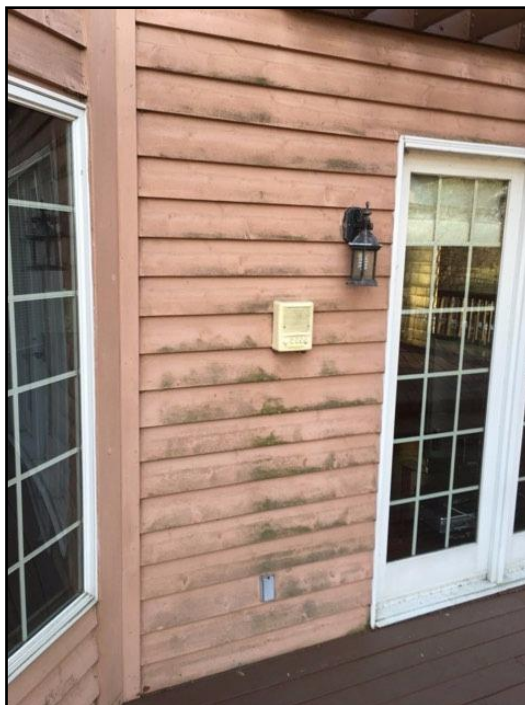
## 7. Condition: • [Paint or stain - needed](#)

*Paint or stain - needed*

**Task:** Improve

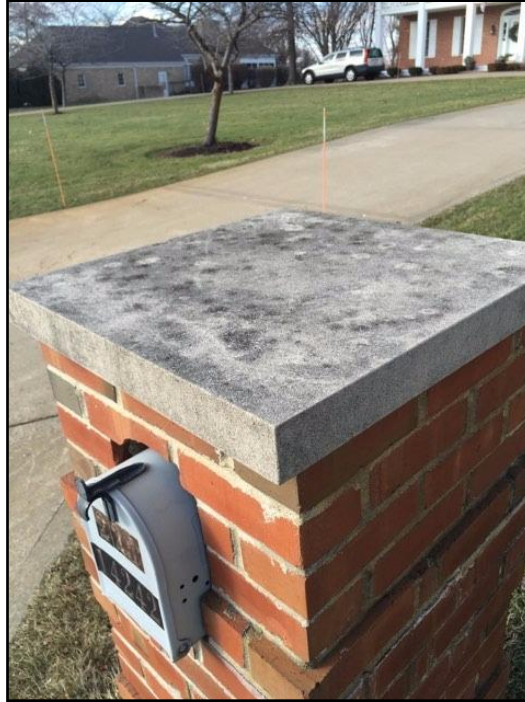
**8. Condition:** • The concrete trim on the mailbox is not anchored securely to the masonry.

**Task:** Repair

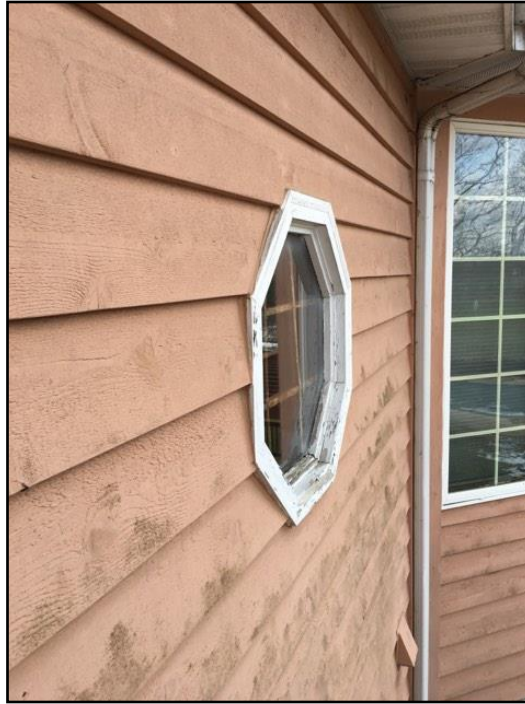
**10. Condition:** • [Paint or stain needed](#)

*Paint or stain needed*

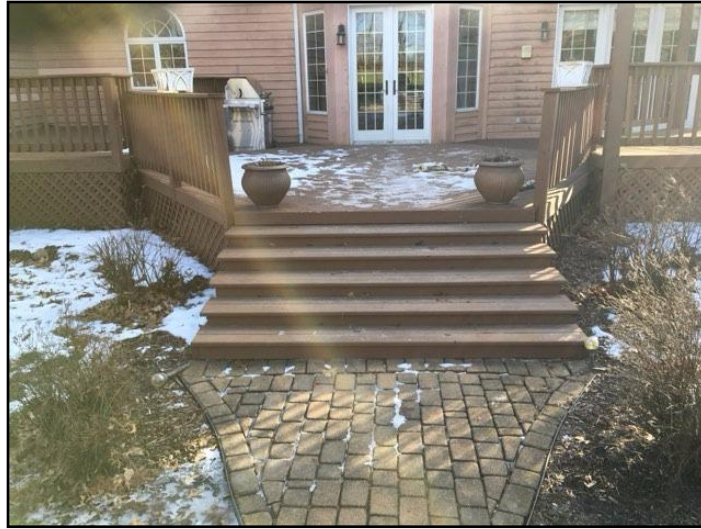
### 15. Condition: • [Missing](#)

*Missing*

**Task:** Repair

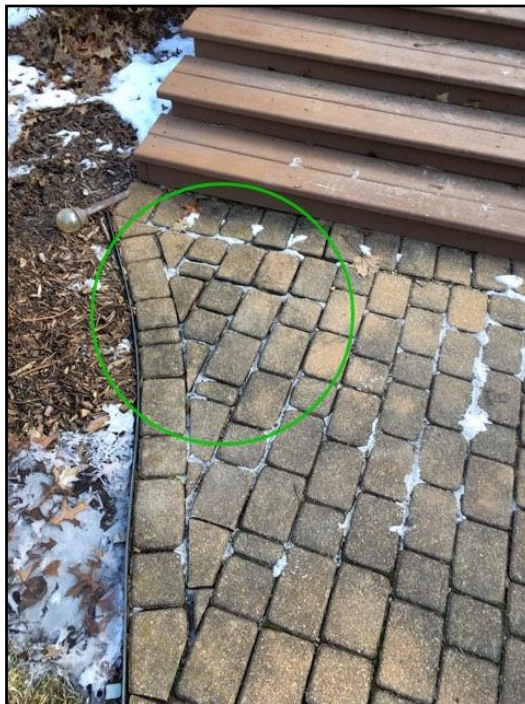
**18. Condition:** • [Uneven \(trip hazard\)](#)

*Uneven (trip hazard)*

**Task:** Repair

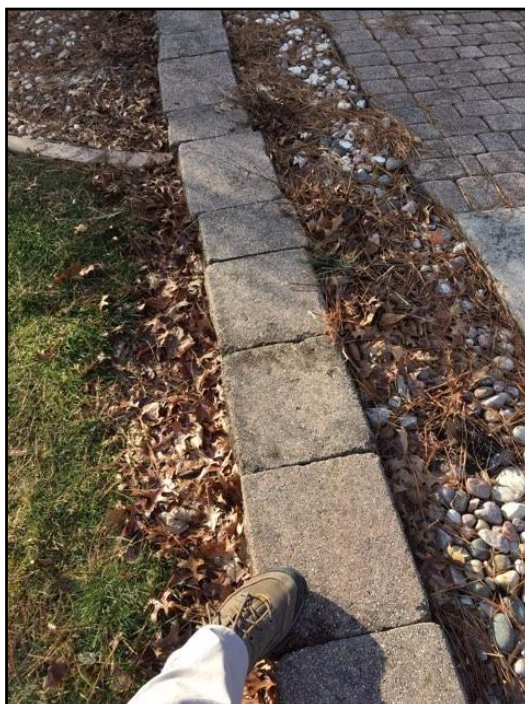
**19. Condition:** • Landscaping trim block was not properly anchored and is loose.

**Task:** Repair

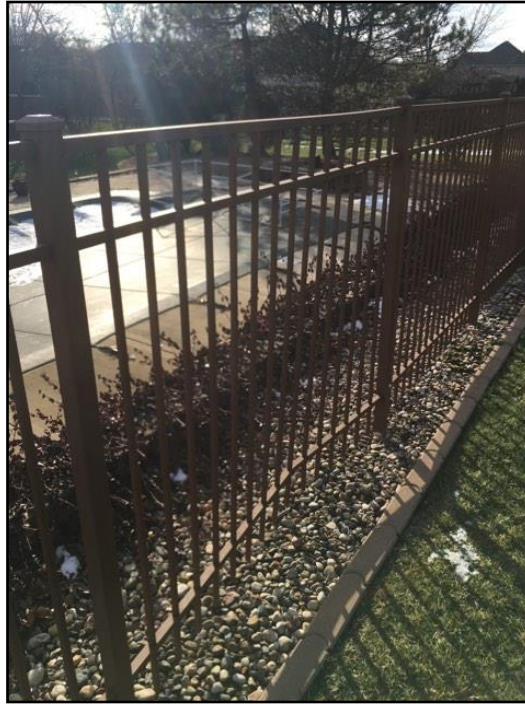
21. Condition: • Damage

*Damage*

**Task:** Repair

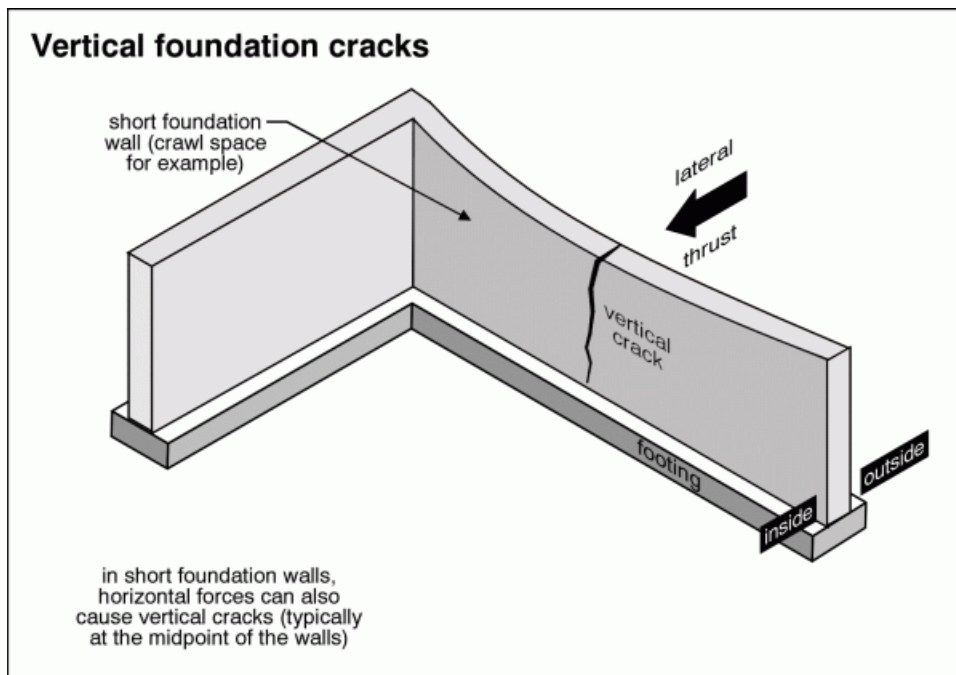
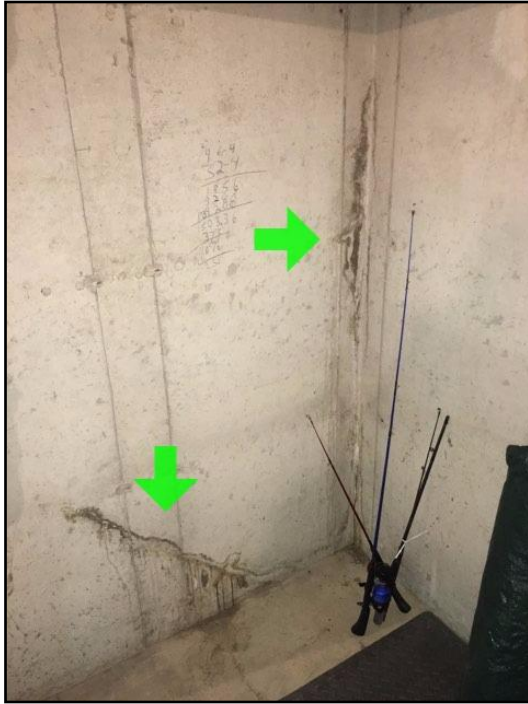
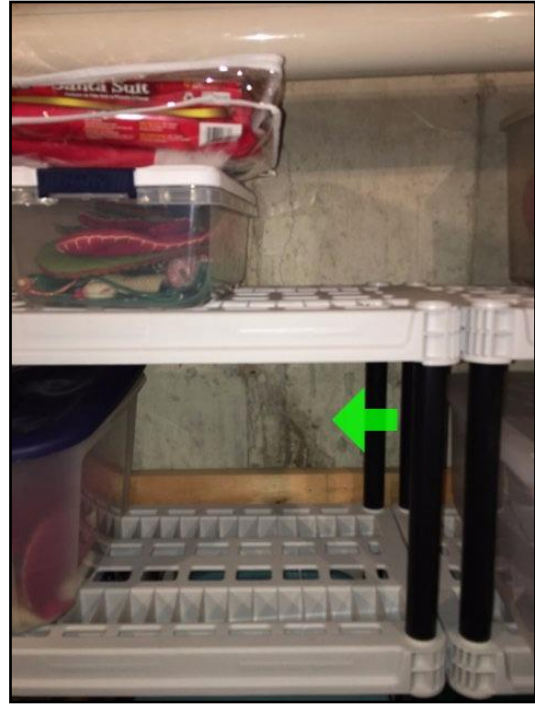
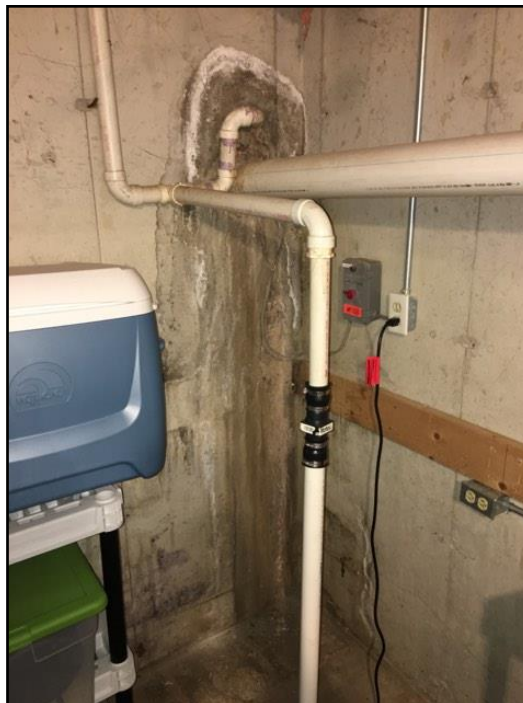
#### **22. Condition:** • [Cracked](#)

Several cracks noted at the foundation wall with past signs of seepage.

*Cracks with signs of seepage*

*Cracked with signs of seepage*

**Task:** Repair by a foundation contractor such as Perma-Seal or U.S. Waterproofing

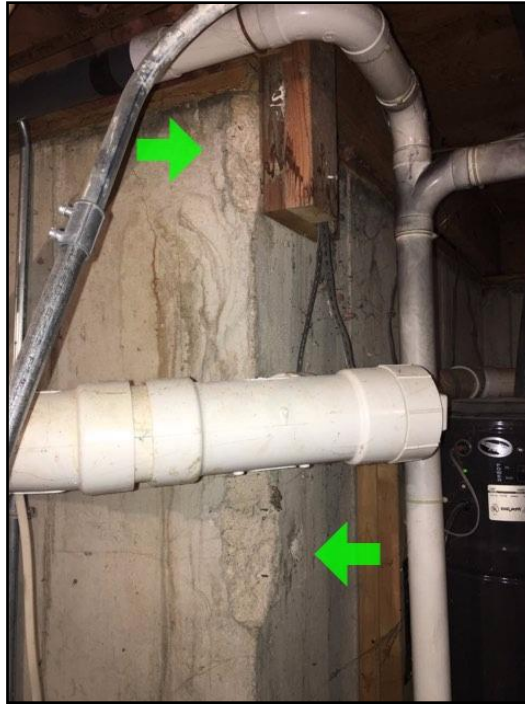
## 23. Condition: • Spalling, crumbling or broken material

It appears that this damage may have happened during construction when the plumbing infrastructure was being installed. This type of damage generally does not have an adverse affect on the foundation wall in this area.

*Spalling, crumbling or broken material*

**Task:** Repair

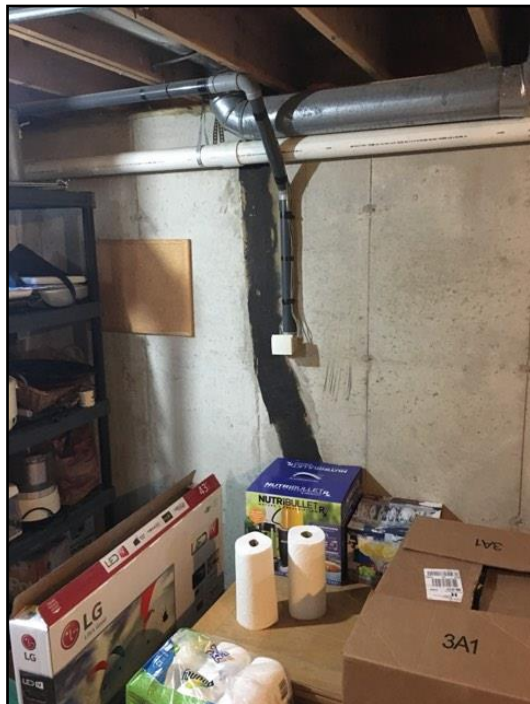
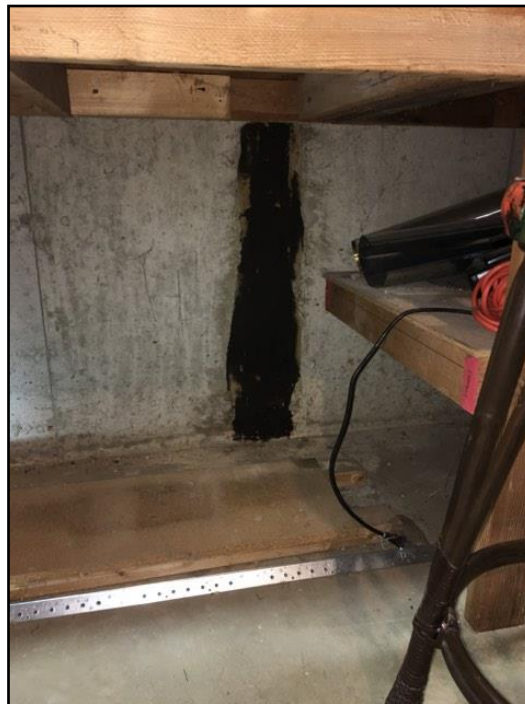
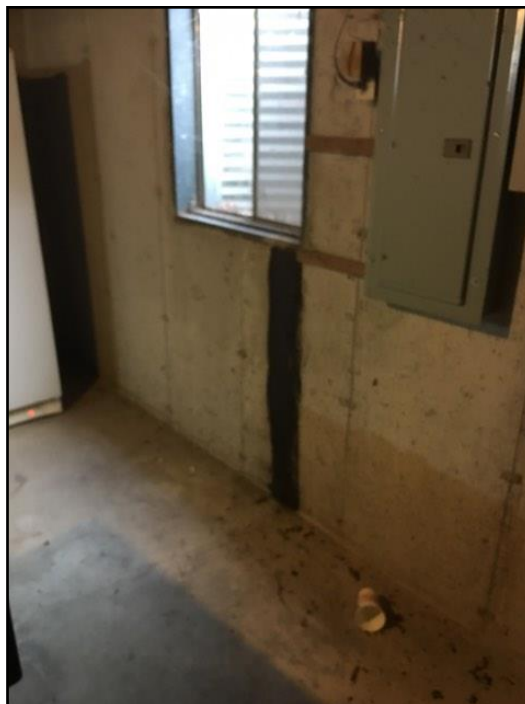
## 24. Condition: • [Prior repairs](#)

Previously repaired foundation cracks noted in the basement. An Epoxy and Polyurethane repair typically indicates a professional repair was performed. Recommend buyer secures warranty paperwork from the seller. the seller which is generally transferable with ownership.

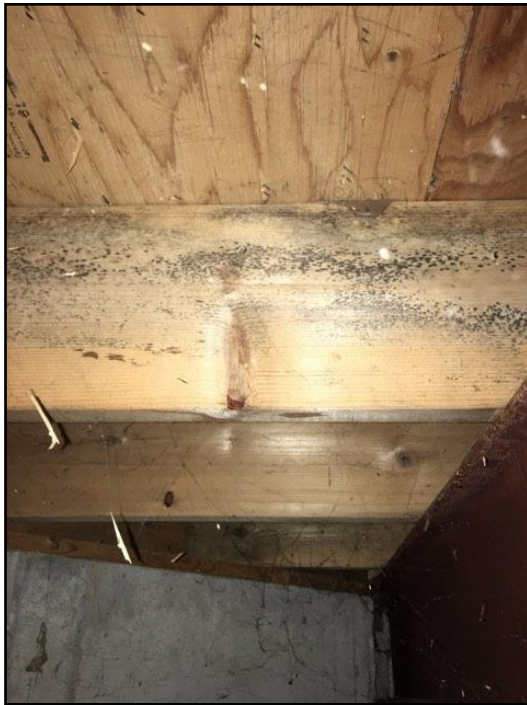
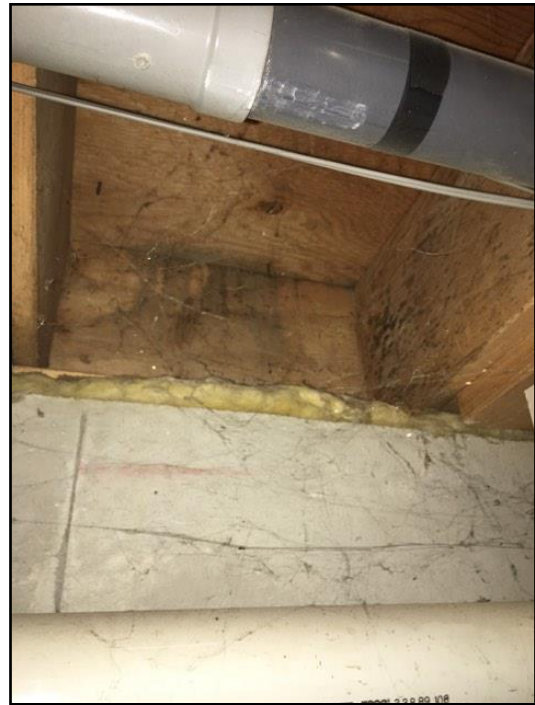
**25. Condition:** • [Mold spots noted on floor, rim joists, as well as some sub-flooring. For further info, please view: http://www.bobvila.com/articles/how-to-remove-mold-from-wood/#.Vpz-KSorLIU](http://www.bobvila.com/articles/how-to-remove-mold-from-wood/#.Vpz-KSorLIU)

**Task:** Clean

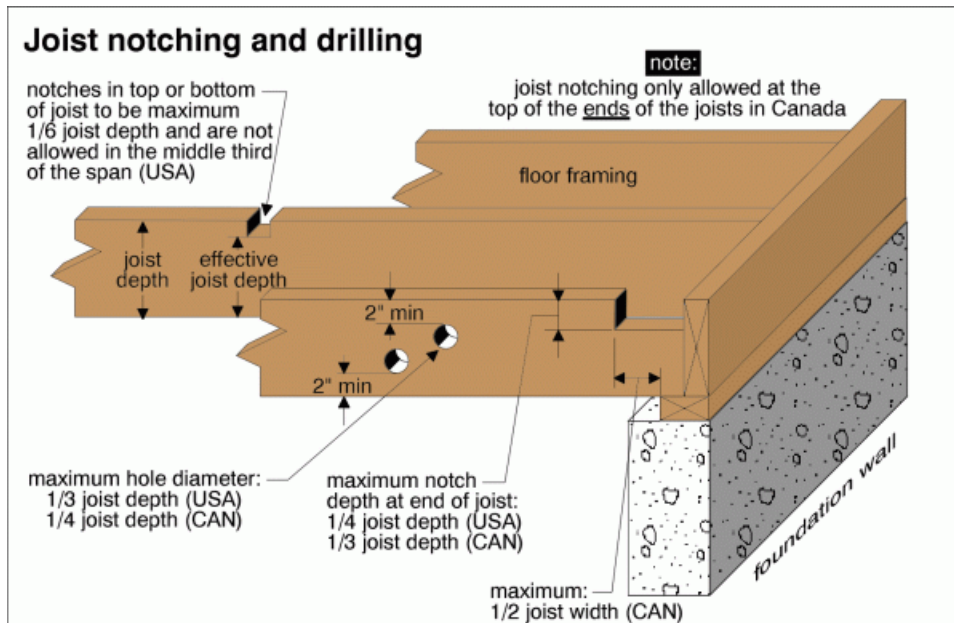
## 26. Condition: • [Notches or holes](#)

Excessively notched blocking noted in the basement to accommodate waste plumbing.

**Task:** Monitor

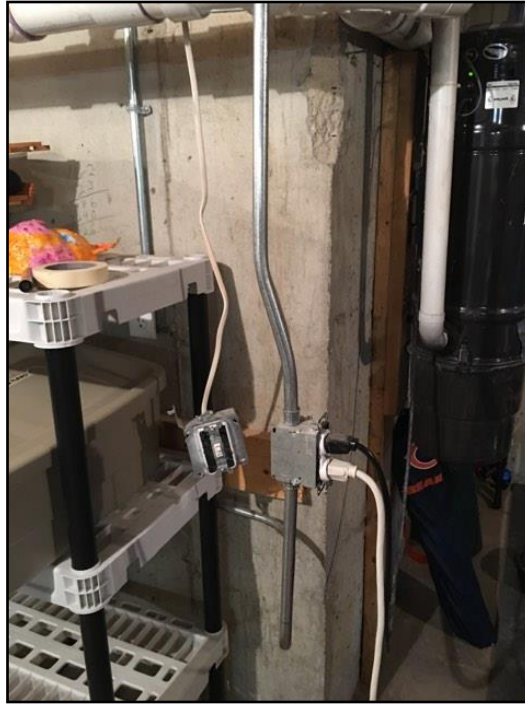
**27.** • It appears that there was a former wall that contained the outlet and switch, but is now missing which is causing these times to hang.

**Task:** Replace wall

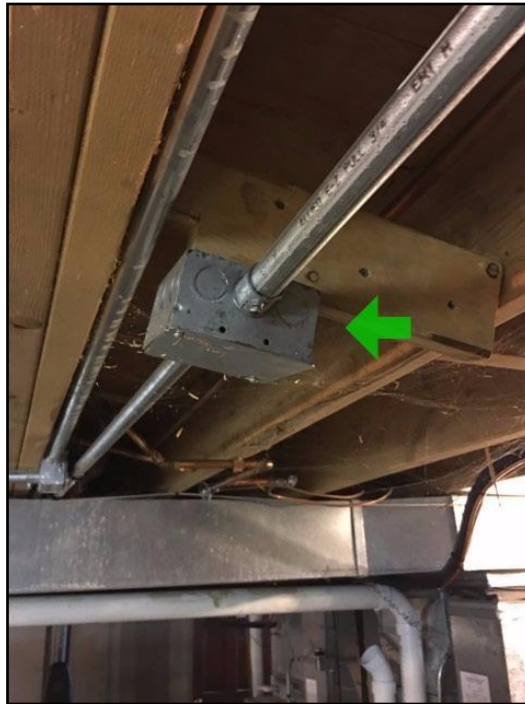
**31. Condition:** • The junction box is not securely attached to the joist.

**Task:** Repair

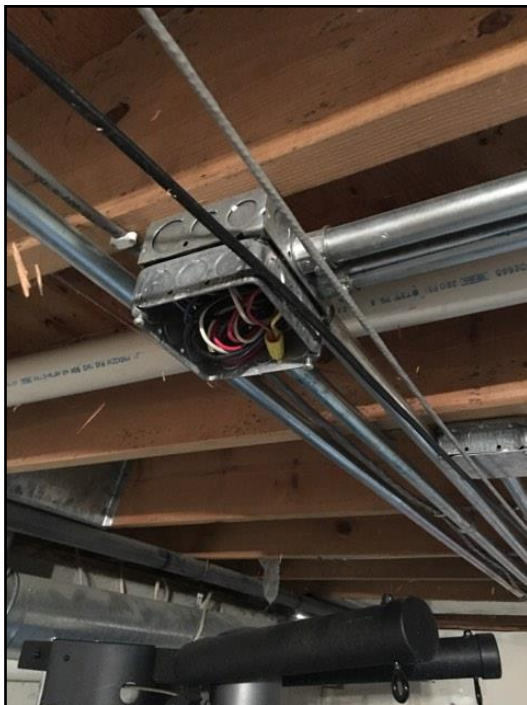
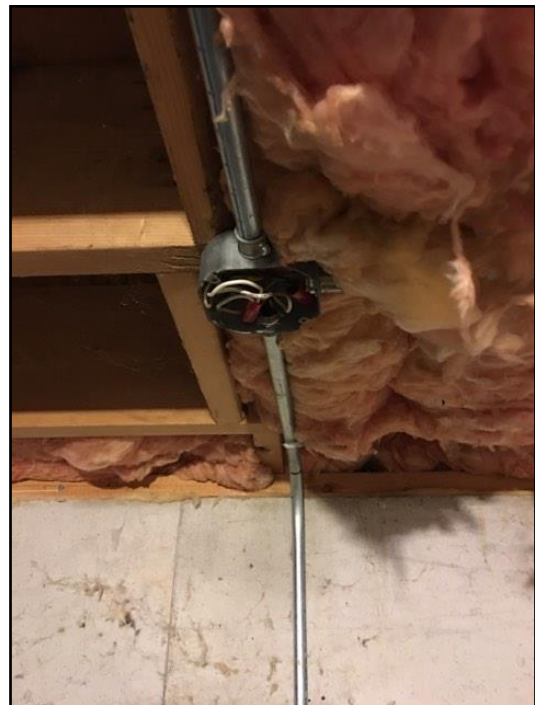
**32. Condition:** • [Cover loose or missing](#)

*Missing Cover Plate*

*Cover loose or missing*

**Task:** Replace

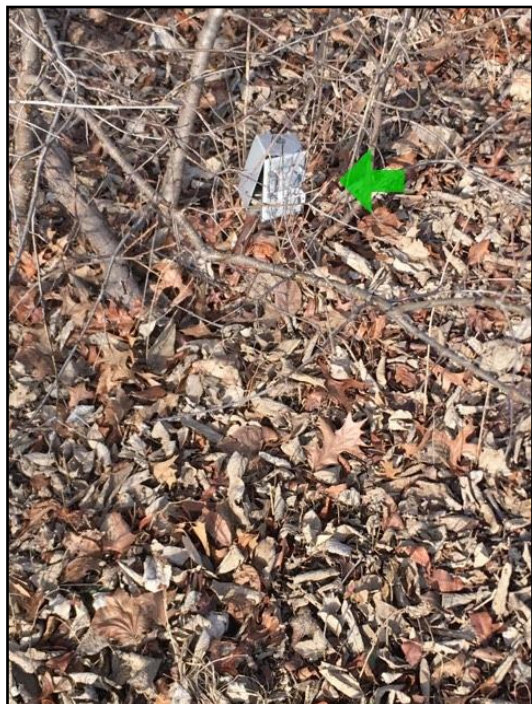
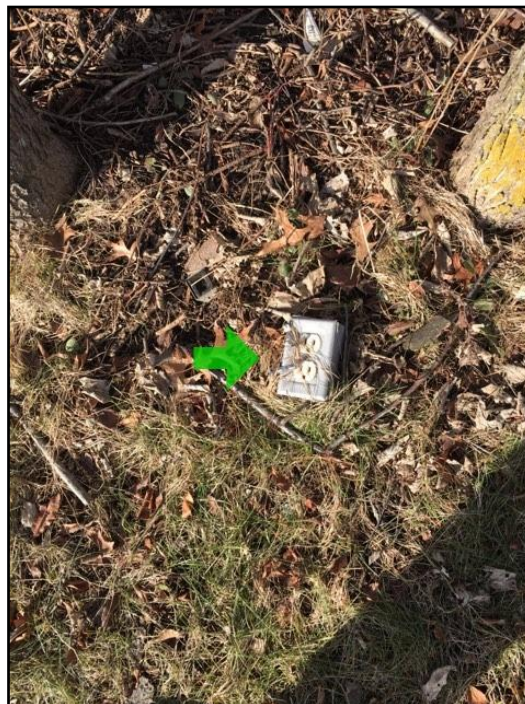
### 33. Condition: • [Damage](#)

Damaged outlets noted along the rear yard tree line.

*Damage*

**Task:** Remove or Replace

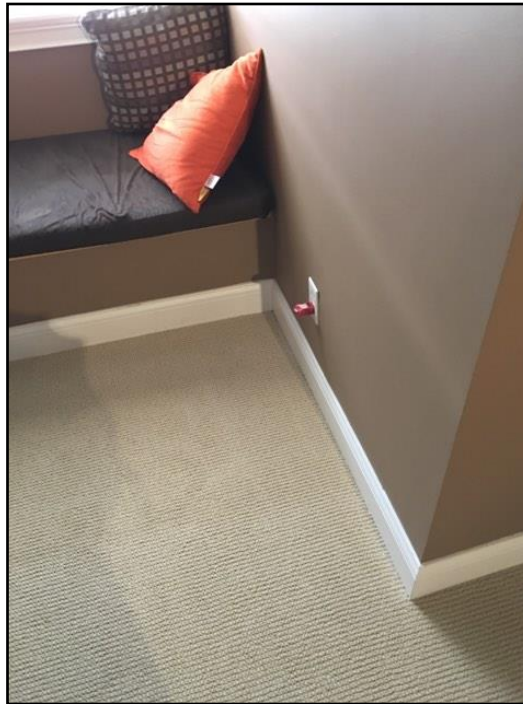
### 34. Condition: • [Inoperative](#)

*Inoperative*

**Task:** Repair

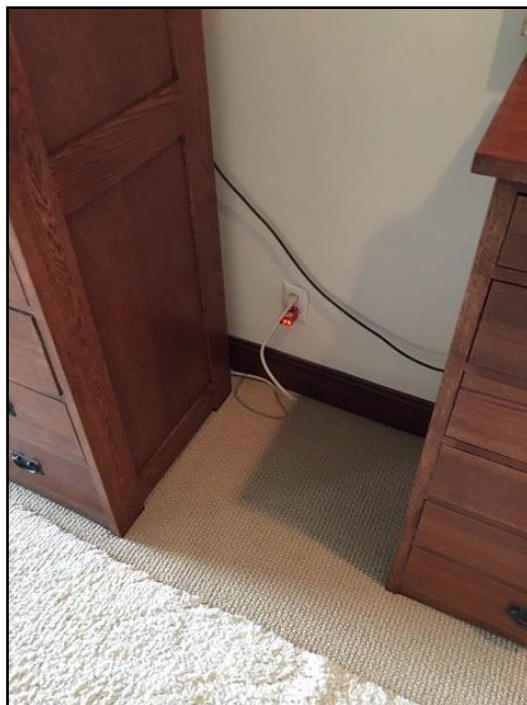
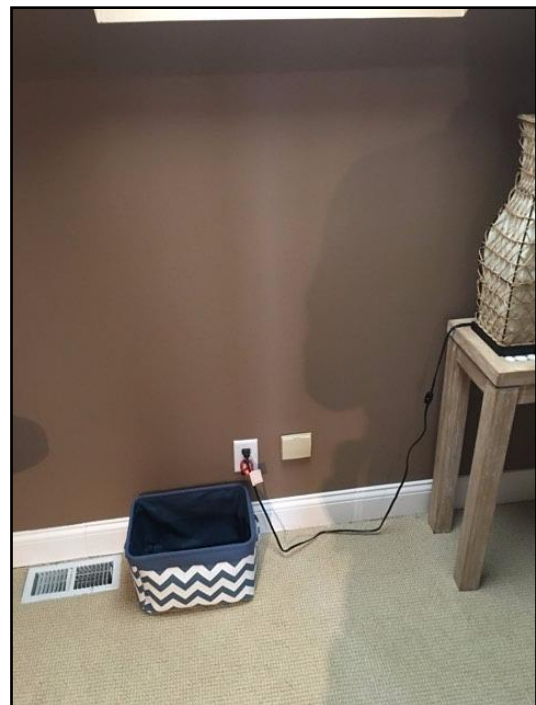
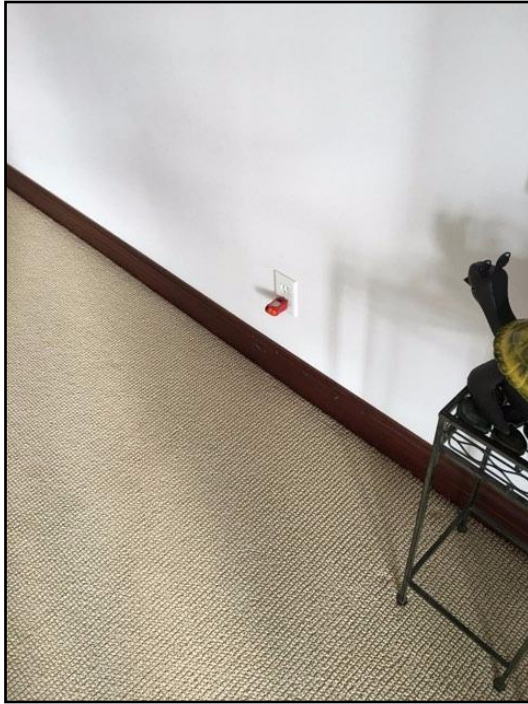
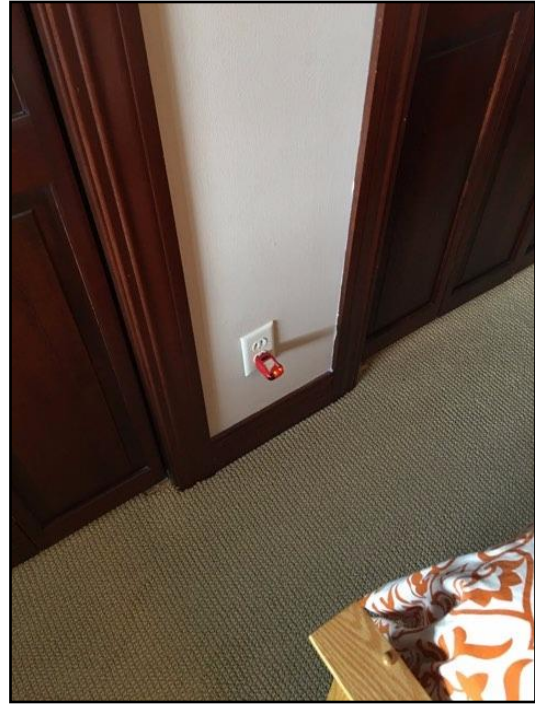
## 35. Condition: • [Loose](#)

*Loose*

Loose

**Task:** Repair

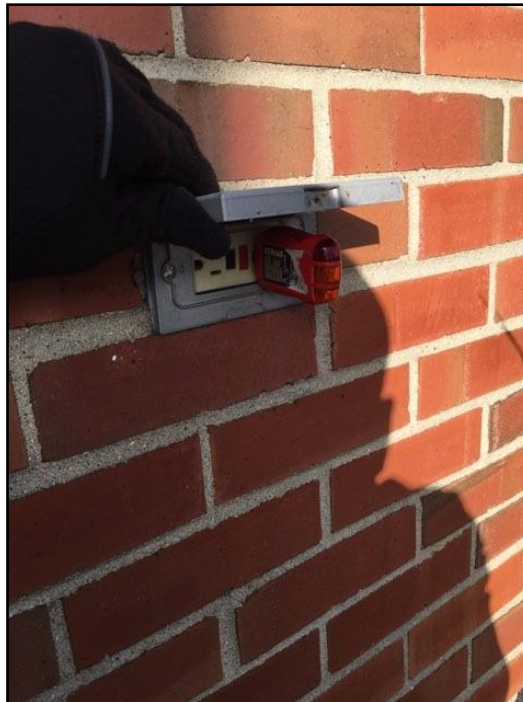
**36. Condition:** • [Test faulty on Ground Fault Circuit Interrupter \(GFCI\)](#)

Test faulty on Ground Fault Circuit...

**Task:** Repair or replace

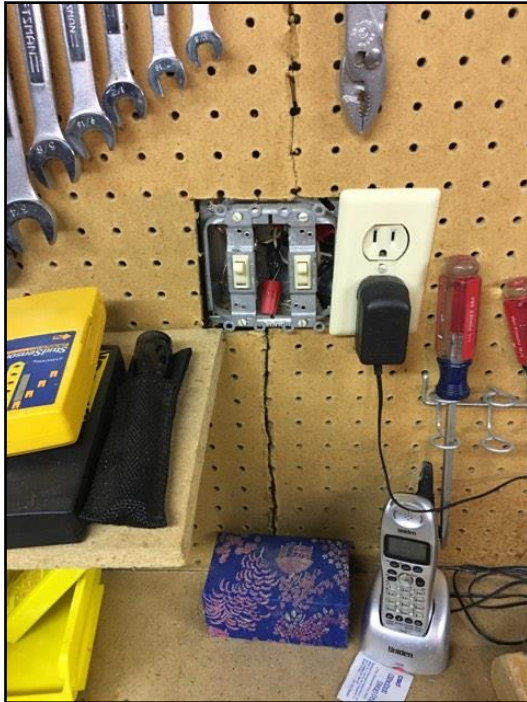
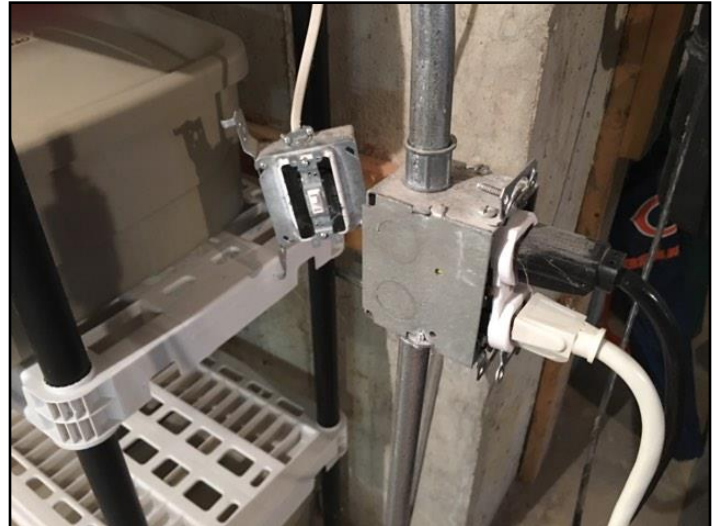
37. Condition: • [Missing](#)

Missing

Task: Replace

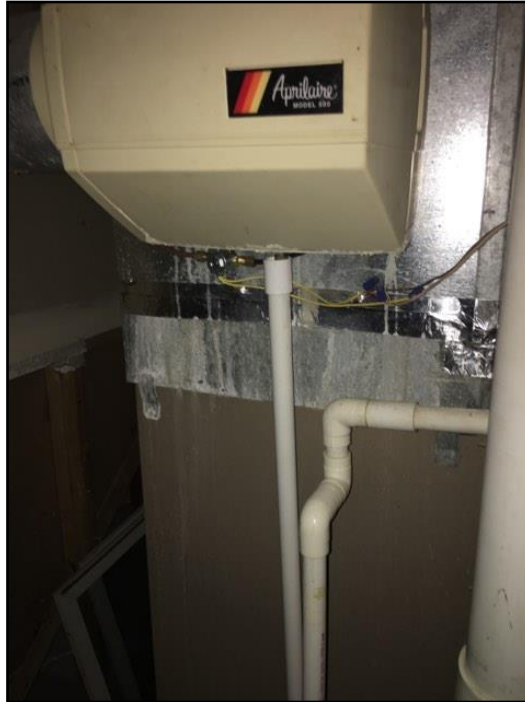
41. Condition: • [Leak](#)

Signs of past leakage from the humidifier.

Leak

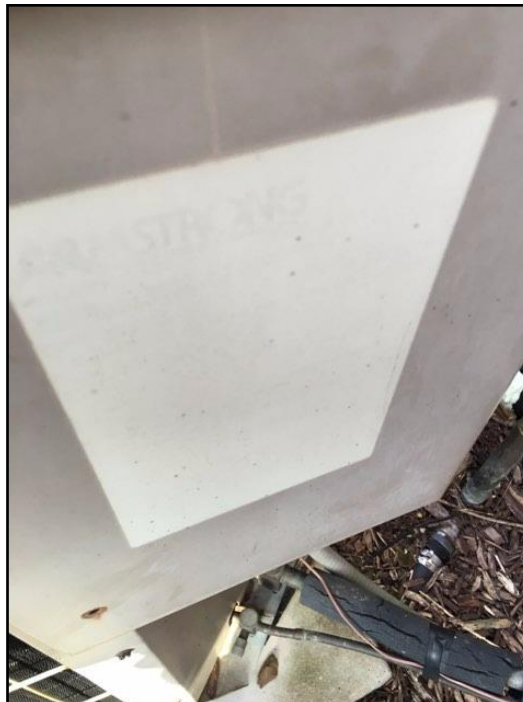
• Not legible

*Information Not Legible*

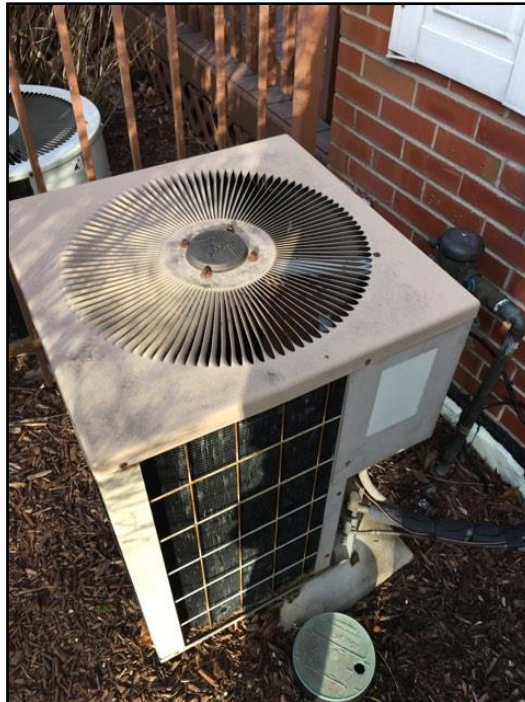
**48. Condition:** • The estimated age of the air conditioning exterior condenser/compressor suggests that it is at or beyond it's expected life span. Budgeting for eventual replacement is recommended.

**Task:** Upgrade

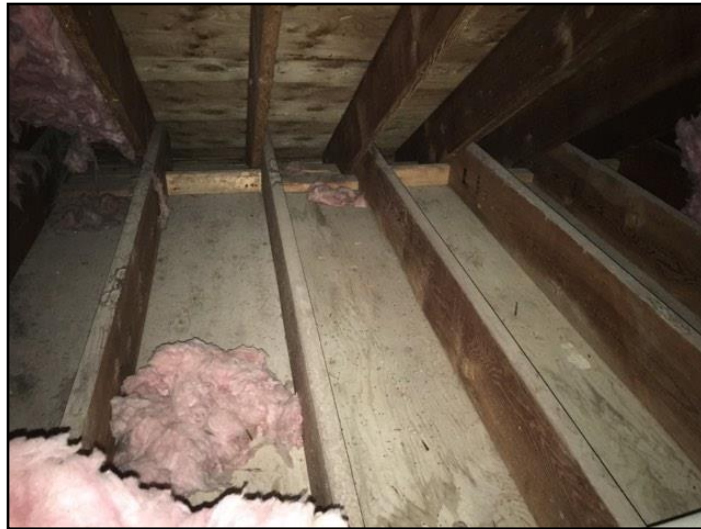
**50. Condition:** • [Gaps or voids](#)

*Gaps or voids*

**Task:** Replace

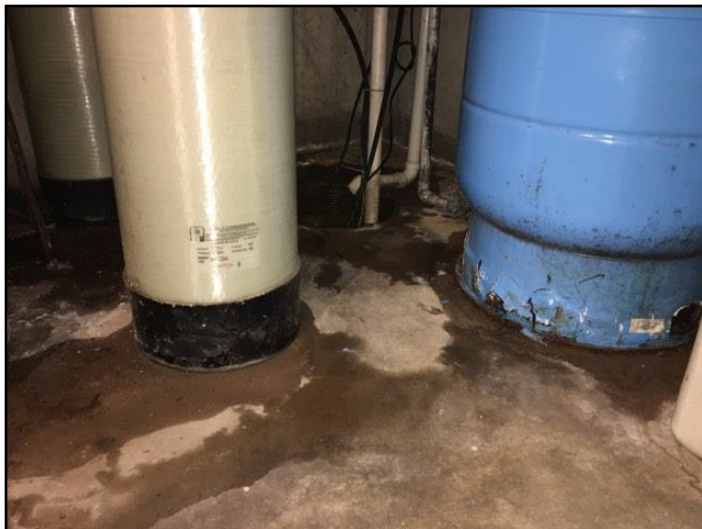
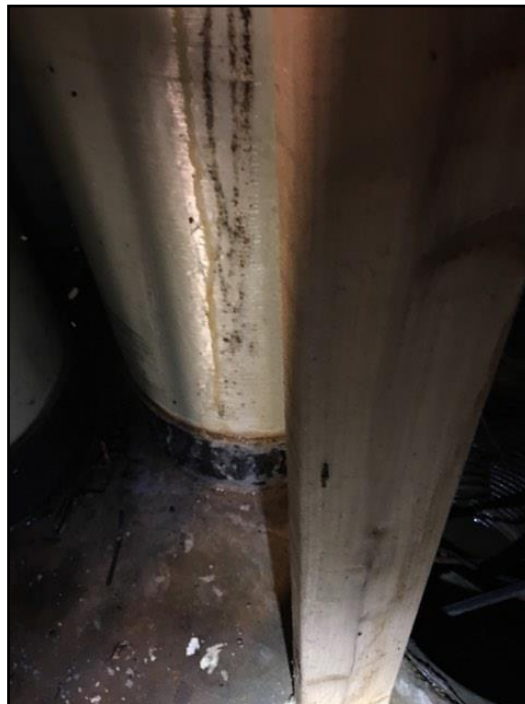
**51. Condition:** • [Leak](#)

It appears that the well pressure tank was leaking, but also the water treatment tanks appear to be leaking as well.

Leak

**Task:** Repair or replace

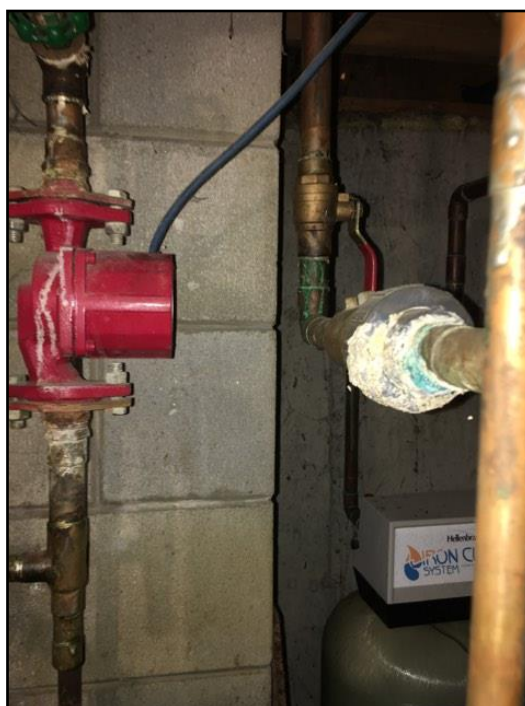
**52. Condition:** • Corrosion noted on supply piping near the water heater.

**Task:** Repair or replace

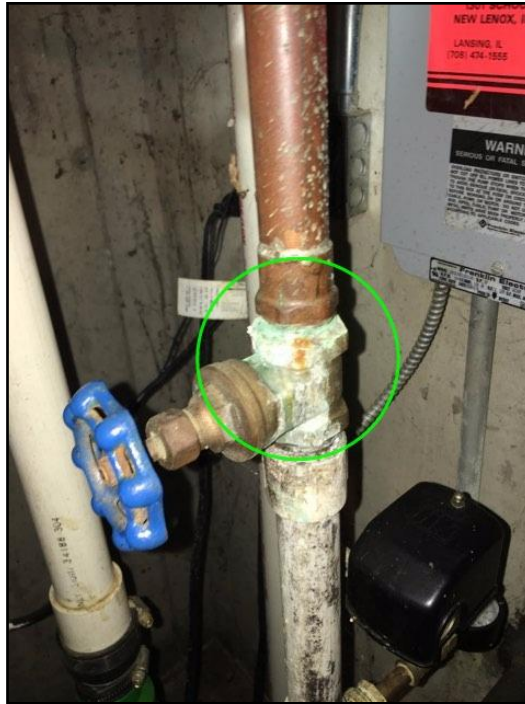
**53. Condition:** • [Leak](#)

*Leak*

**Task:** Repair

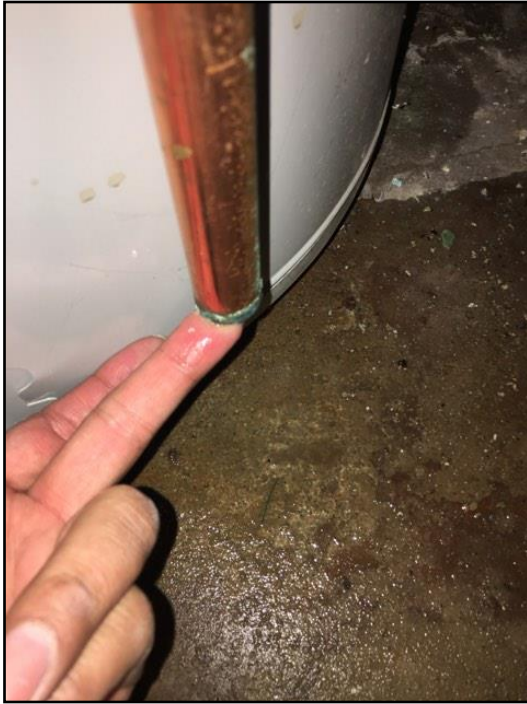
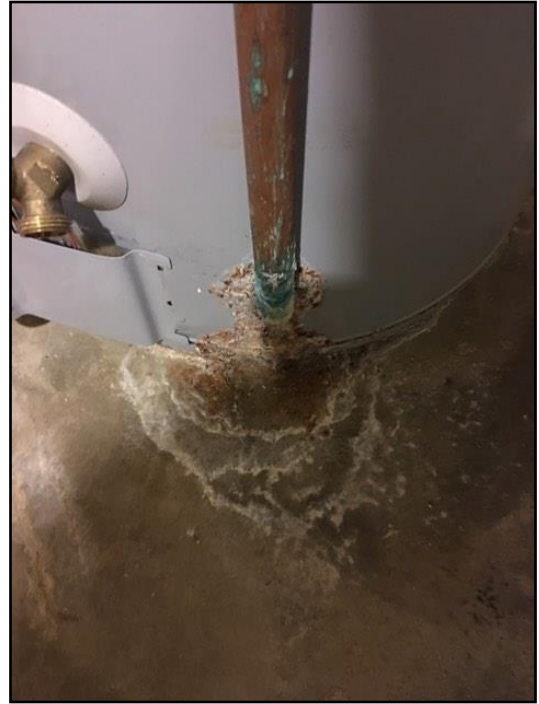
**56. Condition:** • [Leaking](#)

*Leaking*

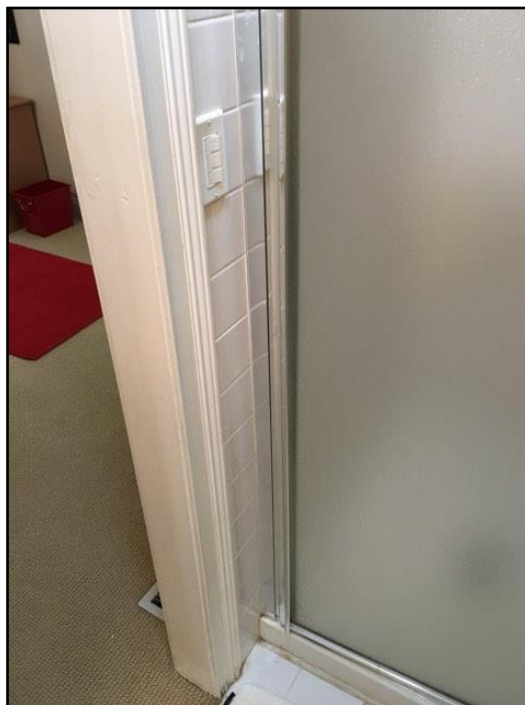
**62. Condition:** • The shower enclosure door was stiff to close.

**Task:** Repair

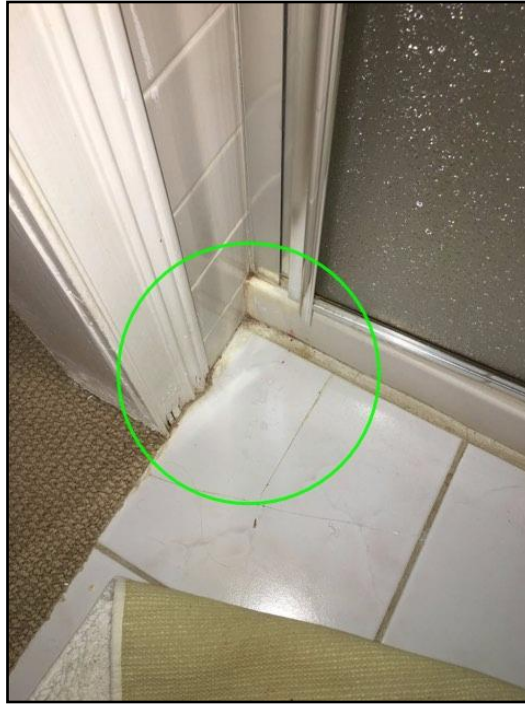
**63. Condition:** • [Leak](#)

The orientation of the shower head direction and door opening can contribute water in the affected areas.

*Leak*

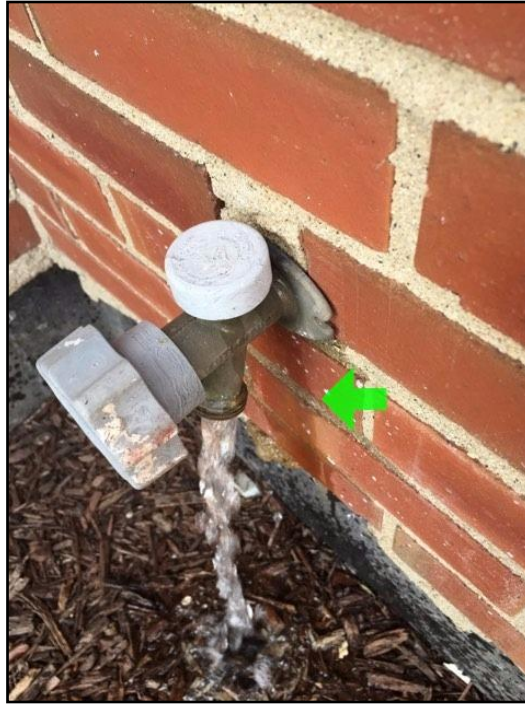
**64. Condition:** • [Leak or drip](#)

The spigot has a secondary leak when operated.

*Leak or drip*

**Task:** Repair

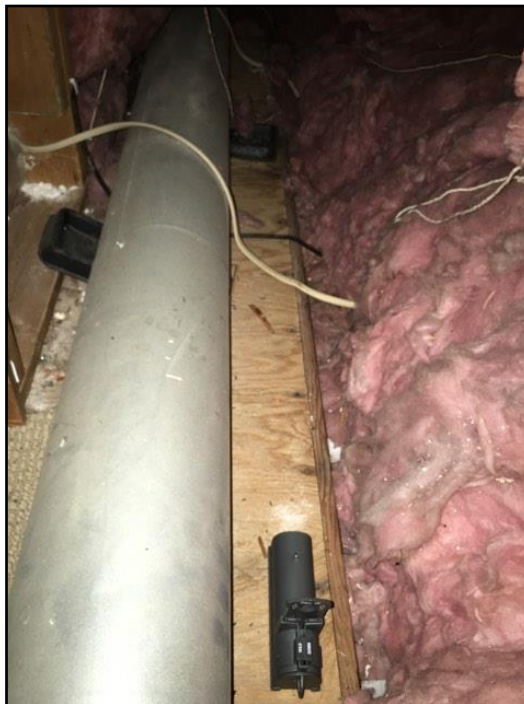
**Location:** East Attic

**66.** • Signs of past rodent activity noted in the attic.

**Task:** Request disclosure

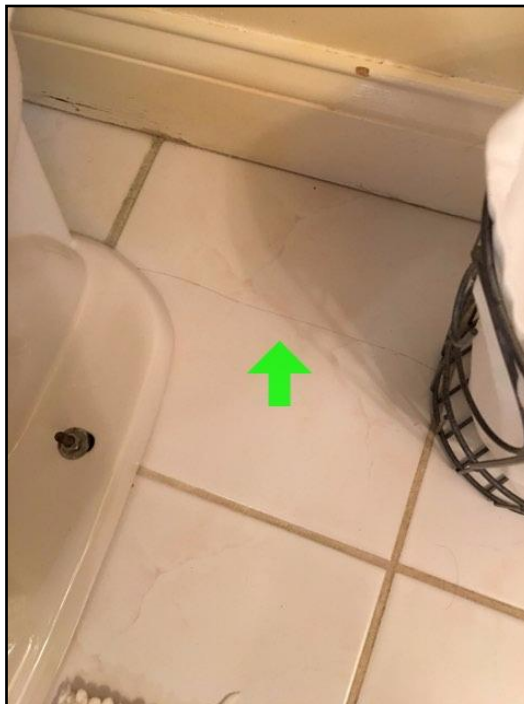
*Tiles cracked*

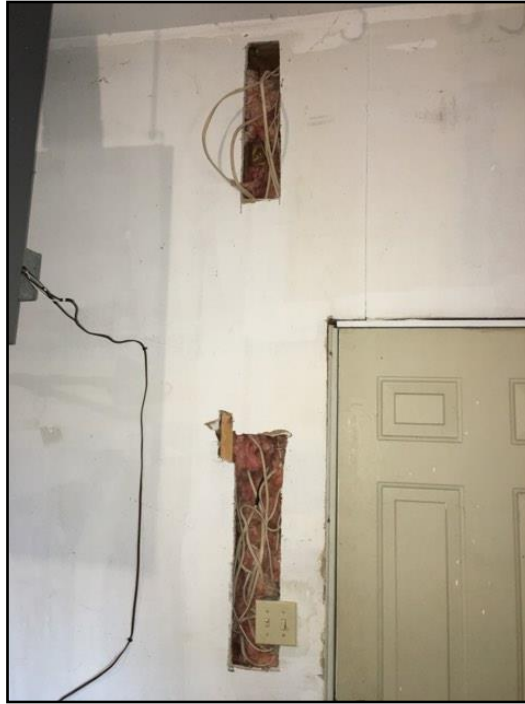
*Damaged*

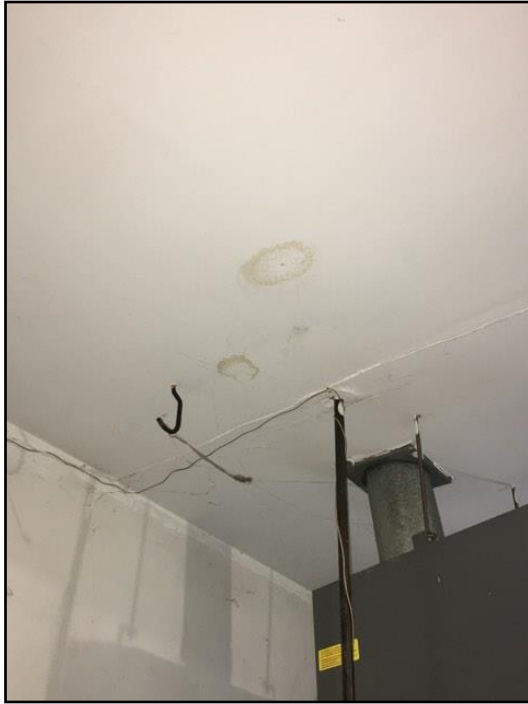
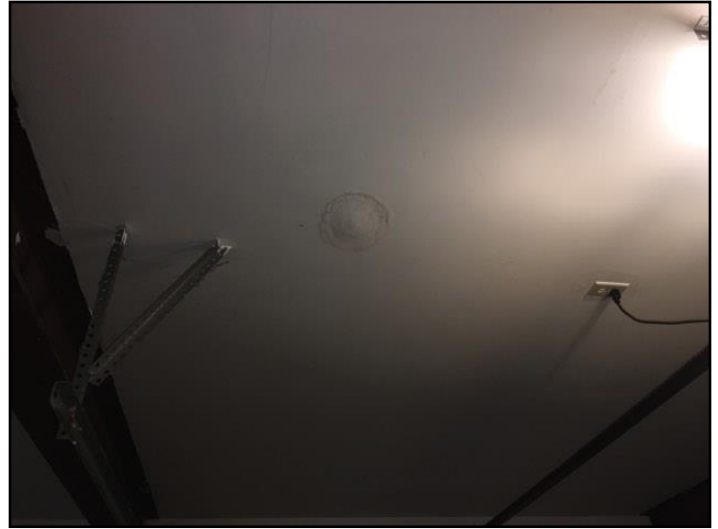
*Water damage*

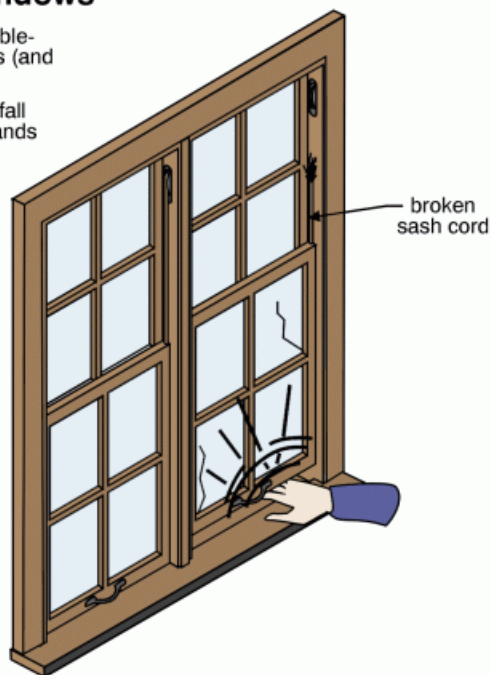
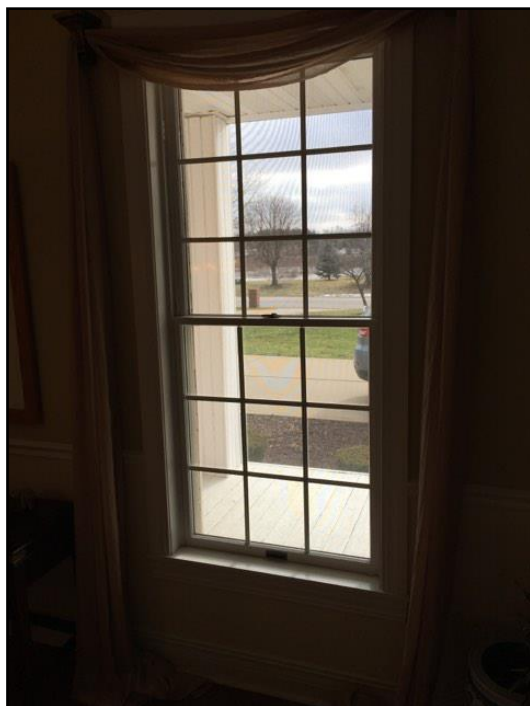
*Won't stay open*

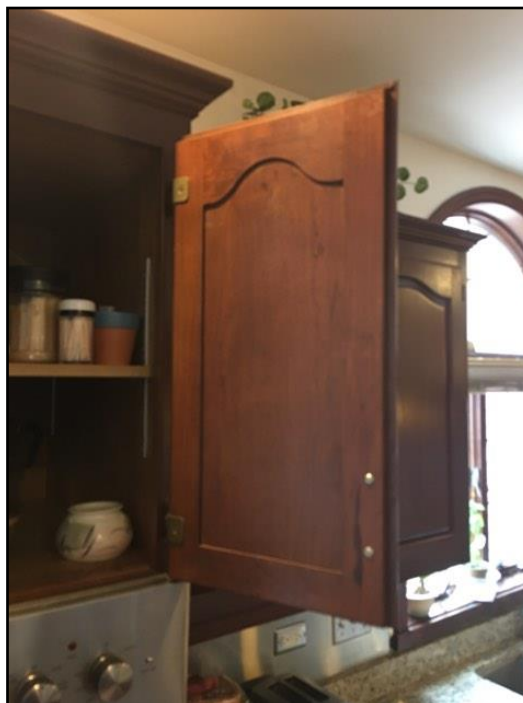
*Doors or drawers missing or loose*

**Task:** Repair

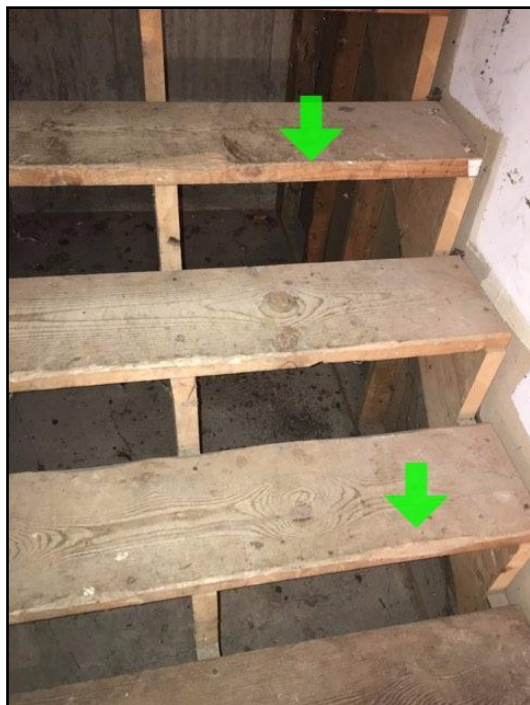
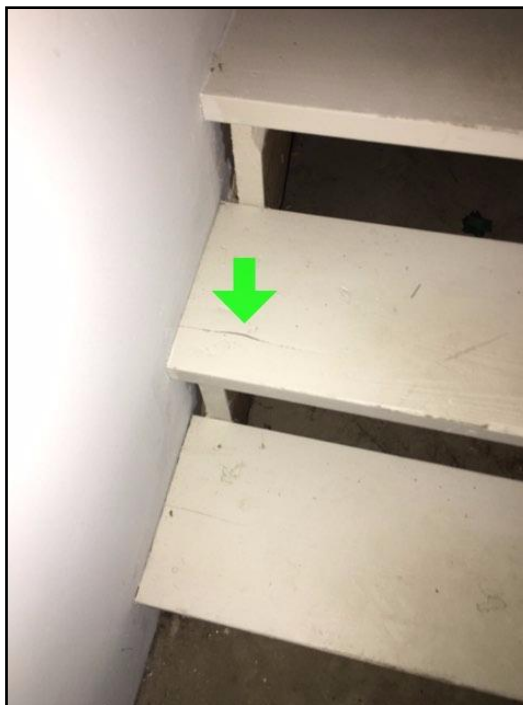
*Worn or damaged*

Task: Repair
