# Your Inspection Report

14242 Summerfield Dr  
New Lenox, IL 60451

Saturday, January 16, 2016

Report No. 6673

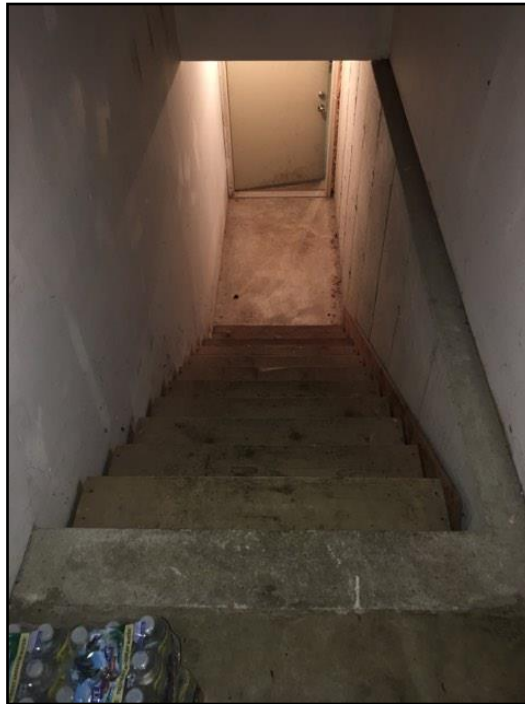
*Missing*

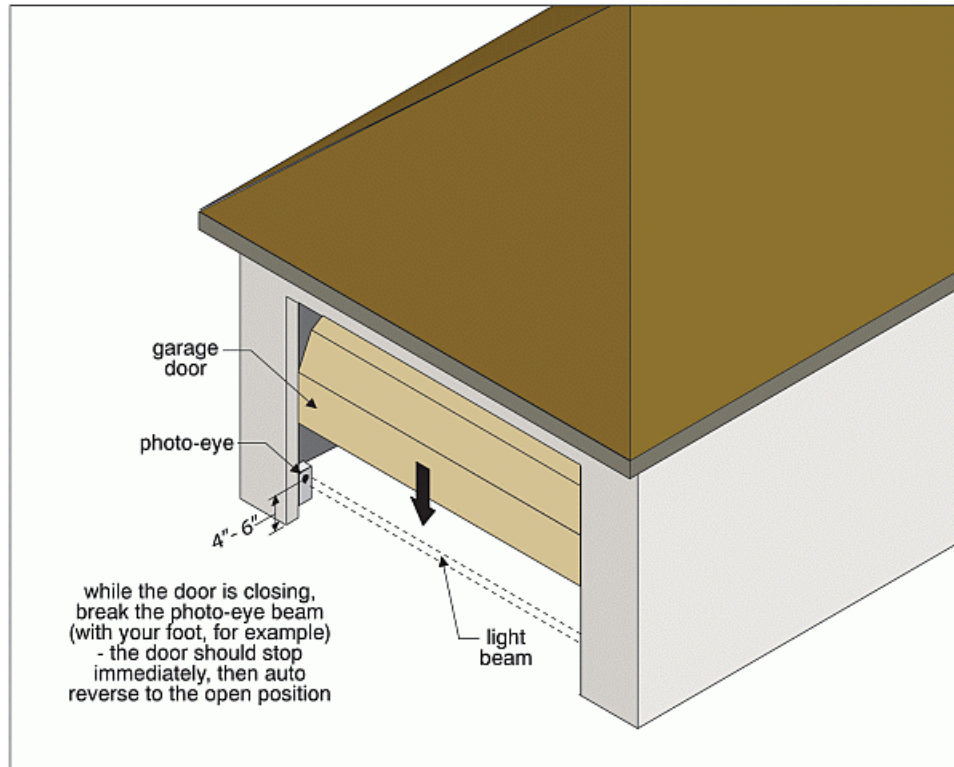
**88. Condition:** • [Fails to auto reverse](#)

**Task:** Provide

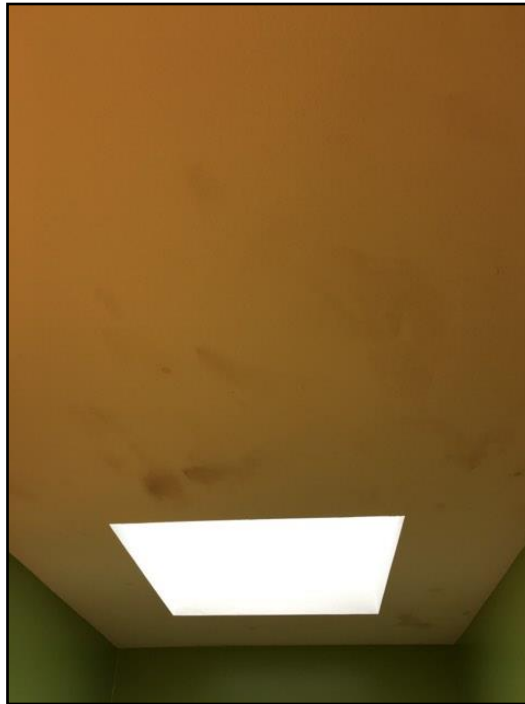
### **89. Condition:** • [Inadequate air movement](#)

*Inadequate air movement*

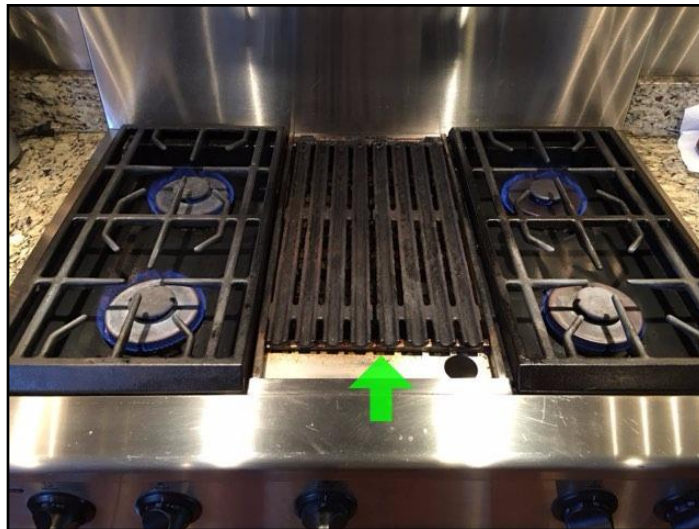
*Burner inoperative*

**Task:** Repair
