Your Inspection Report

123 Main Street
Homewood, IL 60430

INSPECTION DATE:
Wednesday, May 16, 2018

RE: Report No. 9190
123 Main Street
Homewood, IL
60430

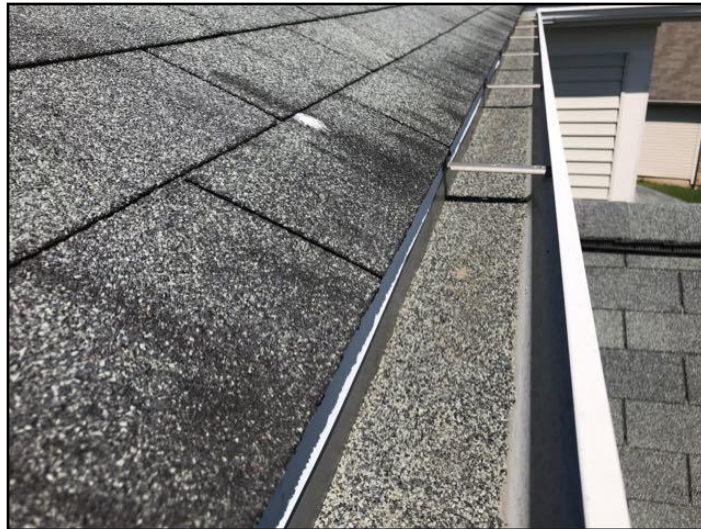
SLOPED ROOFING \ Asphalt shingles

Condition: • [Granule loss](#)

Implication(s): Chance of water damage to contents, finishes and/or structure

Task: Monitor

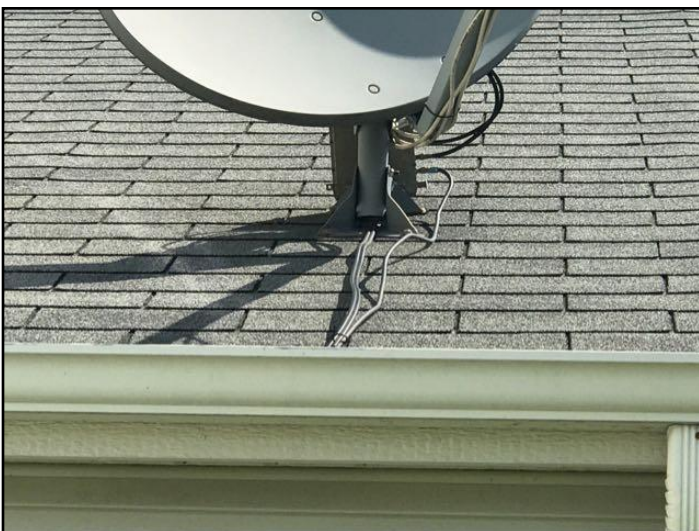
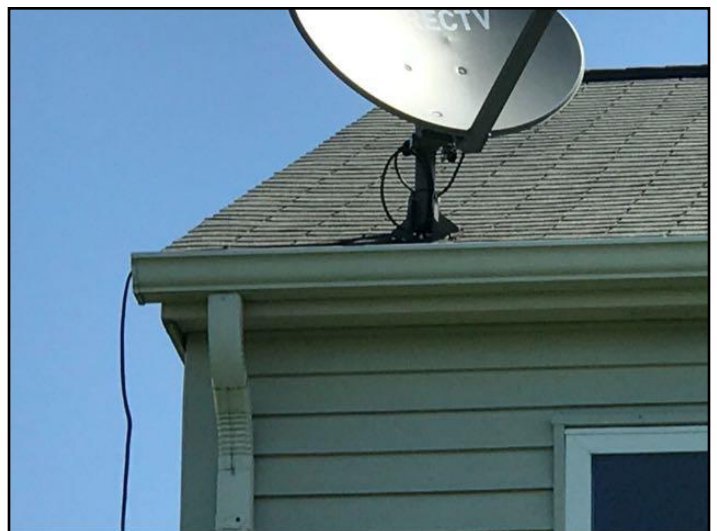
Condition: • [Vulnerable areas](#)

Satellite dish attachments and/or antennas can be a source of leakage without regular maintenance.

Implication(s): Chance of water damage to contents, finishes and/or structure

Task: Improve

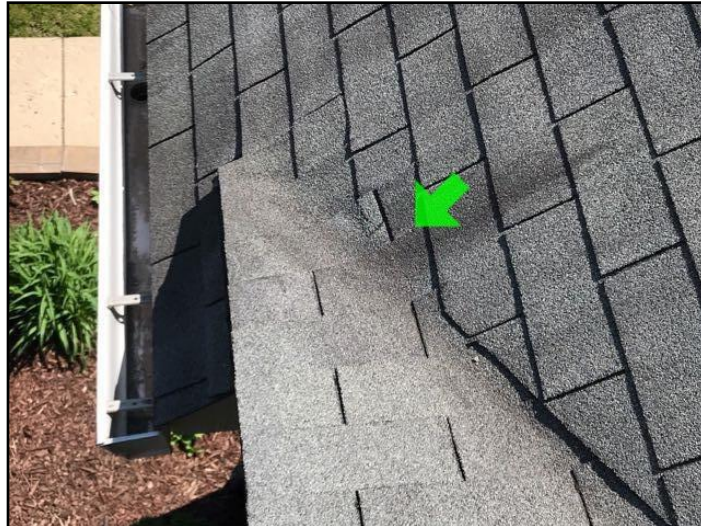
SLOPED ROOF FLASHINGS \ Valley flashings

Condition: • Wear damage noted at the base of the valley.

Task: Repair or replace

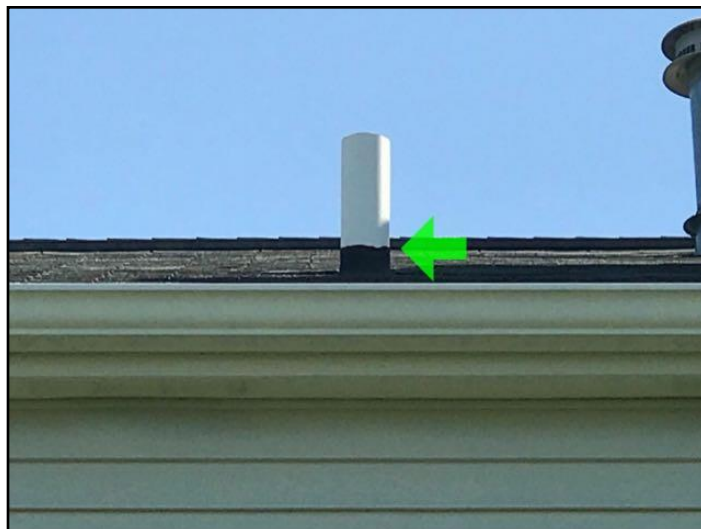
SLOPED ROOF FLASHINGS \ Pipe/stack flashings

Condition: • [Damage](#)

Implication(s): Chance of water damage to contents, finishes and/or structure

Task: Replace

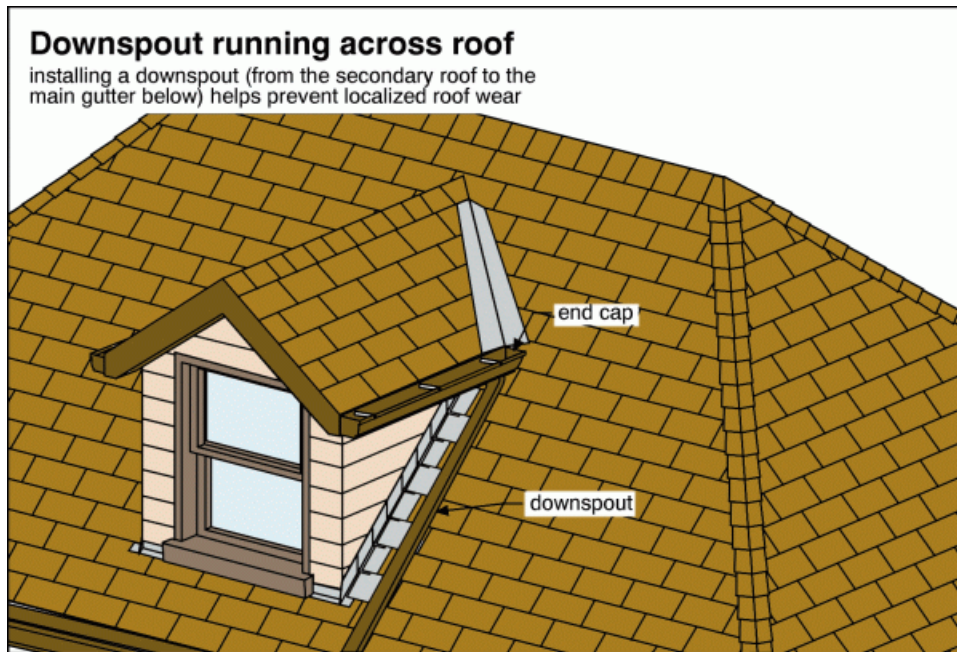
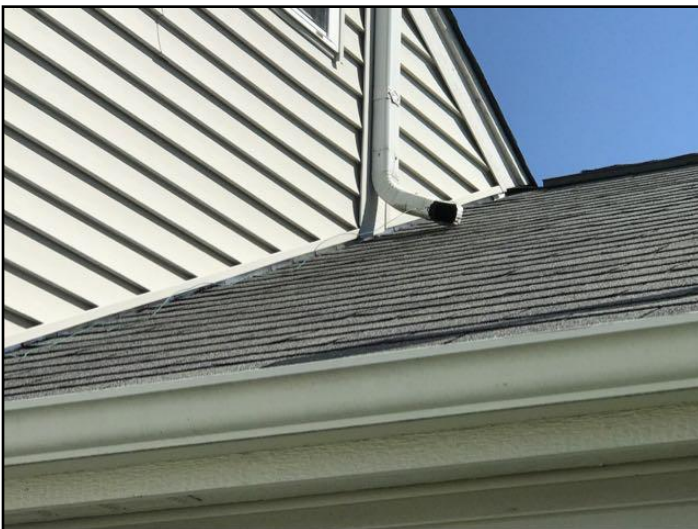
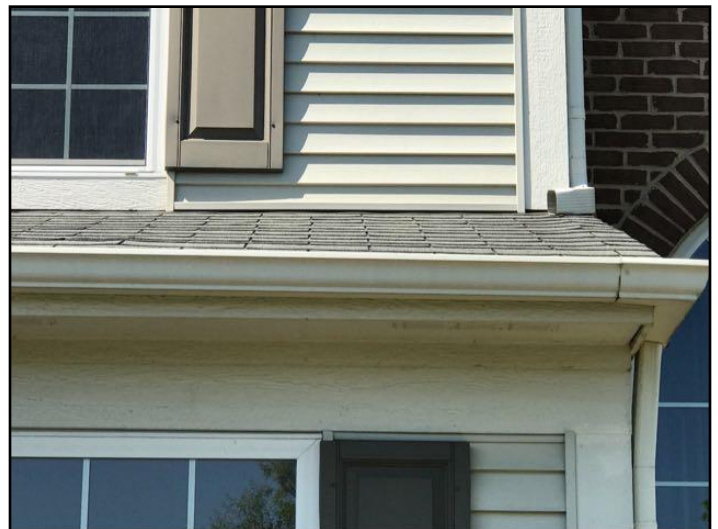
ROOF DRAINAGE \ Downspouts

Condition: • [Discharge onto roofs](#)

Implication(s): Chance of water damage to contents, finishes and/or structure

Task: Improve

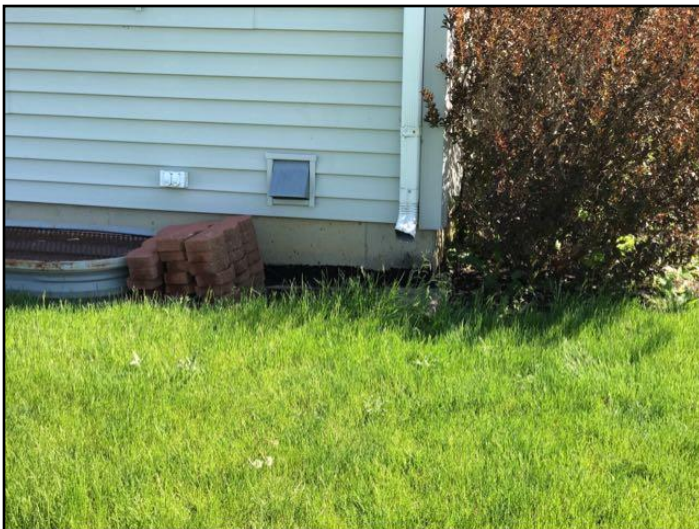
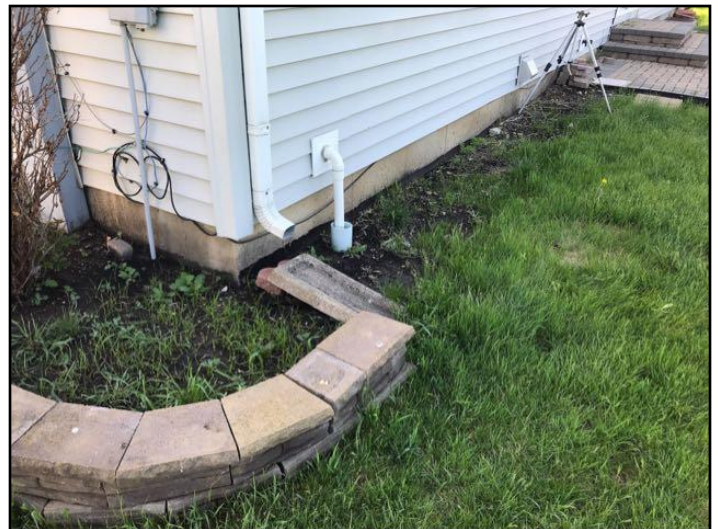
Condition: • [Should discharge 6 feet from building](#)

Implication(s): Chance of water damage to contents, finishes and/or structure

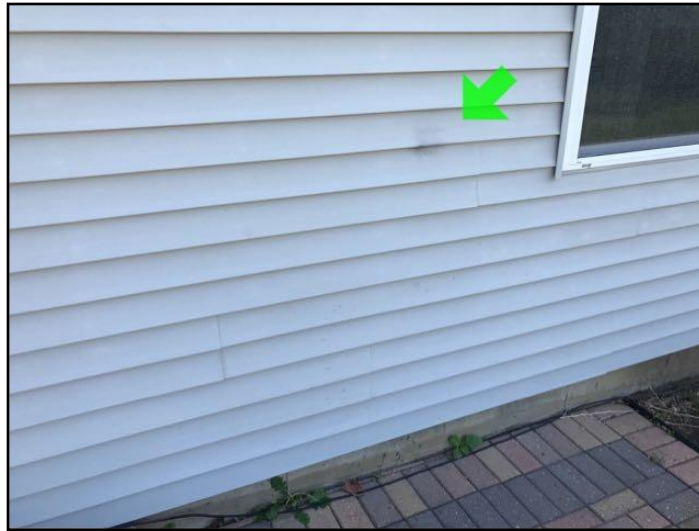
WALLS \ Vinyl siding

Condition: • [Mechanical damage](#)

Minor burn damage at siding

Task: Replace

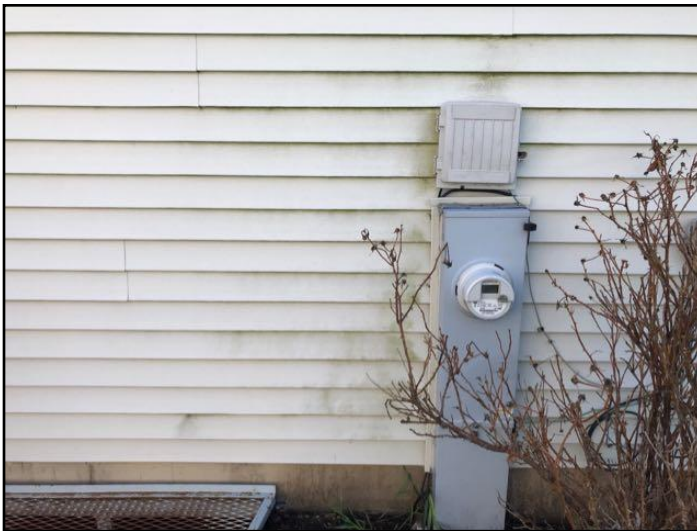
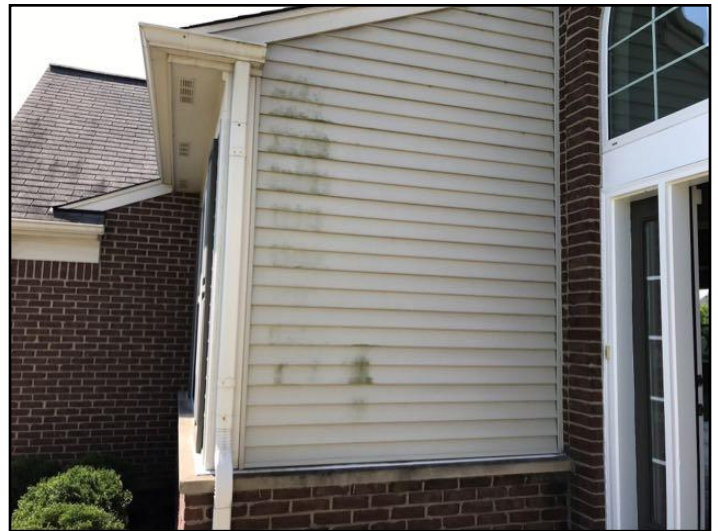
Condition: • [Discolored](#)

Minor moss discoloration noted from a lack of sunlight.

Implication(s): Shortened life expectancy of material | Material deterioration

Task: Clean

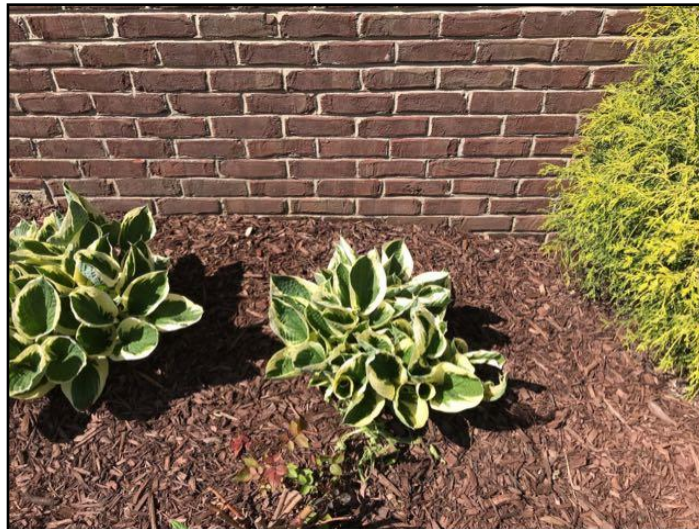
WALLS \ Brick, stone and concrete

Condition: • [Too close to grade](#)

Implication(s): Chance of water entering building | Weakened structure | Rot

Task: Improve

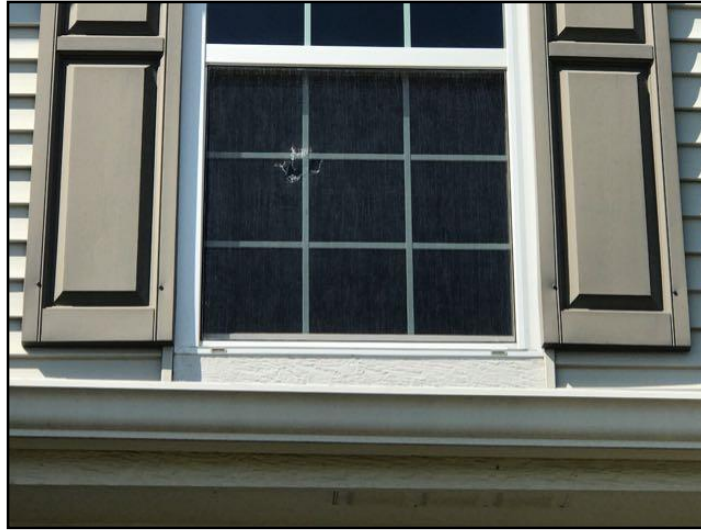
EXTERIOR GLASS/WINDOWS \ Storms and screens

Condition: • [Torn or holes](#)

Implication(s): Chance of pests entering building

Task: Repair

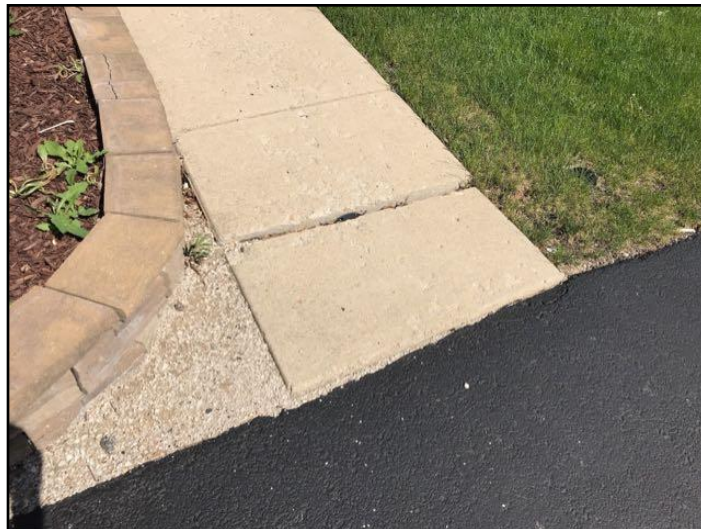
LANDSCAPING \ Walkway

Condition: • [Uneven \(trip hazard\)](#)

Implication(s): Physical injury

Task: Repair

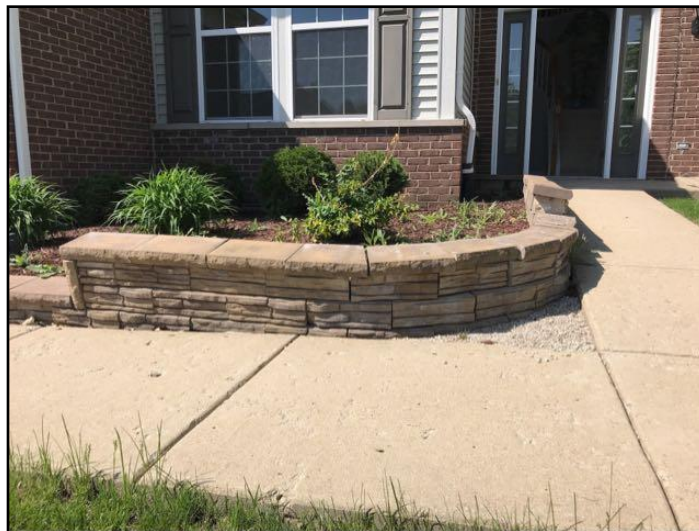
LANDSCAPING \ Retaining wall

Condition: • [Settling or shifting](#)

Implication(s): Weakened structure | Chance of movement

Task: Repair

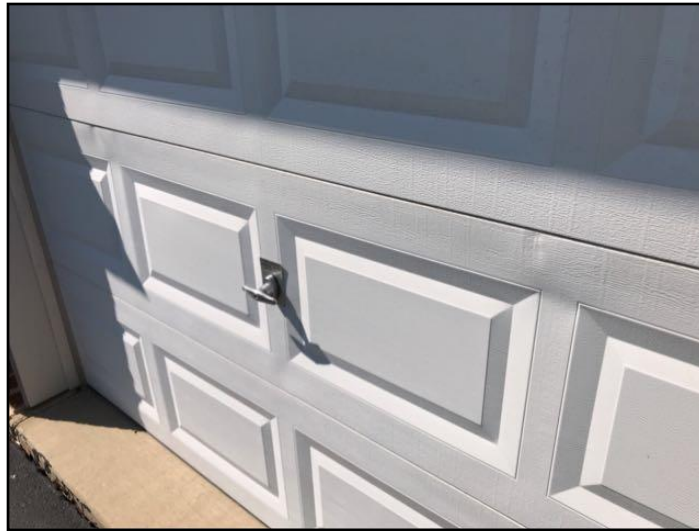
GARAGE \ Vehicle doors

Condition: • Dented

Implication(s): Damage to equipment

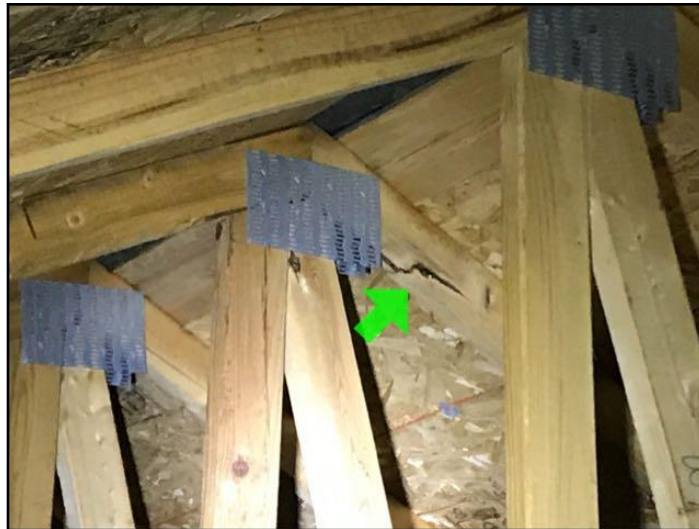
Condition: • [Split](#)

Task: Further evaluation

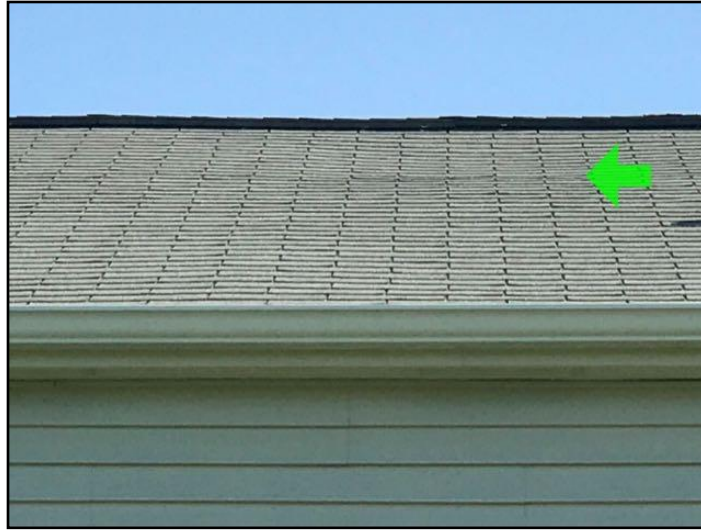
ROOF FRAMING \ Sheathing

Condition: • [Sagging](#)

A view from the attic did not show any obvious signs of damage.

Task: Further evaluation

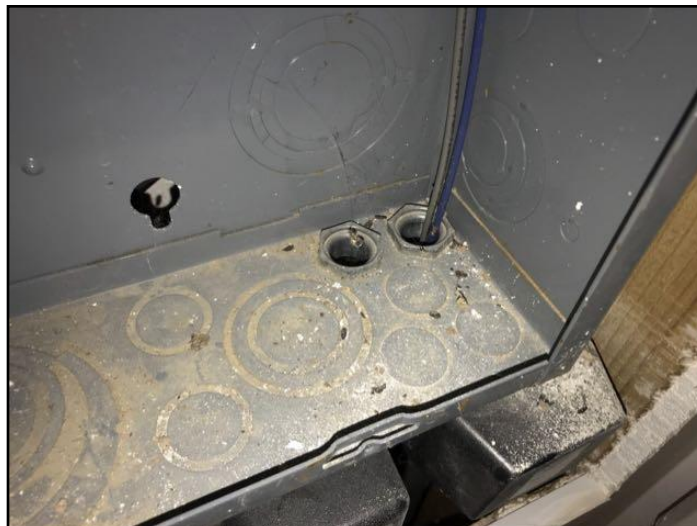
Condition: • [Openings in panel](#)

Implication(s): Electric shock | Fire hazard

Task: Replace

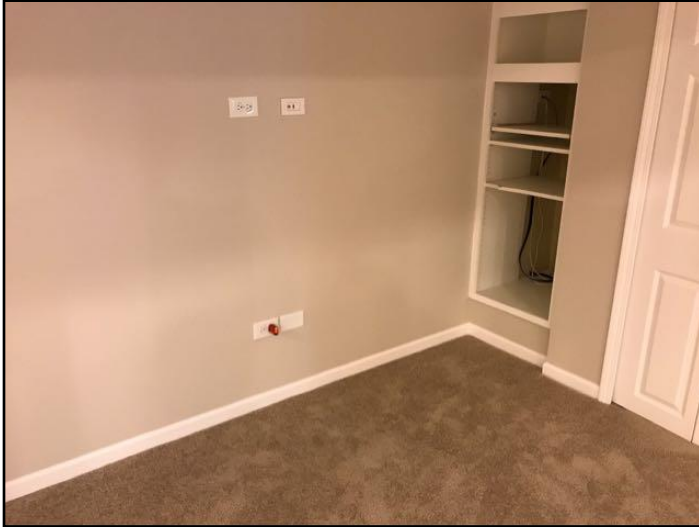
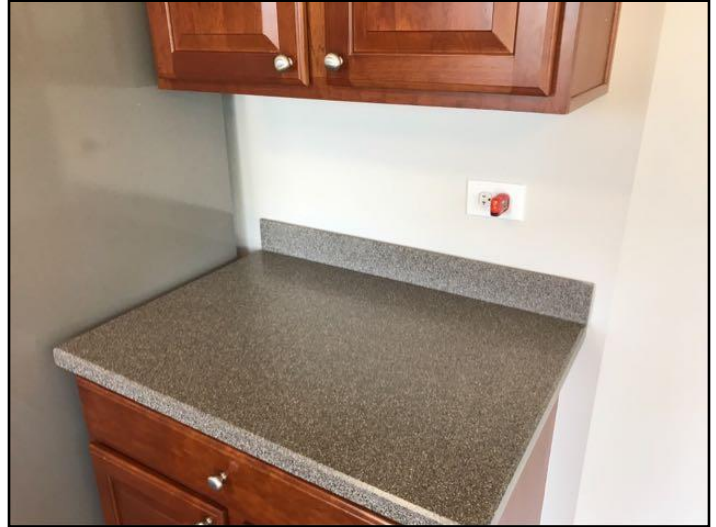
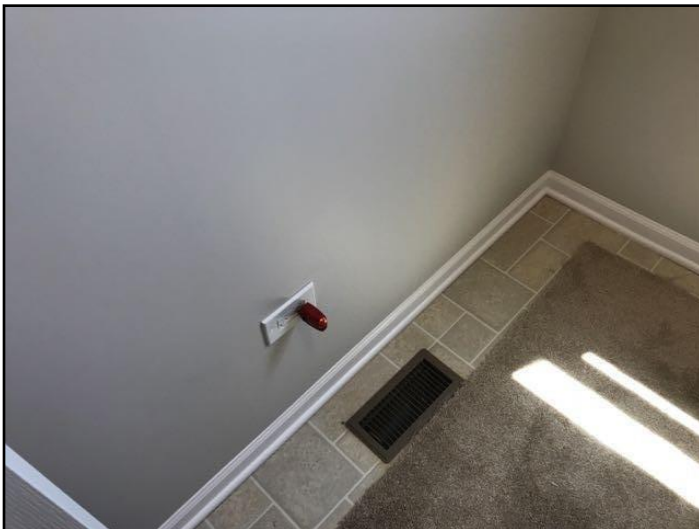
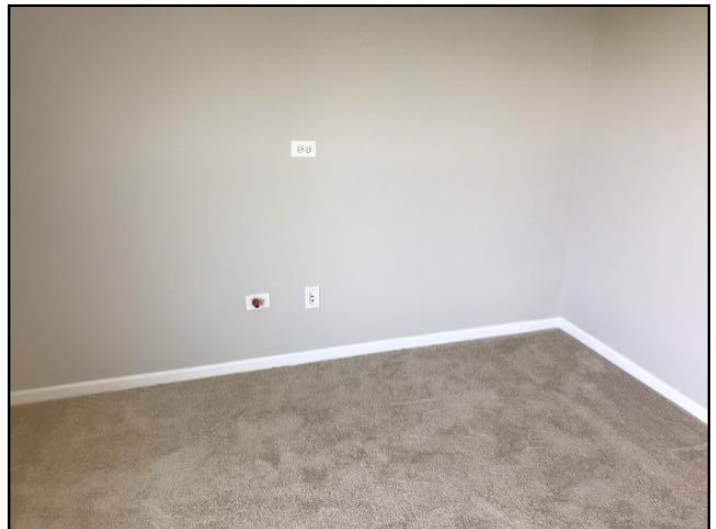
DISTRIBUTION SYSTEM \ Outlets (receptacles)

Condition: • [Loose](#)

Implication(s): Electric shock | Fire hazard

Task: Repair

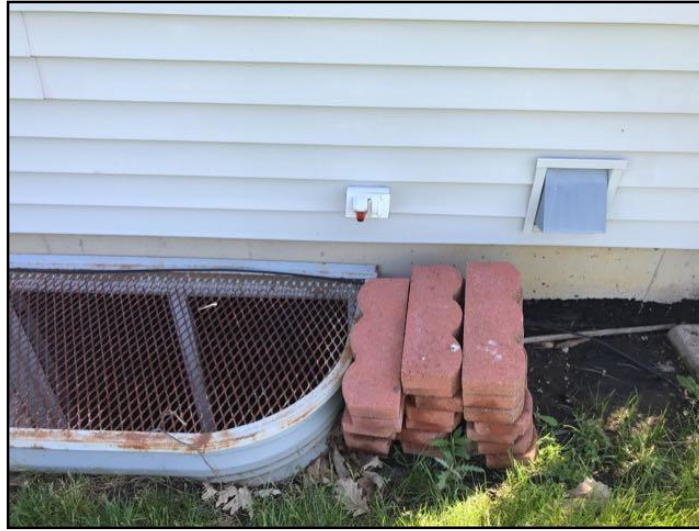
Condition: • [No GFCI/GFI \(Ground Fault Circuit Interrupter\)](#)

Implication(s): Electric shock

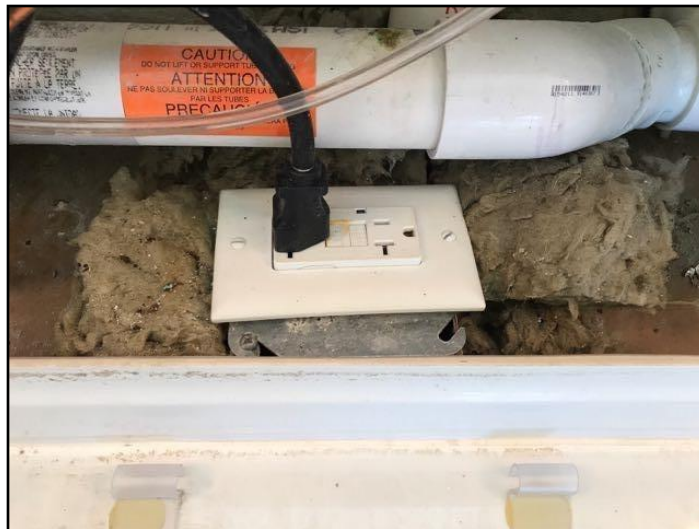
Condition: • [Test faulty on GFCI/GFI \(Ground Fault Circuit Interrupter\)](#)

Implication(s): Electric shock

Task: Replace

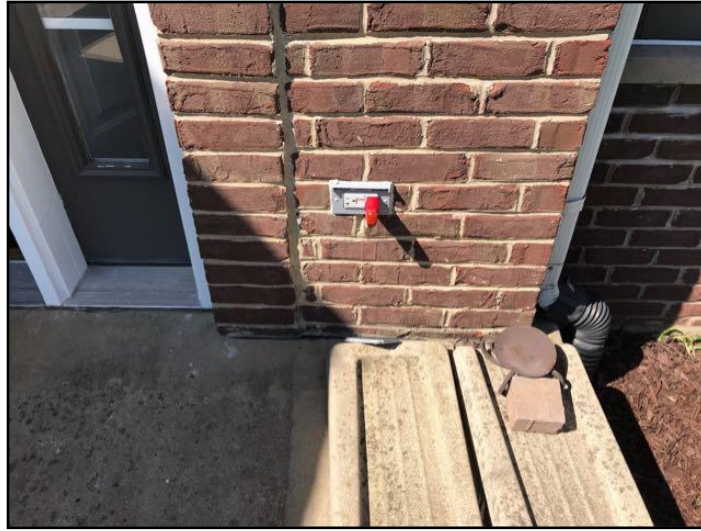
DISTRIBUTION SYSTEM \ Cover plates

Condition: • [Missing](#)

Task: Repair or replace

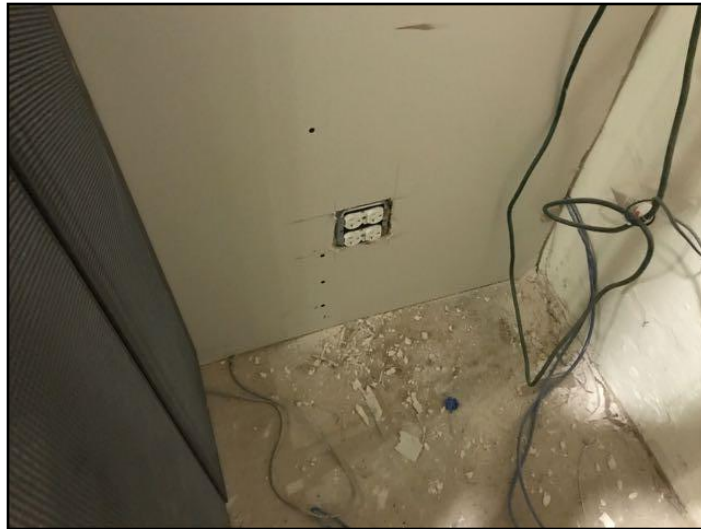
Condition: • [Missing](#)

Implication(s): Electric shock

Task: Replace

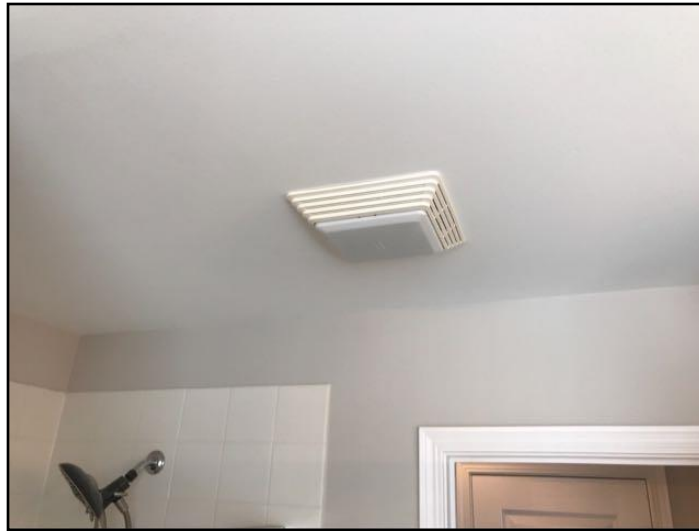
DISTRIBUTION SYSTEM \ Lights

Condition: • [Inoperative](#)

Implication(s): Inadequate lighting

Task: Repair or replace

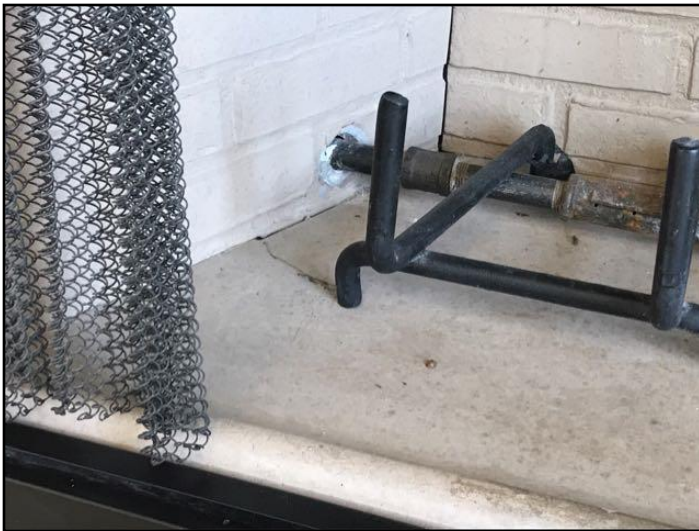
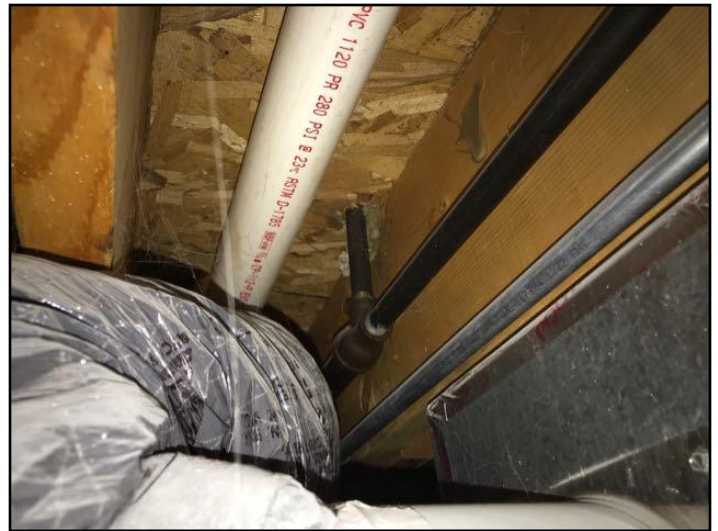
Condition: • There is no gas valve shut off for the fireplace.

Task: Further evaluation

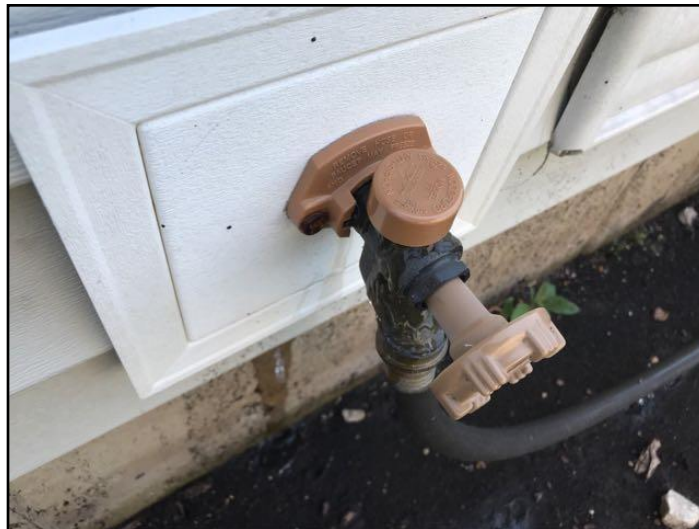
Condition: • [Leak or drip](#)

Implication(s): Chance of water damage to contents, finishes and/or structure

Task: Repair

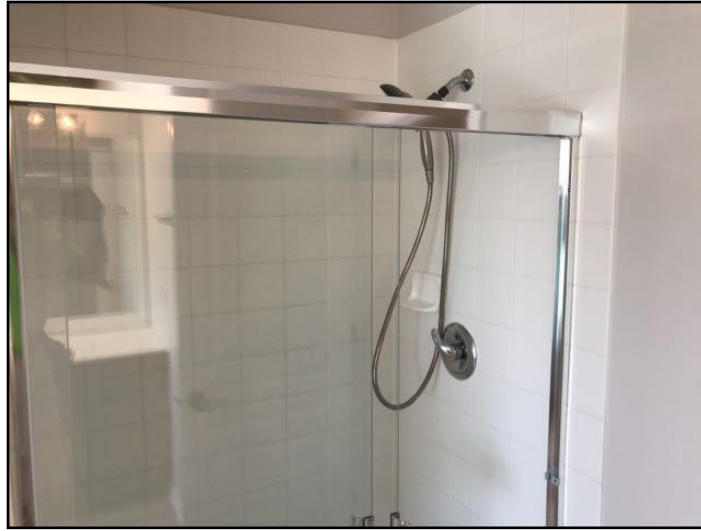
Condition: • The limiter was improperly installed and does not allow for the full range of hot water. For further info, please view: http://www.ehow.com/how_12152564_adjust-limiter-shower-valve.html

Task: Repair

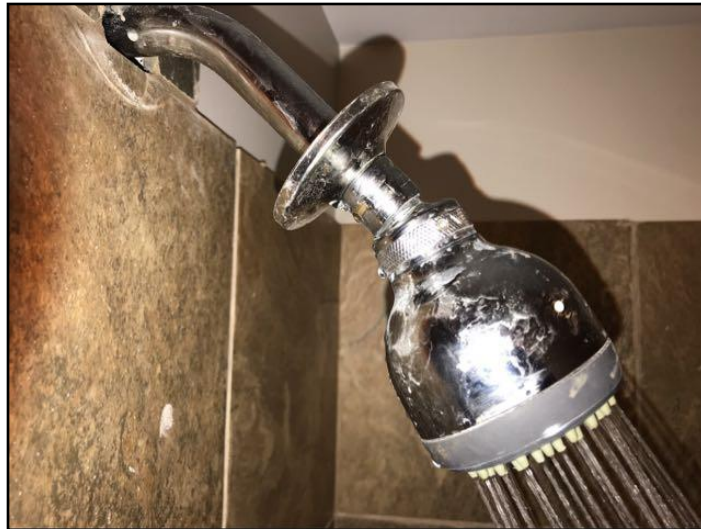
Condition: • [Drip, leak](#)

Implication(s): Chance of water damage to contents, finishes and/or structure

Task: Repair

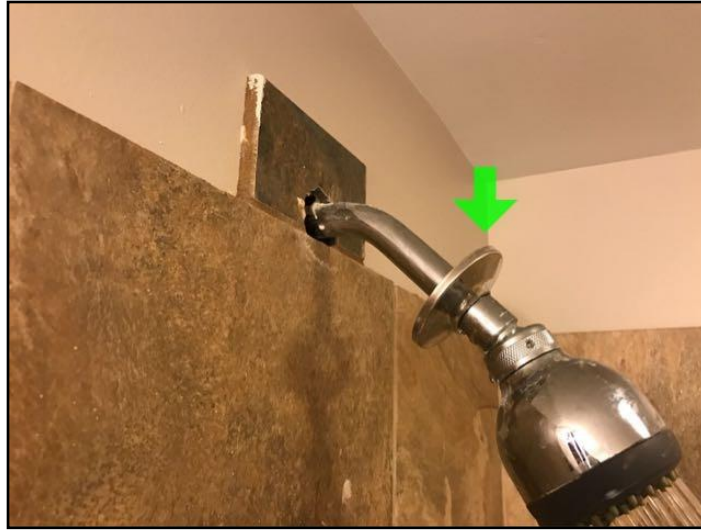
Condition: • [Loose](#)

Loose flange noted at the shower head.

Implication(s): Equipment failure

Task: Repair

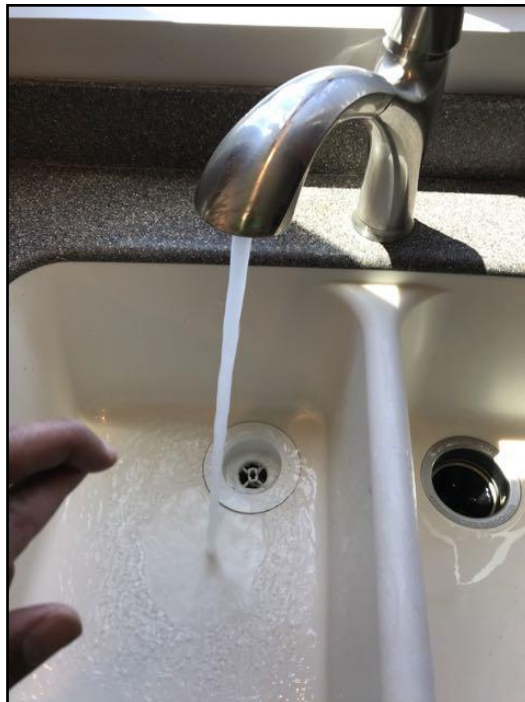
Condition: • [Stiff or inoperative](#)

There was no hot water at the faucet.

Task: Repair

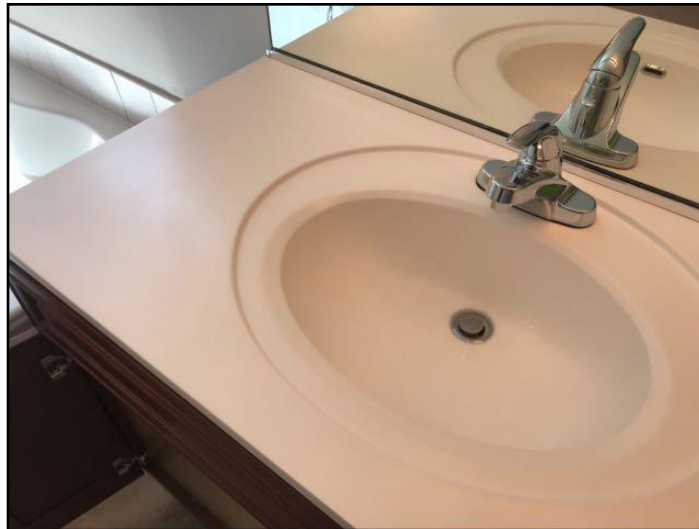
FIXTURES AND FAUCETS \ Basin, sink and laundry tub

Condition: • Drain stop ineffective

Task: Repair

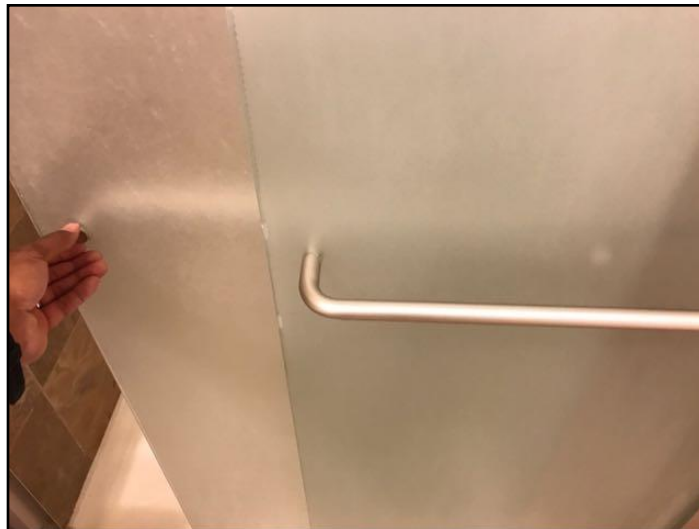
FIXTURES AND FAUCETS \ Shower stall enclosure

Condition: • Loose handles noted at the shower enclosure door.

Task: Repair

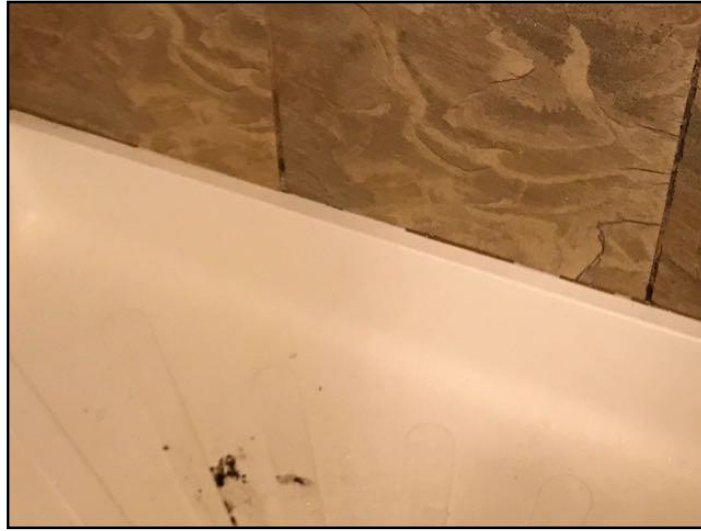
Condition: • [Caulking loose, missing or deteriorated](#)

Implication(s): Chance of water damage to contents, finishes and/or structure

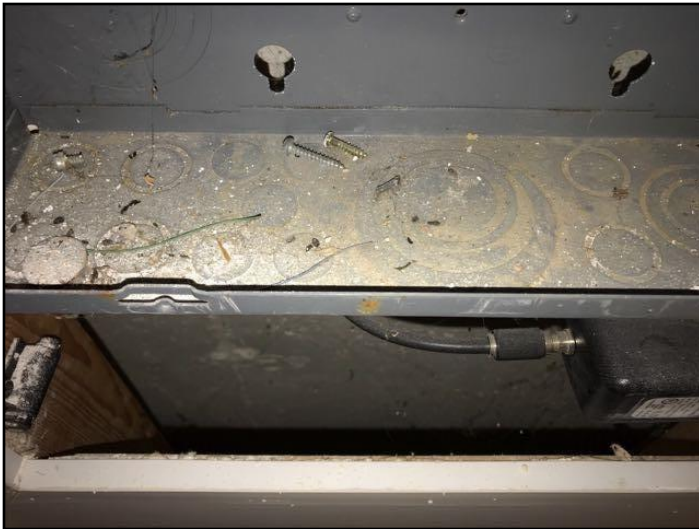
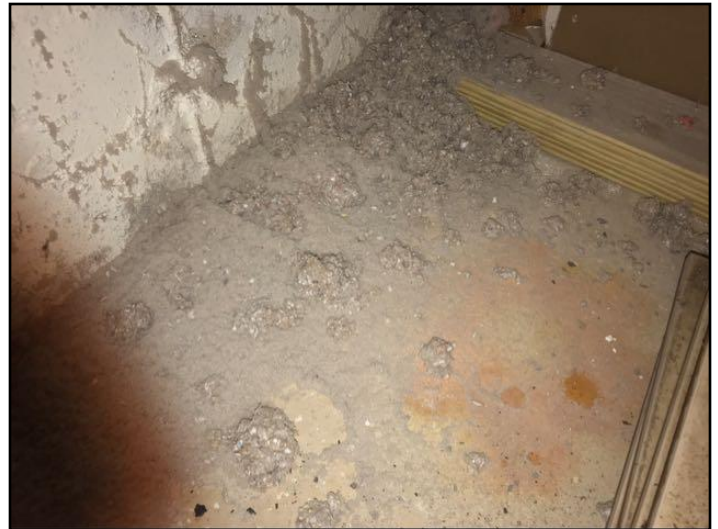
Condition: • The home interior had signs indicating a rodent infestation which should be addressed. The Inspector recommends further evaluation by a pest control service.

Rodent droppings in electric panel

Task: Further evaluation

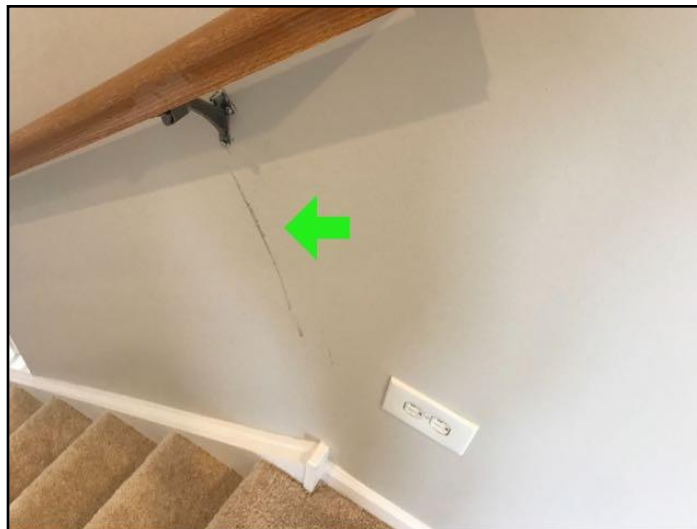
WALLS \ Plaster or drywall

Condition: • Damaged

Implication(s): Damage or physical injury due to falling materials

Task: Repair

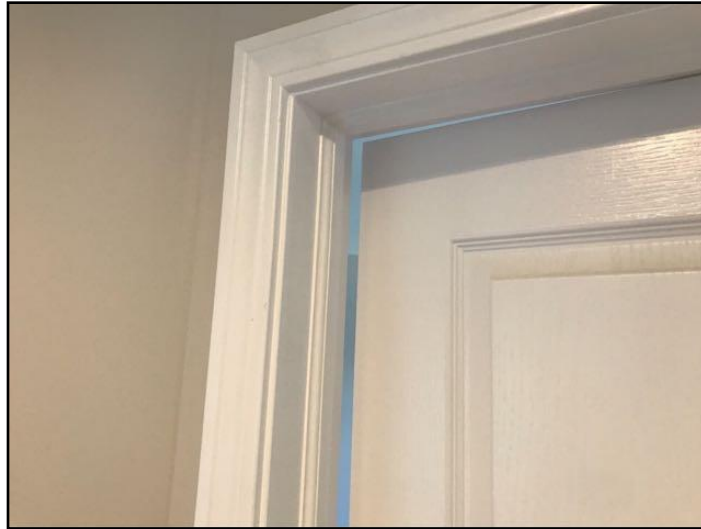
Condition: • [Stiff](#)

Task: Repair

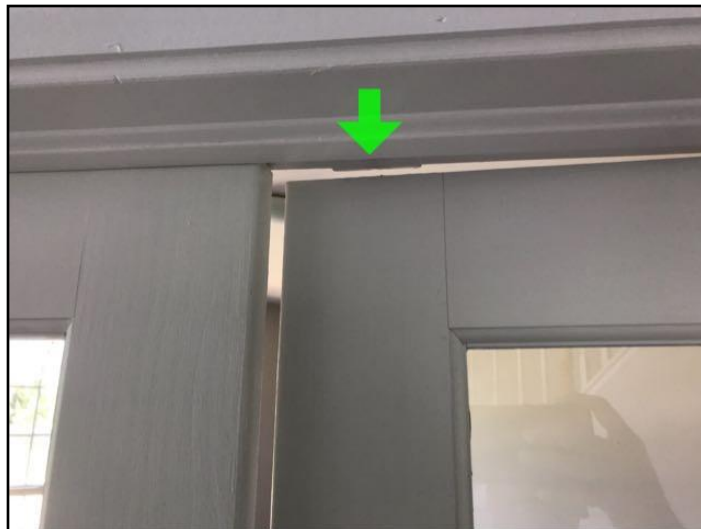
DOORS \ Hardware

Condition: • Does not latch properly

Task: Repair

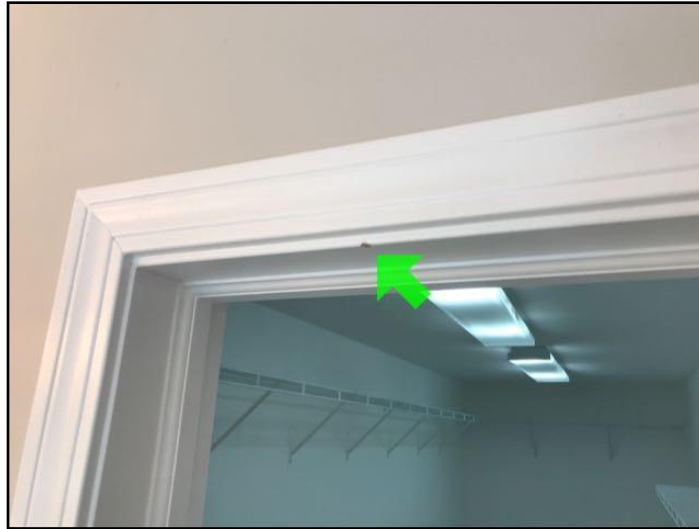
DOORS \ Interior trim

Condition: • [Cracked](#)

Task: Repair

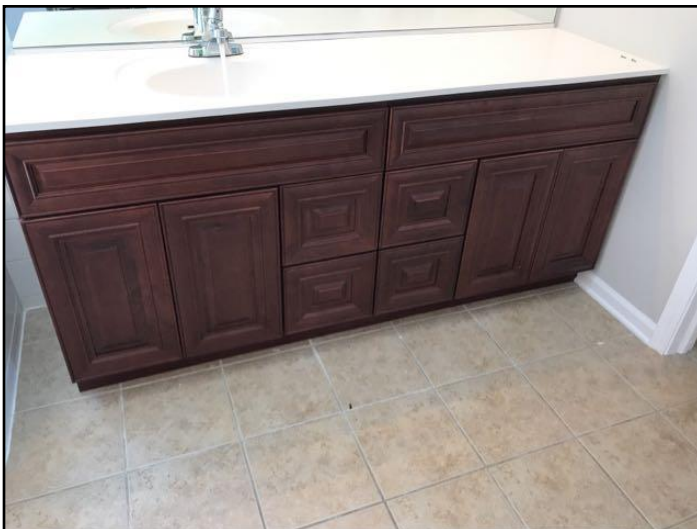
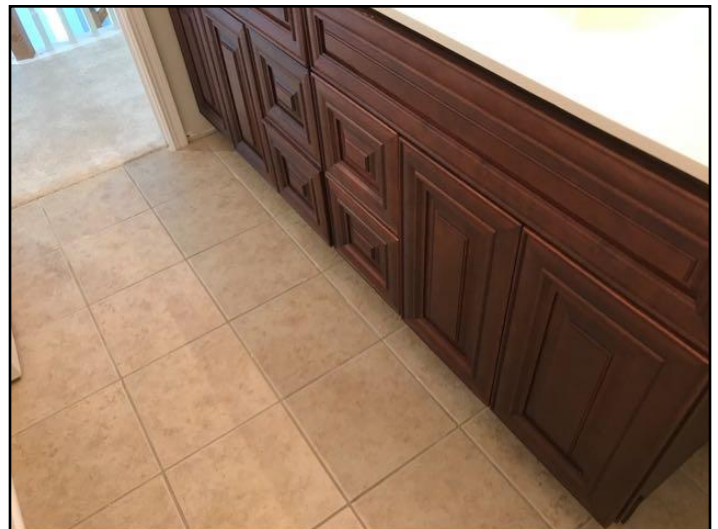
Condition: • [Pieces missing or loose](#)

Missing handles noted at the cabinet doors and drawers.

Implication(s): Damage or physical injury due to falling materials

Task: Provide

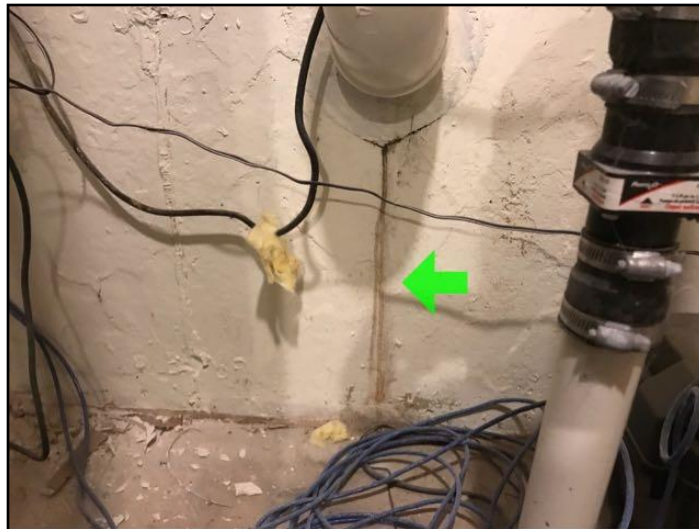
BASEMENT \ Wet basement - evidence

Condition: • [Stains](#)

Past where water stains noted where the main sewer line exits the home.

Task: Repair

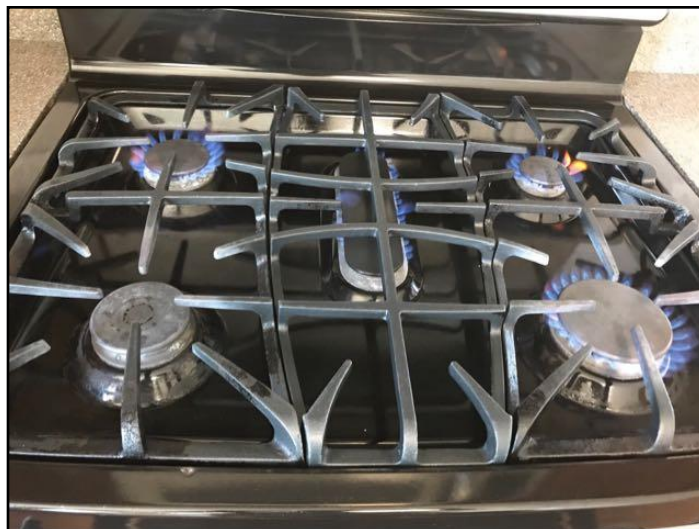
APPLIANCES \ Range

Condition: • Burner inoperative

Front left burner was inoperative

Task: Repair

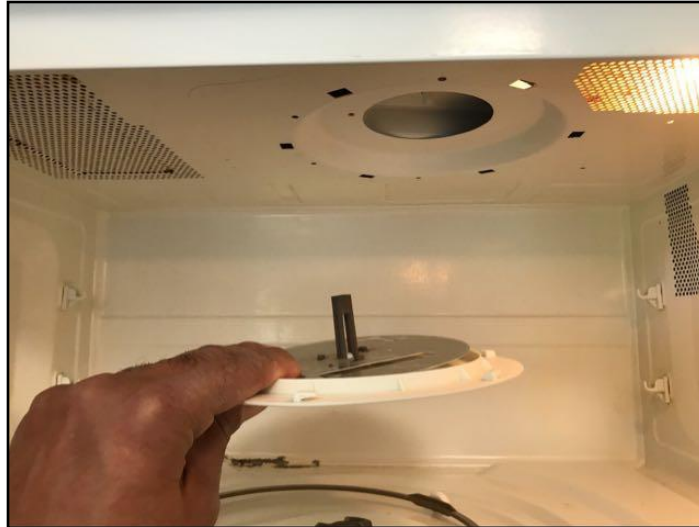
APPLIANCES \ Microwave oven

Condition: • Parts broken/missing

Task: Repair or replace
