Your Inspection Report

123 Main Street
Homewood, IL 60430

INSPECTION DATE:
Tuesday, January 5, 2021

PREPARED BY:
Sean Bacon 450.0001531

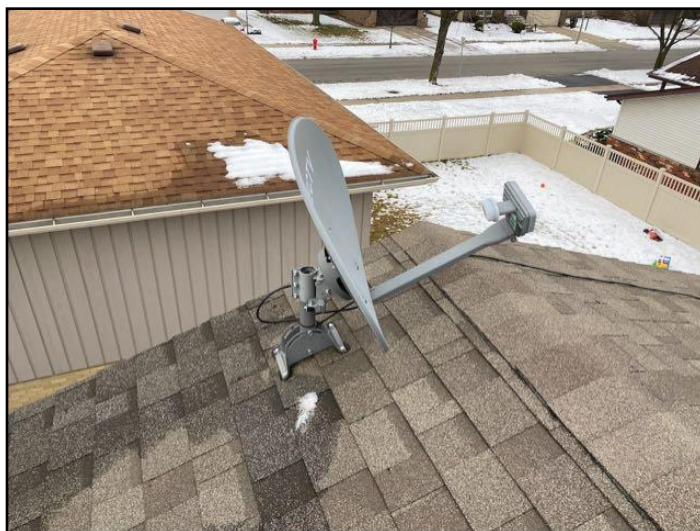
1. Condition: • [Vulnerable areas](#)

Satellite dish attachments and/or antennas can be a source of leakage without regular maintenance.

Implication(s): Chance of water damage to structure, finishes and contents

Location: Roof

Task: Remove or Repair

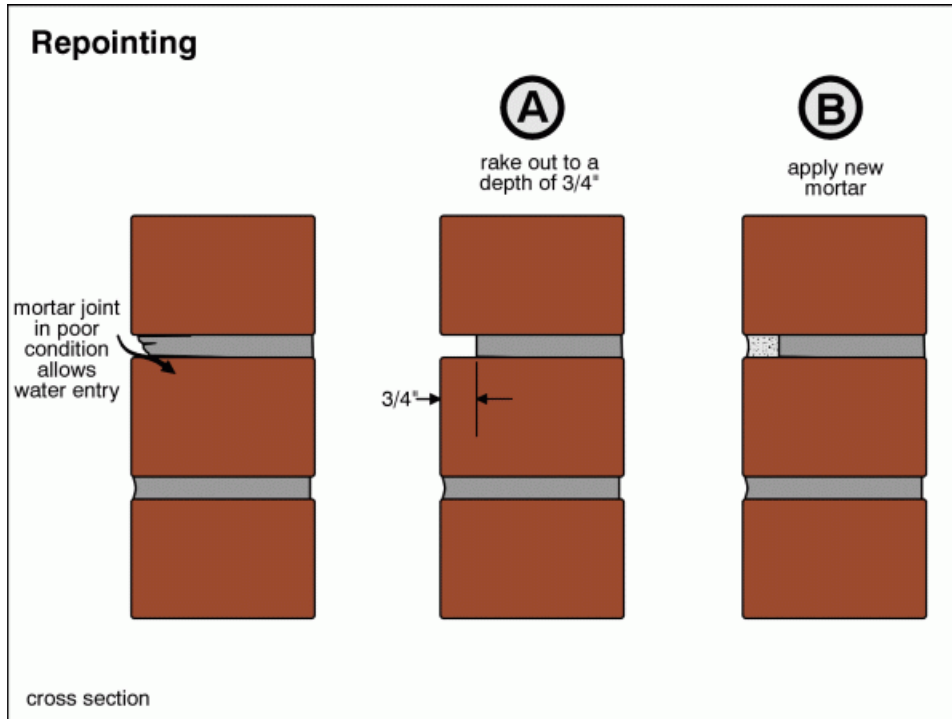
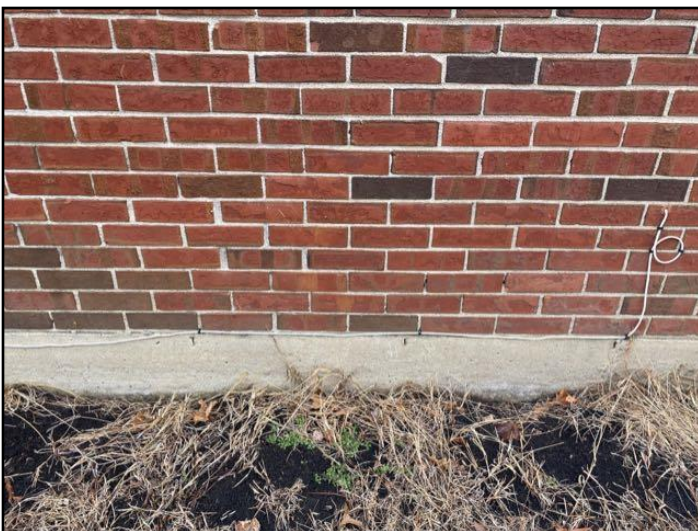
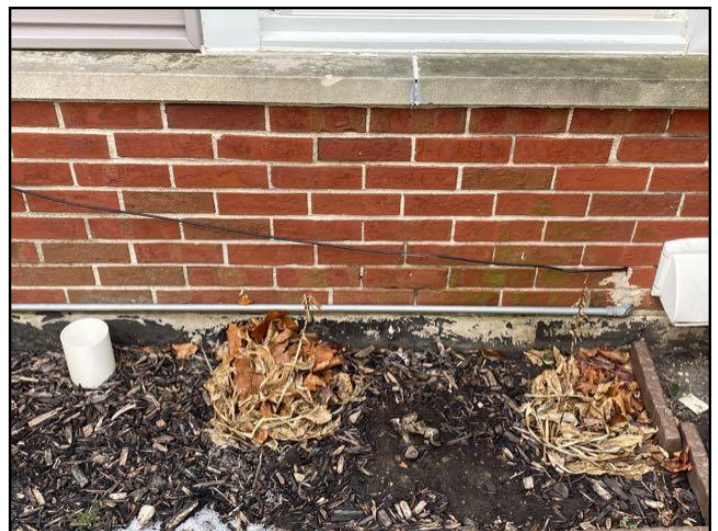
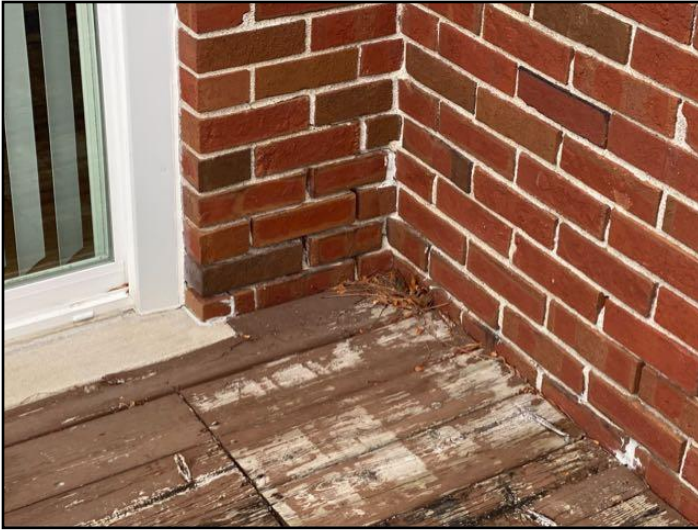
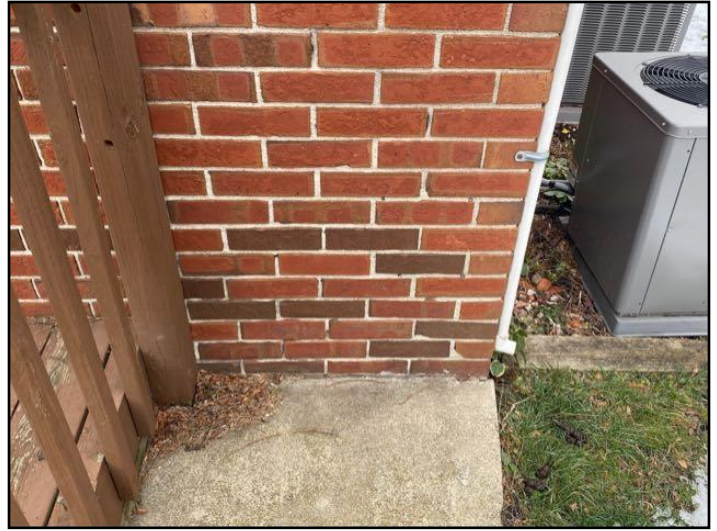
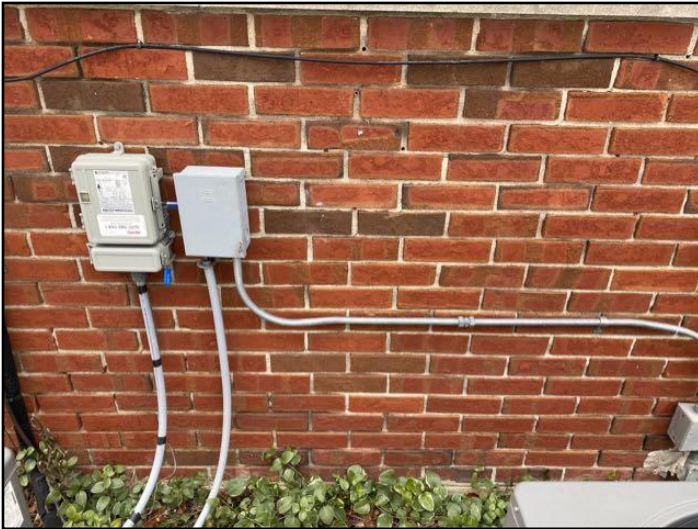
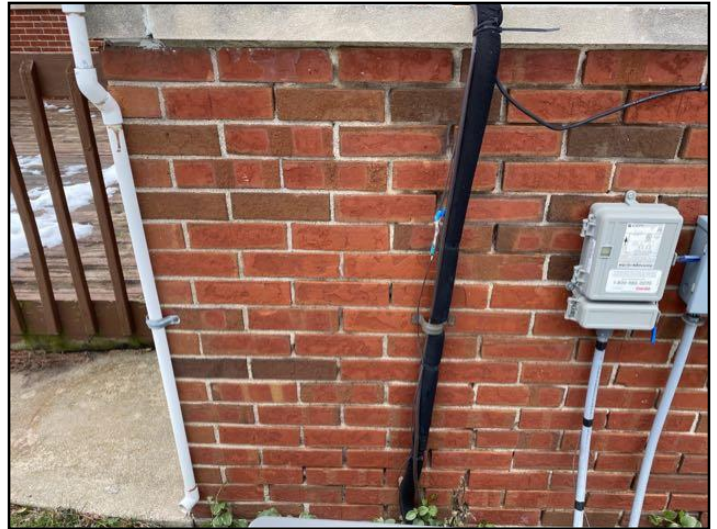
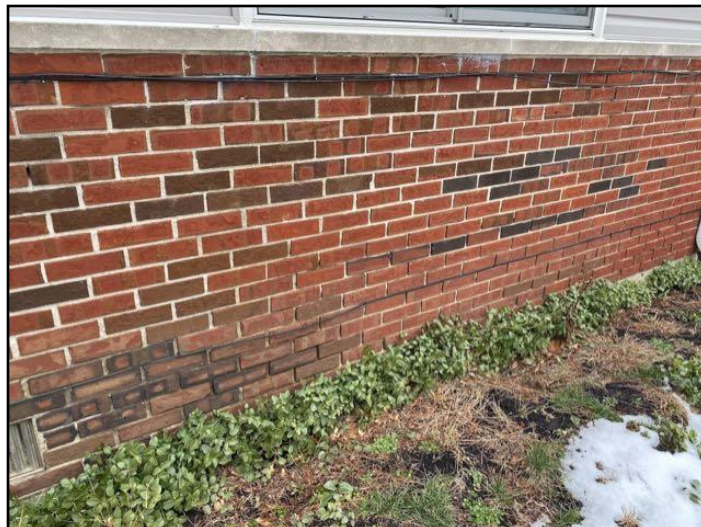
2. Condition: • [Mortar deterioration](#)

Implication(s): Chance of water entering building | Weakened structure | Chance of structural movement

Location: Various Exterior Wall

Task: Repair

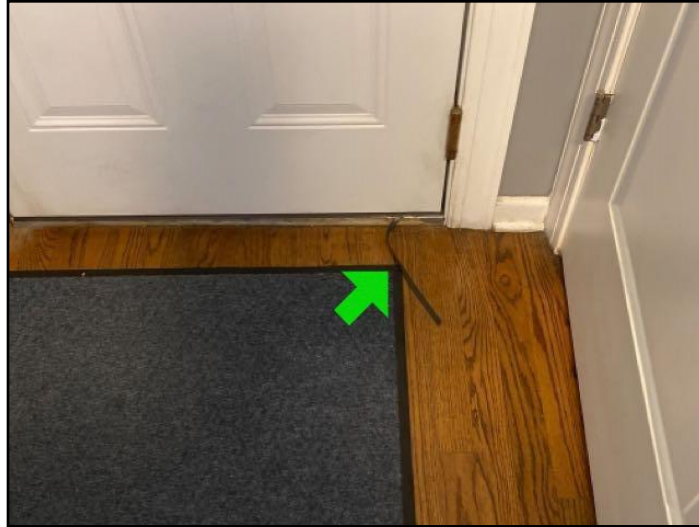
3. Condition: • [Air leaks](#)

Loose weather stripping noted along the bottom of the door.

Implication(s): Chance of damage to finishes and structure | Increased heating and cooling costs

Location: Garage

Task: Repair

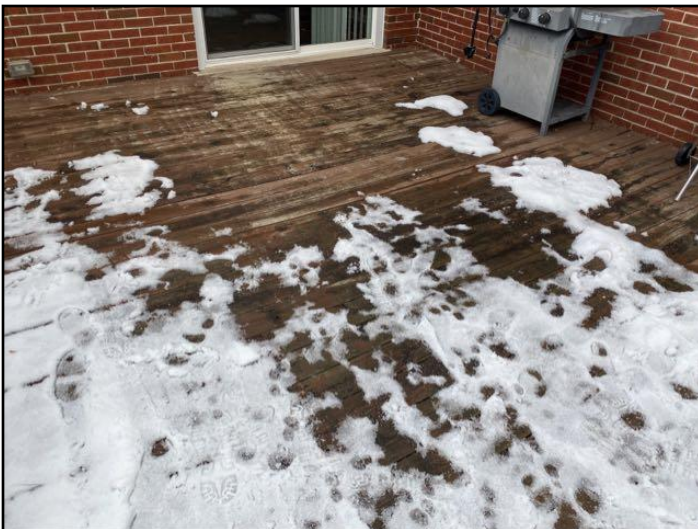
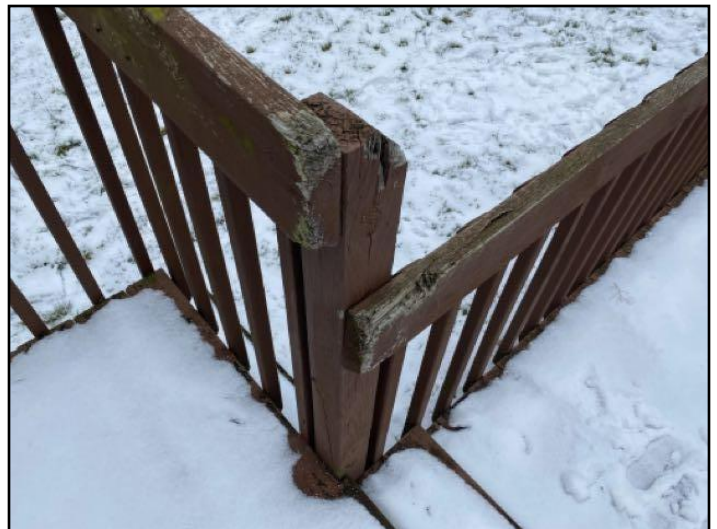
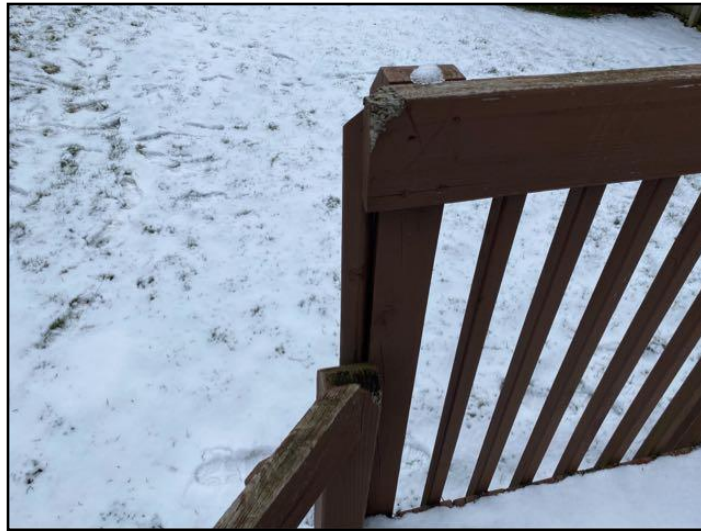
4. Condition: • All exterior wooden deck surfaces should be professionally cleaned and sealed against weather in order to extend the service life of the materials

Small areas of rot noted on the deck.

Location: Deck

Task: Repair

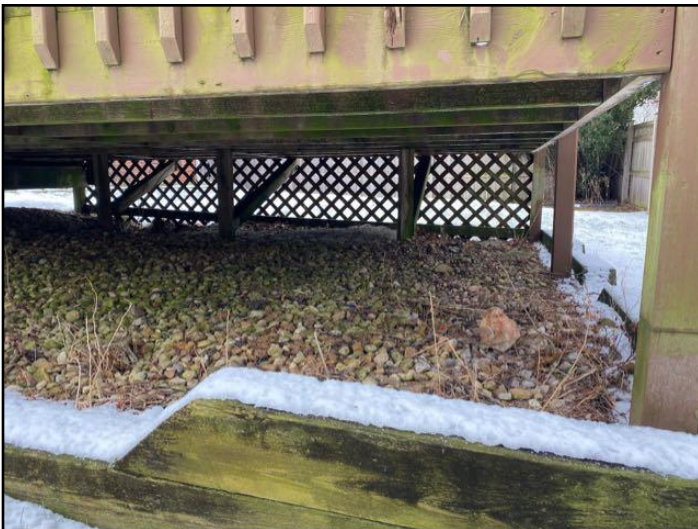
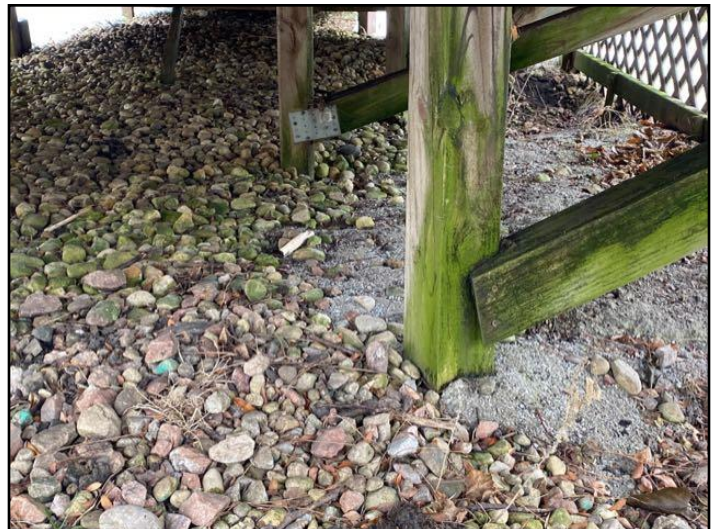
5. Condition: • [Wood/soil contact](#)

The inspector could not determine if there are concrete footers under the deck posts. This is important to prevent frost heave of the deck, as well as premature rot of the columns. For further info, please view:

Some movement of the deck already has appeared to have happened.

Implication(s): Weakened structure | Chance of movement | Rot | Insect damage

Location: Deck

Task: Further evaluation

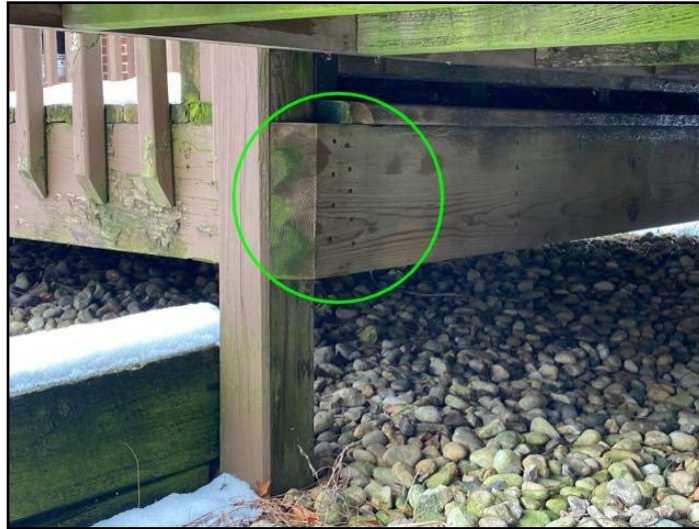
6. Condition: • [Connections weak](#)

The beam/column connection should be lag bolted, not nailed at the deck.

Implication(s): Weakened structure | Chance of structural movement

Location: Deck

Task: Repair

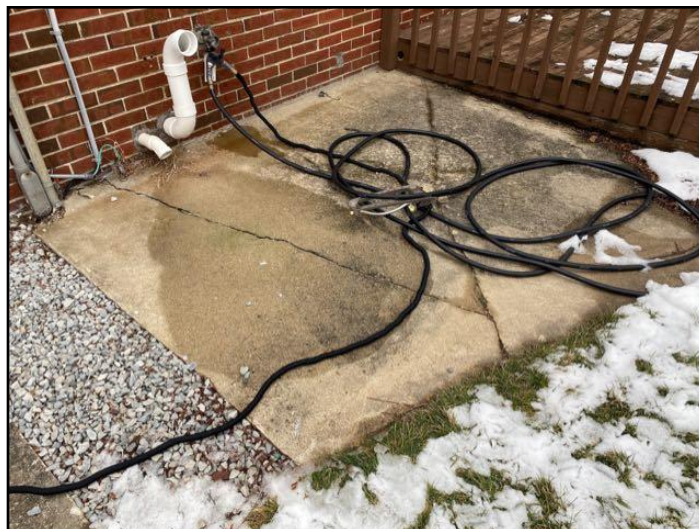
7. Condition: • [Concrete cracked](#)

Implication(s): Chance of damage to structure | Material deterioration | Trip or fall hazard

Location: Rear Exterior

Task: Repair

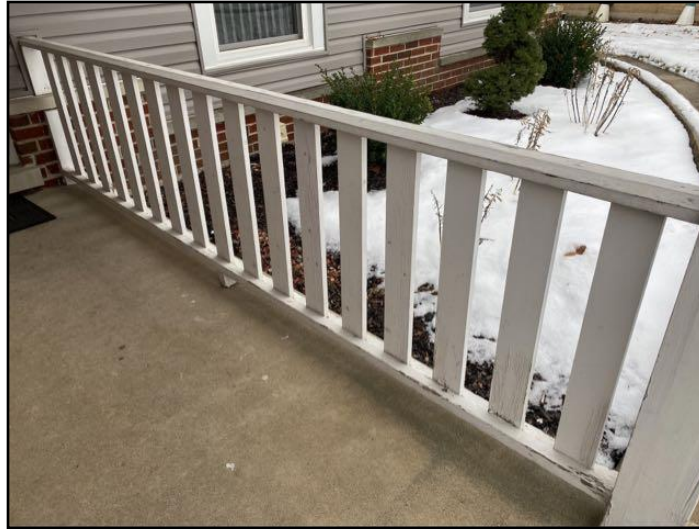
8. Condition: • Flaking paint noted at the guardrail

Location: Front Porch

Task: Repair

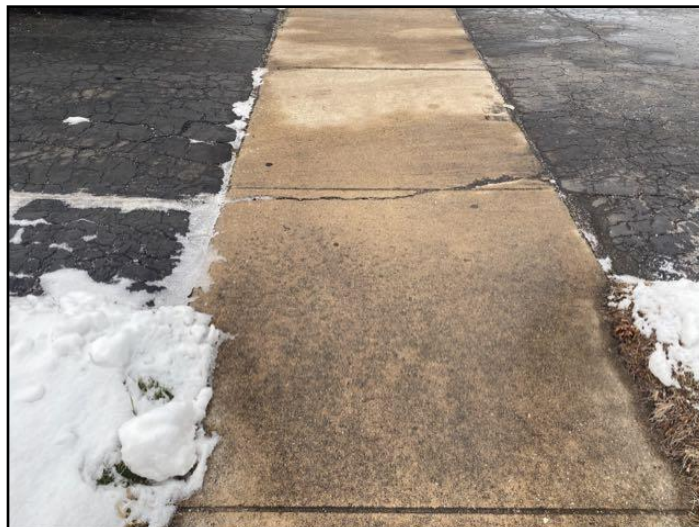
9. Condition: • [Cracked or damaged surfaces](#)

Implication(s): Trip or fall hazard

Location: Front Exterior

Task: Repair

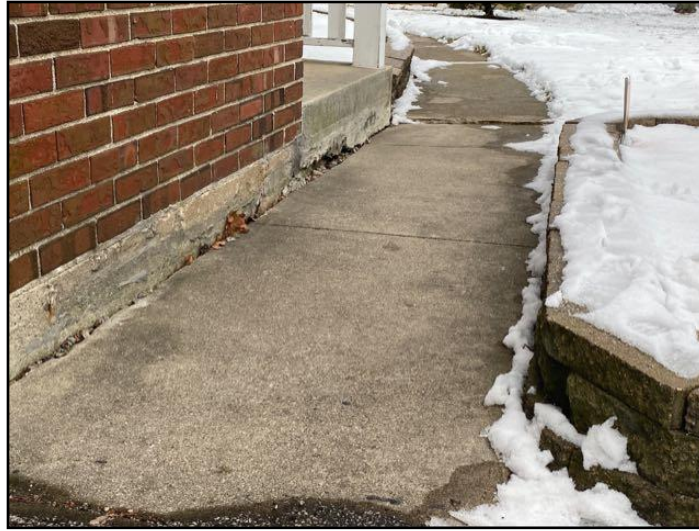
10. Condition: • Settlement

Location: Front Exterior

Task: Repair

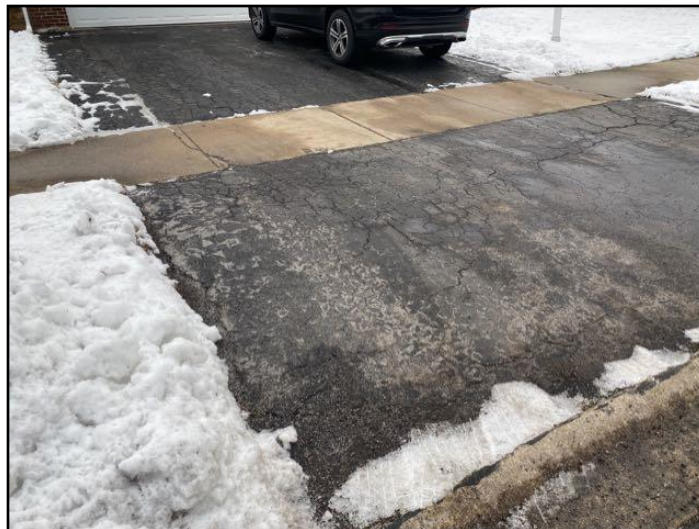
11. Condition: • [Cracked or damaged surfaces](#)

Asphalt driveway in need of resurfacing.

Implication(s): Trip or fall hazard

Location: Front Exterior

Task: Repair

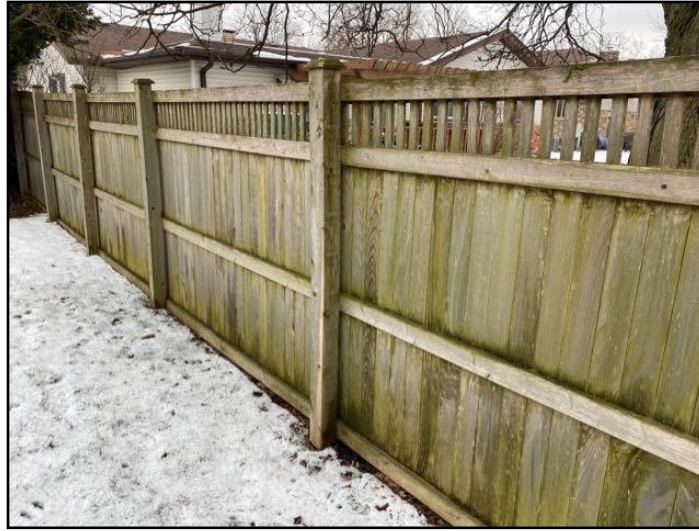
12. Condition: • Stain

Implication(s): Material deterioration

Location: Yard

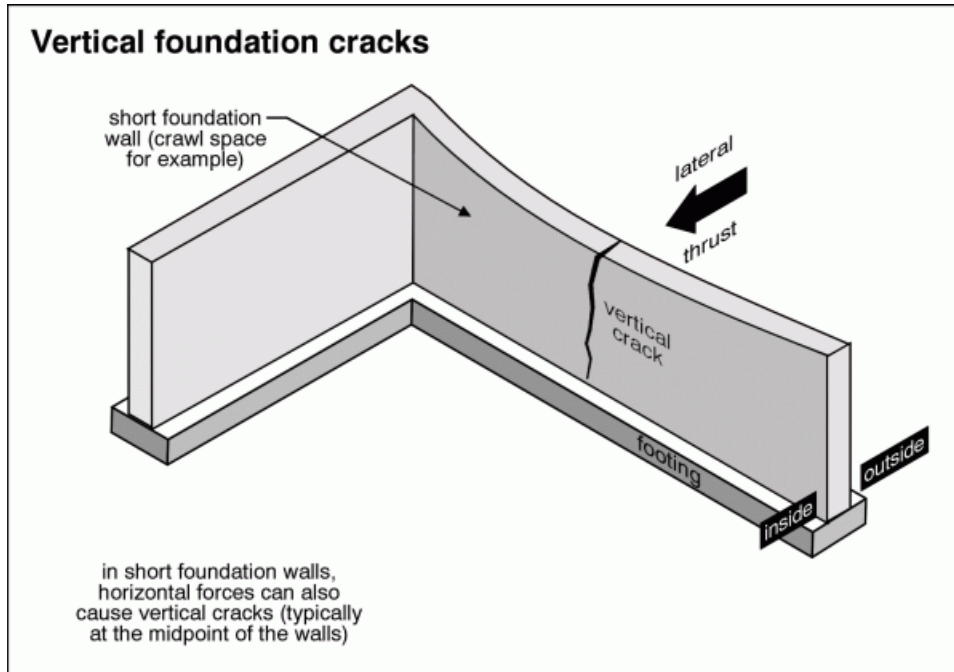
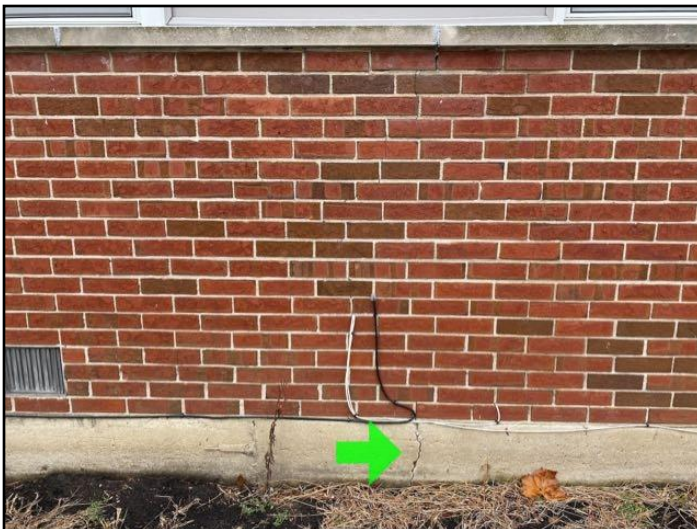
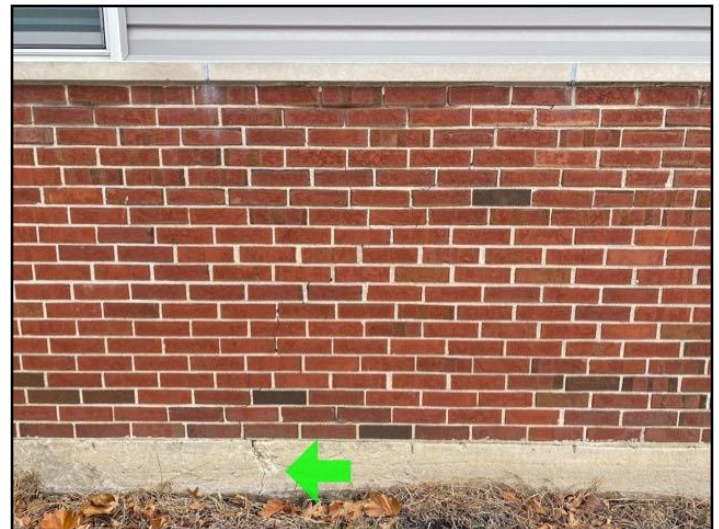
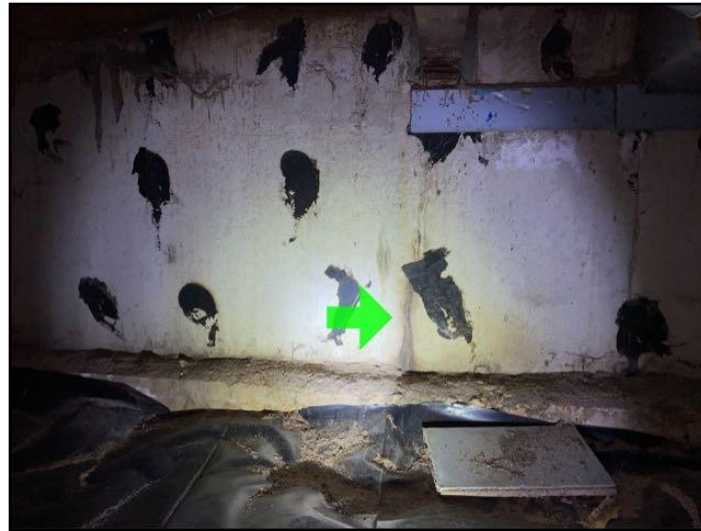
13. Condition: • [Cracked](#)

Implication(s): Chance of water damage to structure, finishes and contents | Weakened structure

Location: East Exterior Wall (Two), Rear Crawlspace

Task: Repair

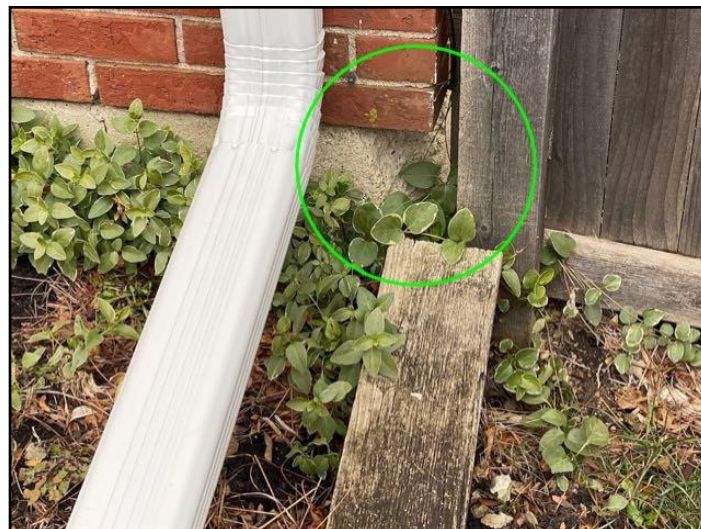
14. Condition: • [Spalling, crumbling or broken material](#)

Implication(s): Weakened structure | Chance of structural movement

Location: Southeast Exterior Wall

Task: Repair

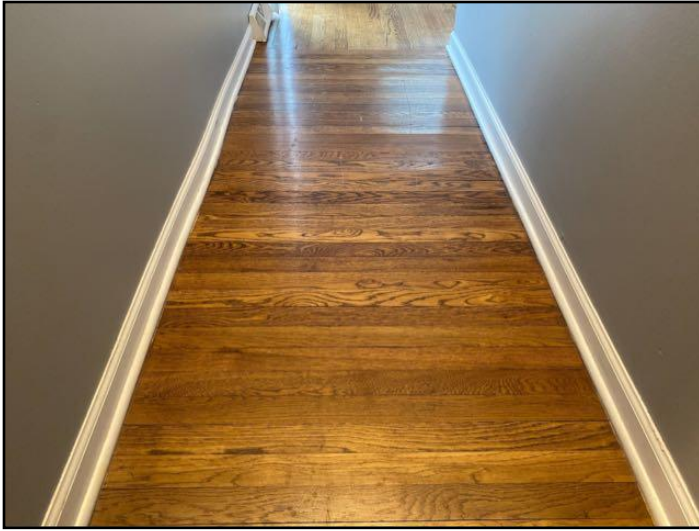
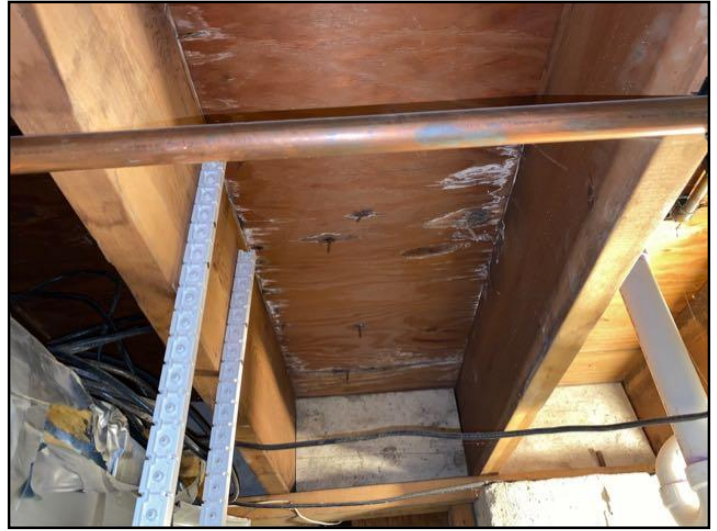
15. Condition: • Sagging

Implication(s): Weakened structure | Chance of structural movement

Location: First Floor Hall/Crawlspace

Task: Further evaluation

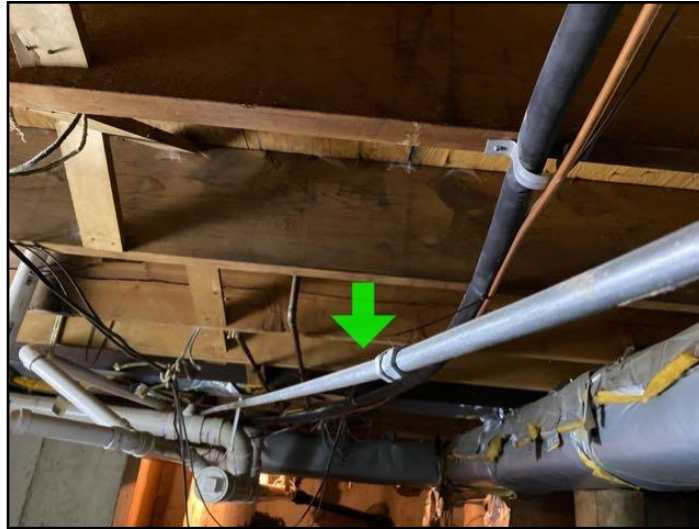
16. Condition: • [Loose connections](#)

Implication(s): Electric shock | Fire hazard | Interruption of electrical service

Location: Crawl Space

Task: Repair

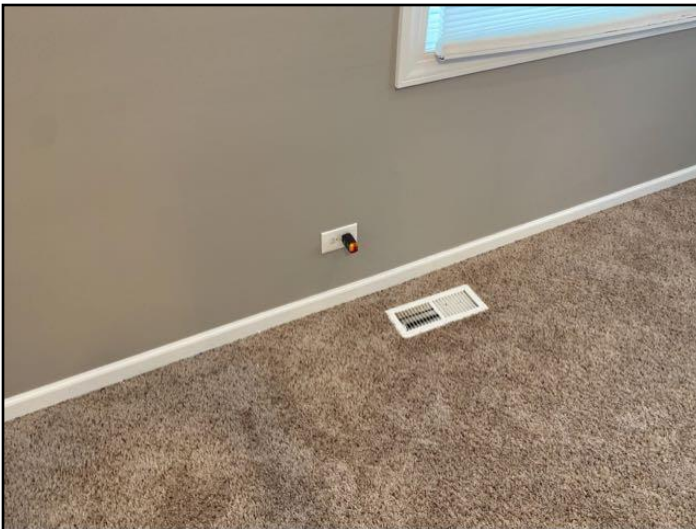
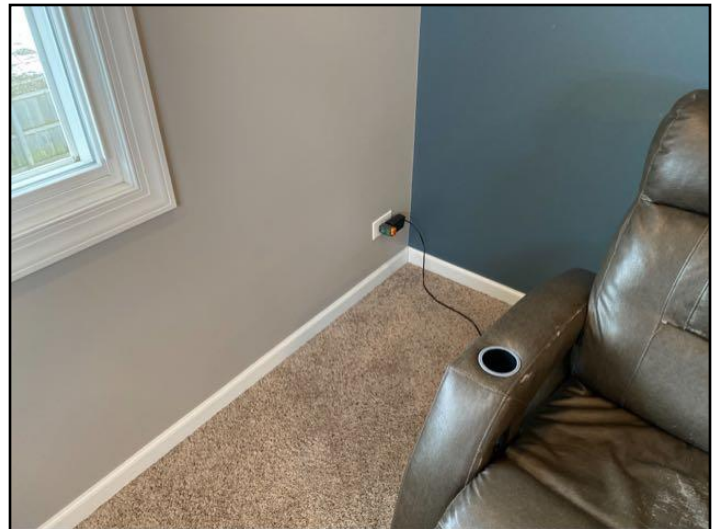
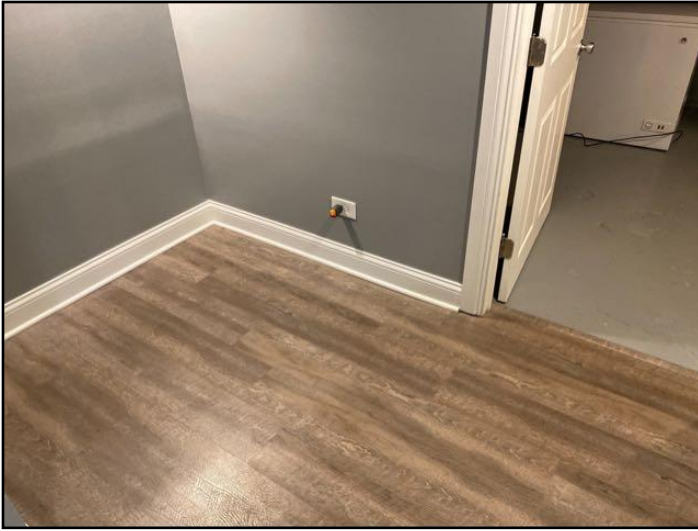
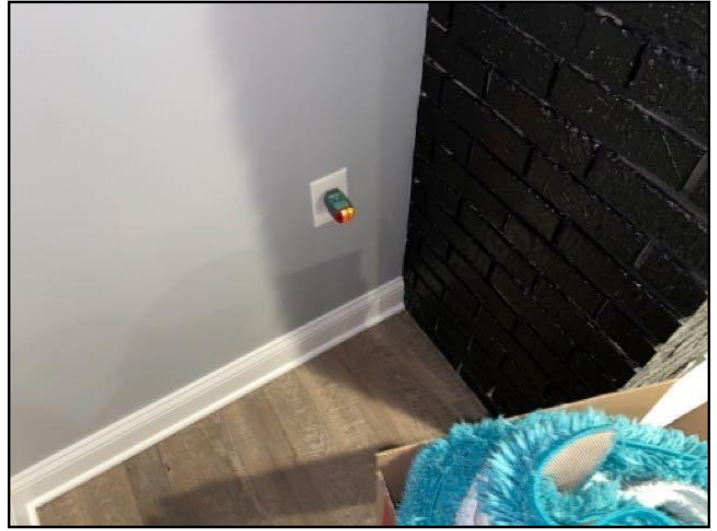
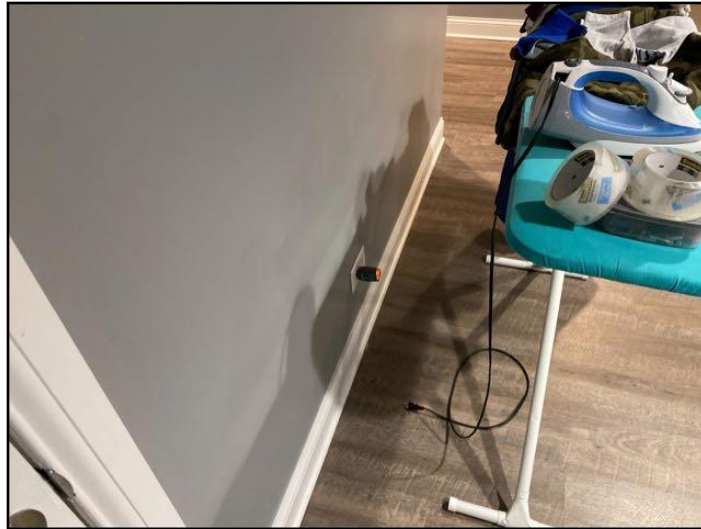
17. Condition: • [Loose](#)

Implication(s): Electric shock | Fire hazard

Location: Second Floor Family Room, Basement (Several)

Task: Repair

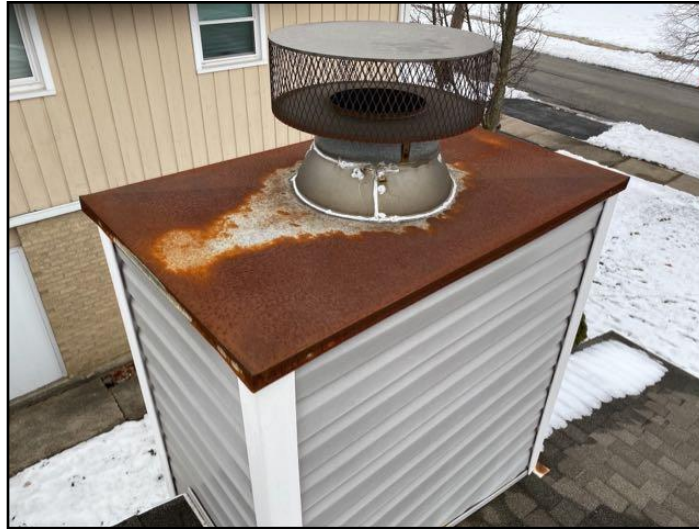
19. Condition: • Rust

Implication(s): Reduced system life expectancy

Location: Roof

Task: Repair

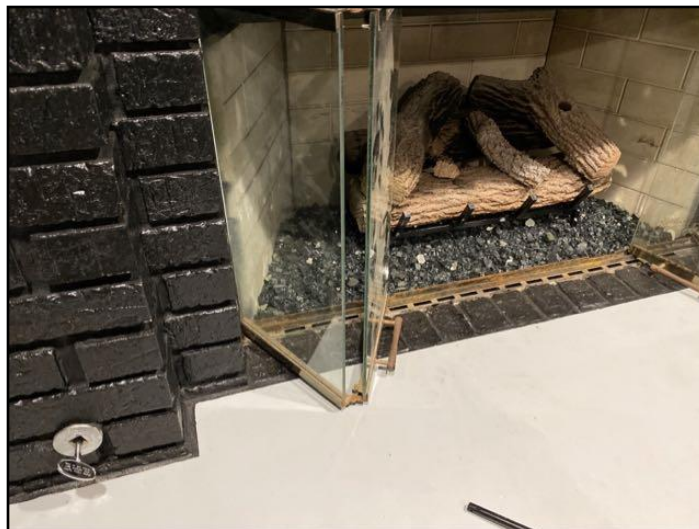
20. Condition: • Inoperative

Implication(s): System inoperative

Location: Family Room Basement

Task: Further evaluation

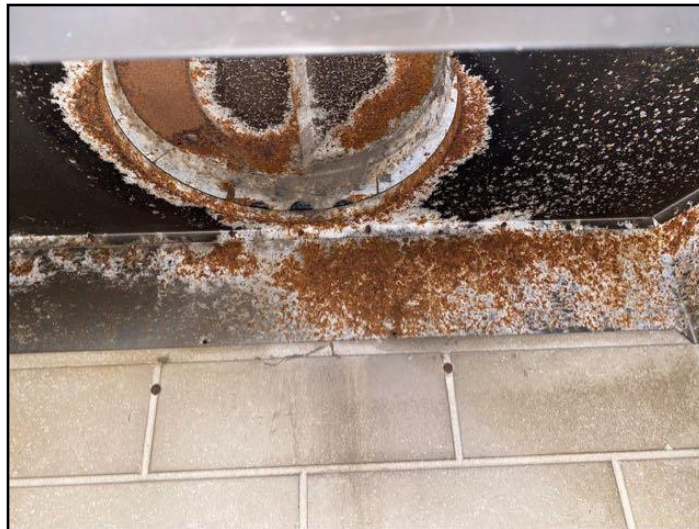
21. Condition: • [Damper or frame rusted](#)

Implication(s): Hazardous combustion products entering home | Increased heating costs | Reduced comfort

Location: Basement Family Room

Task: Further evaluation

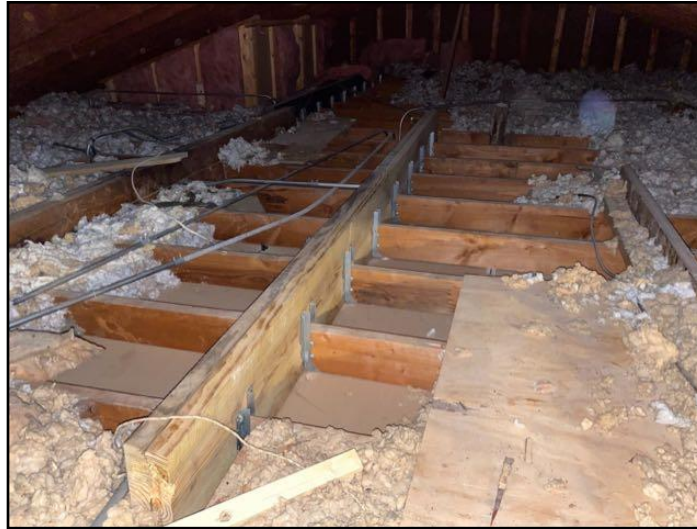
22. Condition: • [Gaps or voids](#)

Task: Repair

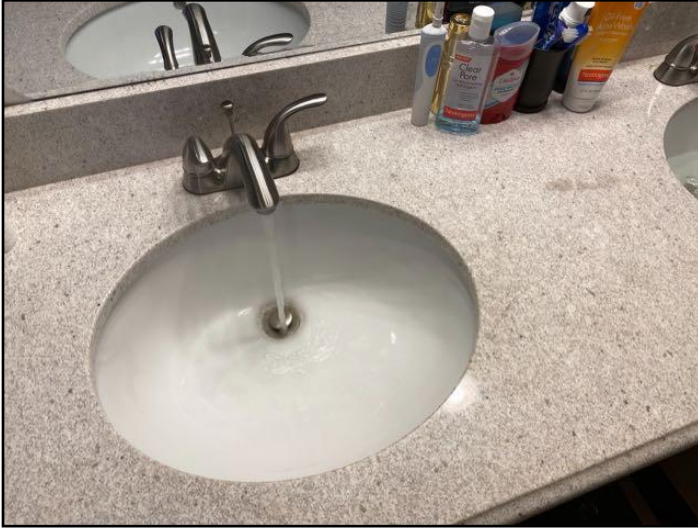
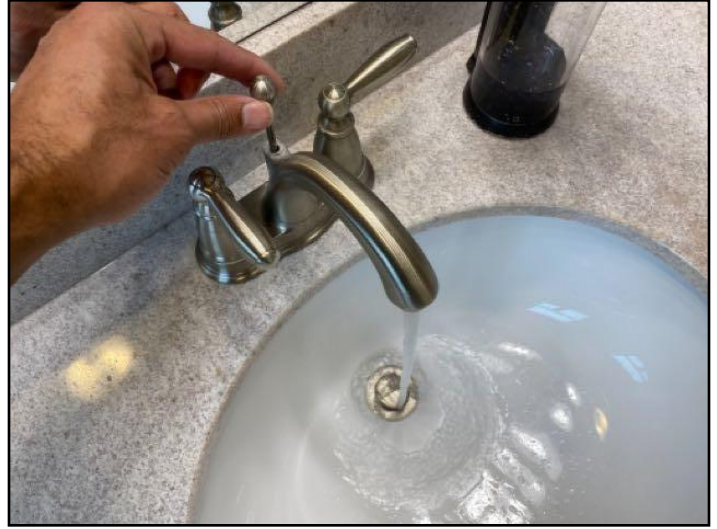
23. Condition: • Drain stop ineffective

Task: Repair

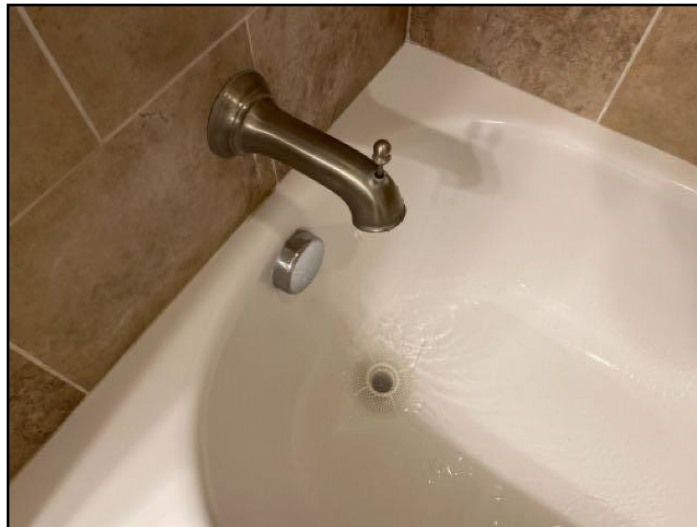
24. Condition: • Drain stop missing

Task: Provide

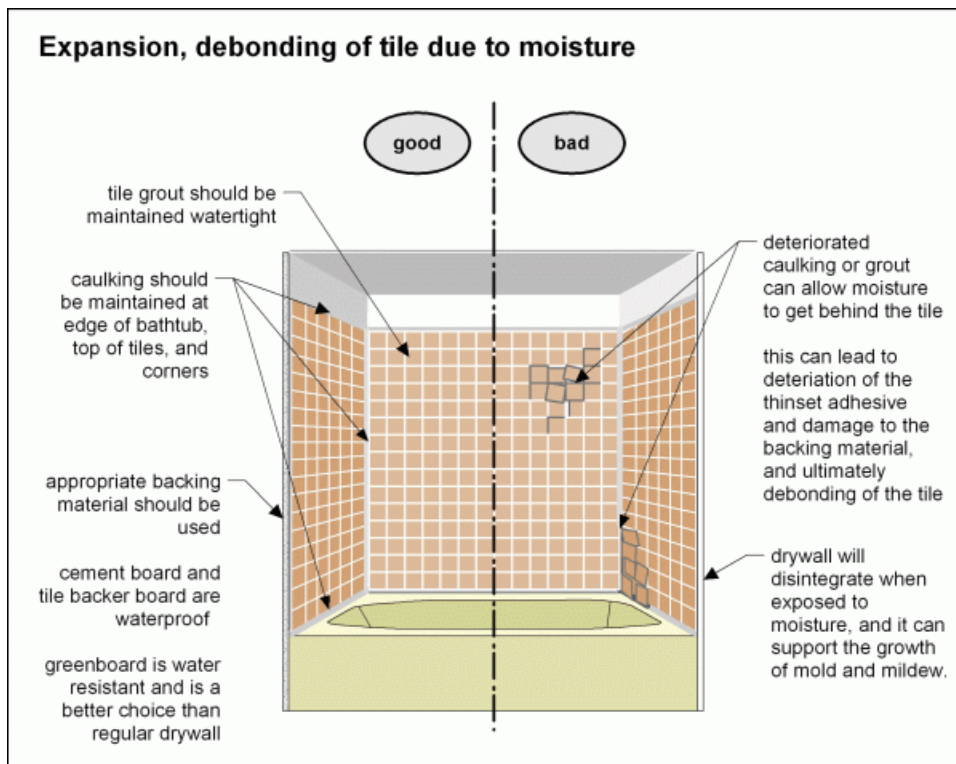
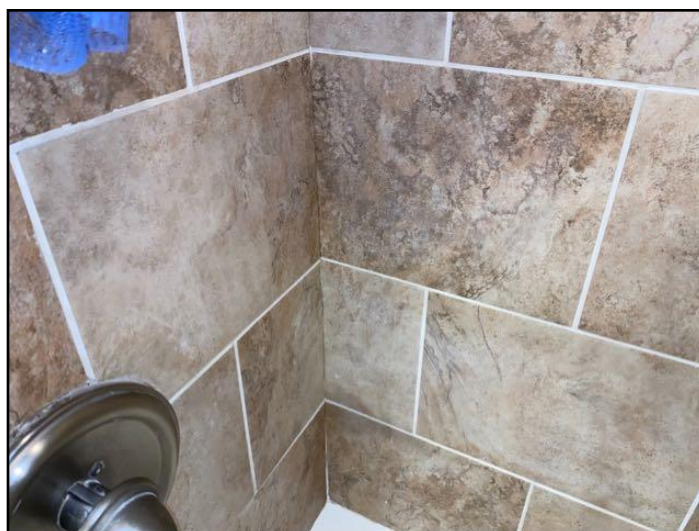
25. Condition: • [Grout loose, missing or deteriorated](#)

Implication(s): Chance of water damage to structure, finishes and contents

Task: Improve

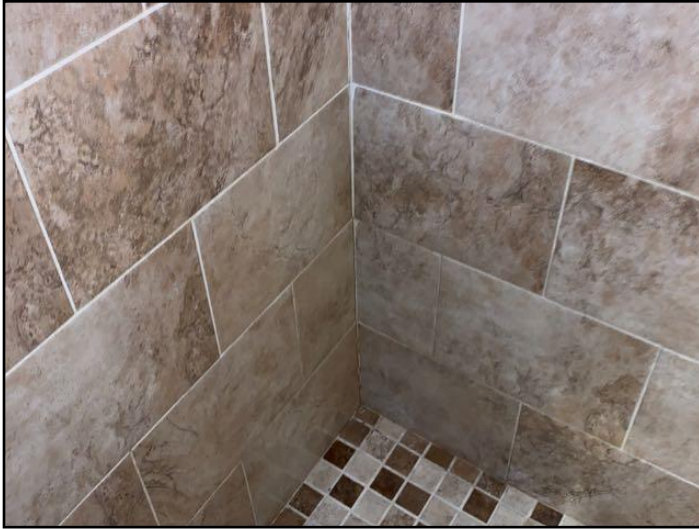
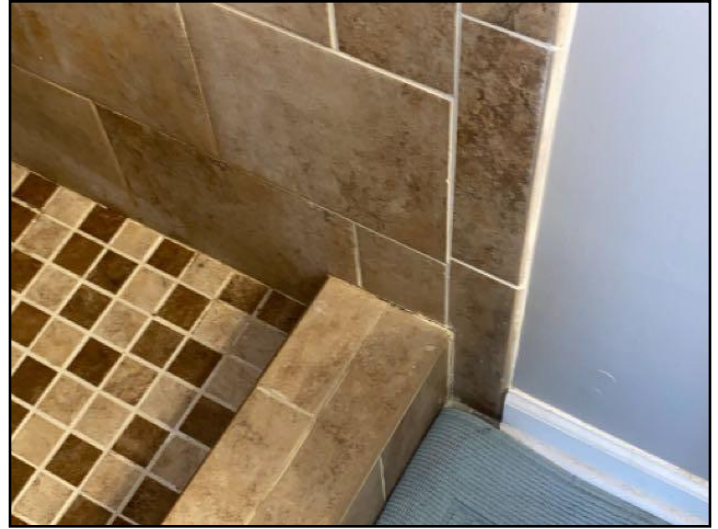
26. Condition: • [Grout loose, missing or deteriorated](#)

Implication(s): Chance of water damage to structure, finishes and contents

Task: Improve

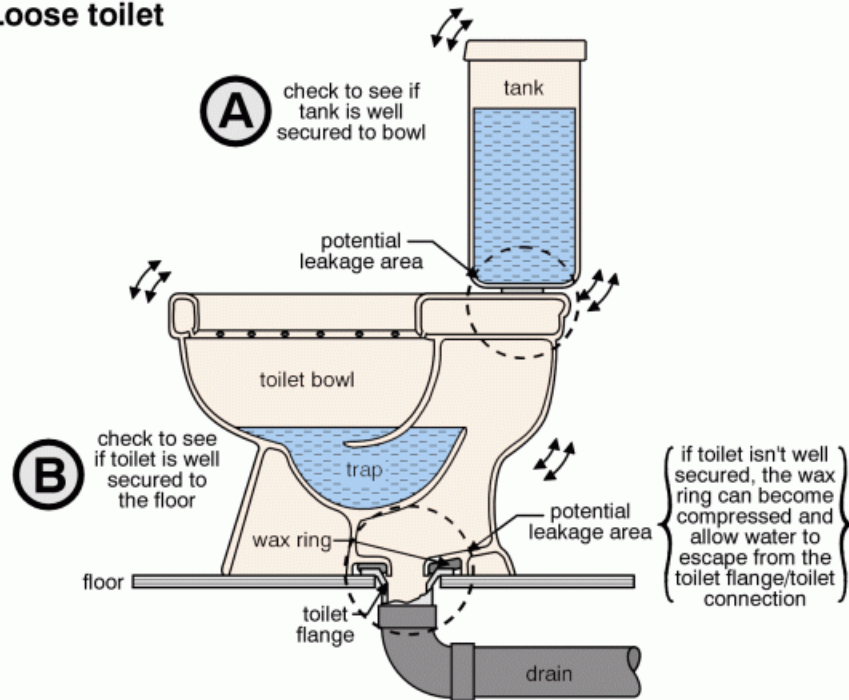
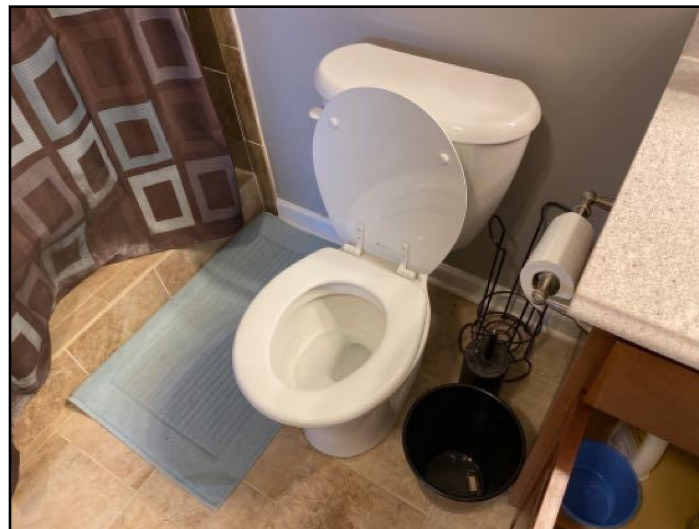
27. Condition: • [Loose](#)

Implication(s): Chance of water damage to structure, finishes and contents | Sewage entering the building | Possible hidden damage

Loose toilet

Task: Repair

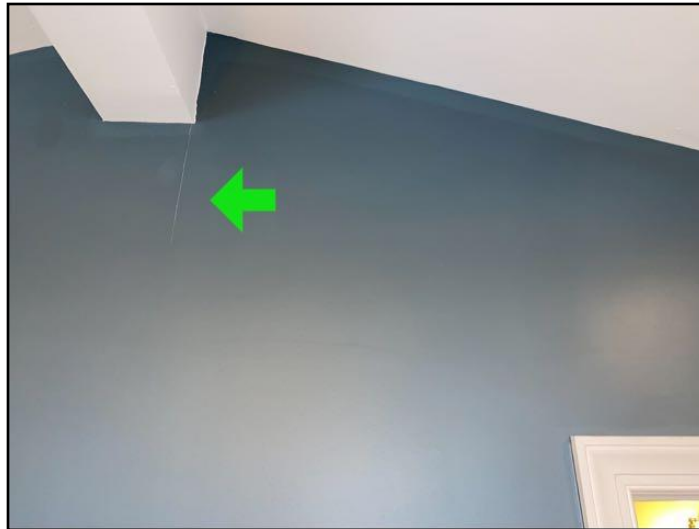
28. Condition: • [Poor joints](#)

Task: Improve

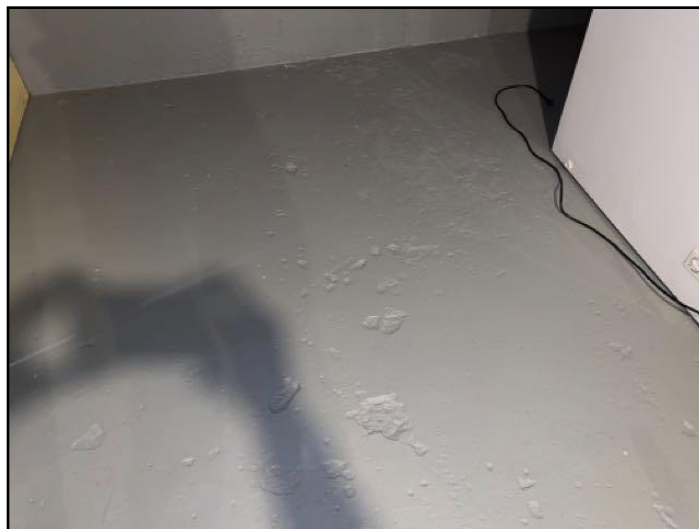
29. Condition: • [Shaling, spalling](#)

Implication(s): Material deterioration

Task: Repair

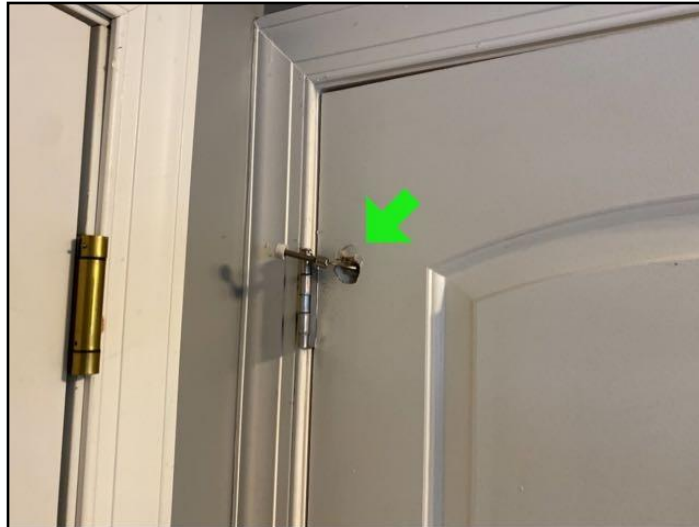
30. Condition: • [Damage](#)

Implication(s): Material deterioration | Increased heating and cooling costs | Reduced comfort

Task: Repair

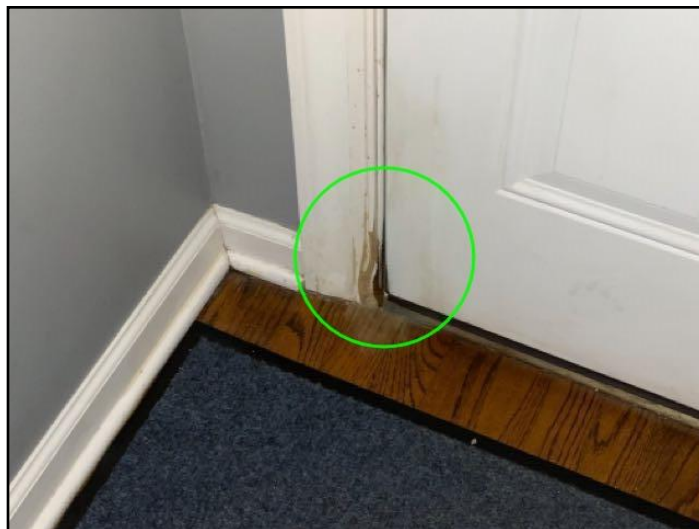
31. Condition: • Damaged

Task: Repair

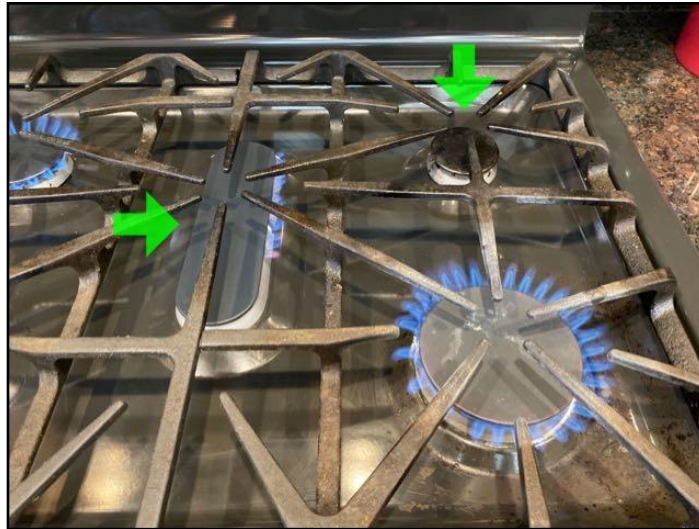
32. Condition: • Burner inoperative

Task: Repair
