# Your Inspection Report

14242 Summerfield Dr  
New Lenox, IL 60451

Saturday, January 16, 2016

Report No. 6673

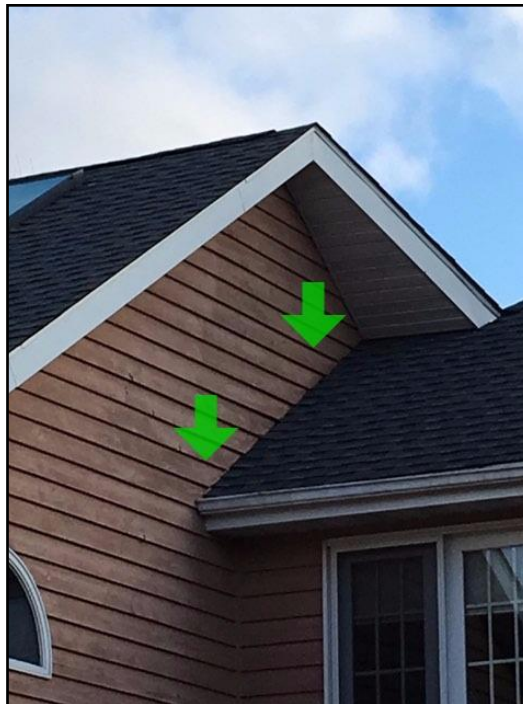
**1. Condition:** • [Siding not cut back](#)

*Siding not cut back from roof*

**Task:** Improve

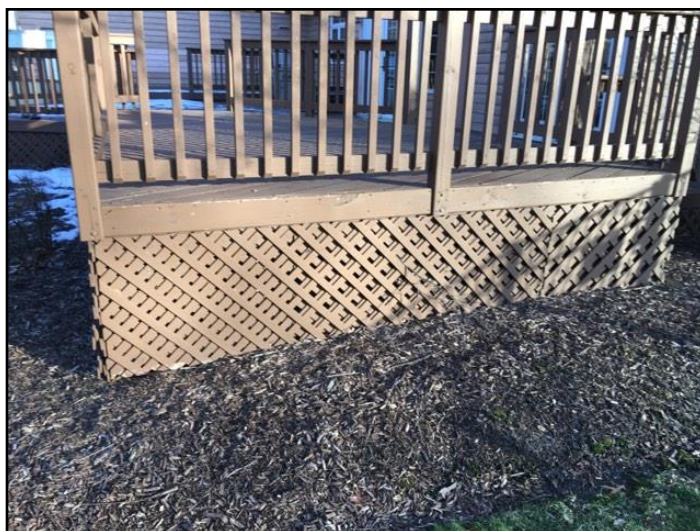
- Car in garage
  - Poor access under steps, deck, porch
- There was no access under the deck or the front porch.

*No Access Under The Deck*

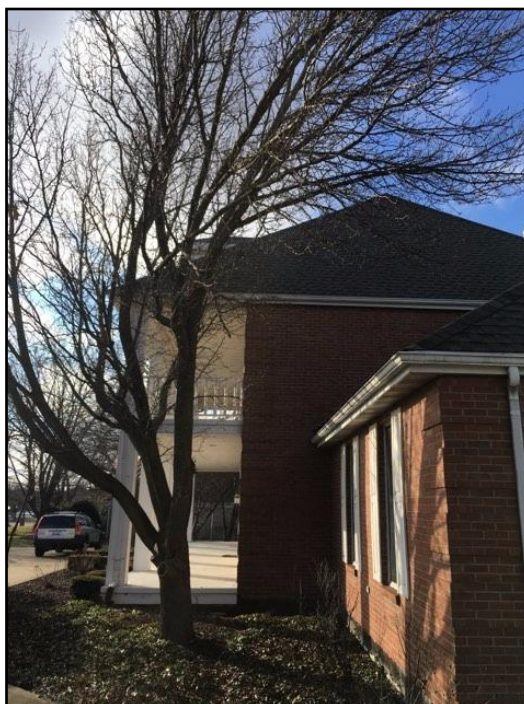
*Trees or shrubs too close to building*

**Task:** Improve

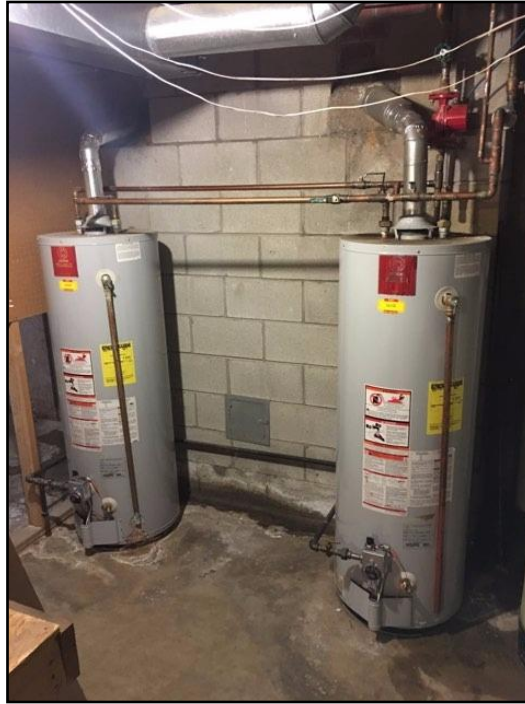
**Condition:** • The estimated age of the water heater suggests that it is at or beyond it's expected life span. Budgeting for eventual replacement is recommended.

*The estimated age of the water heater...*

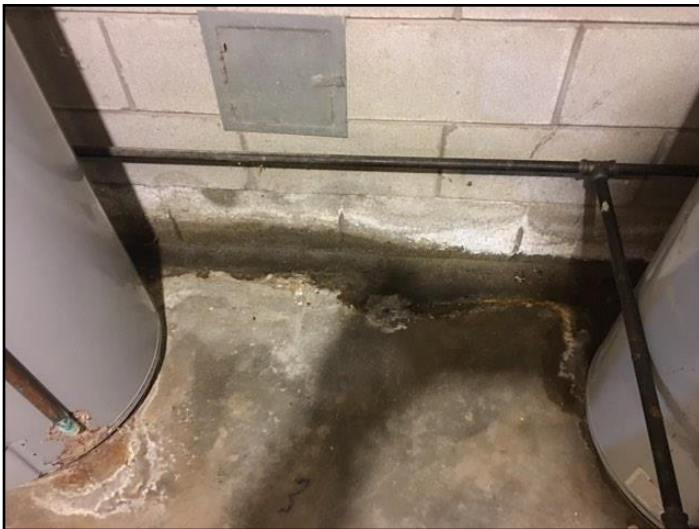
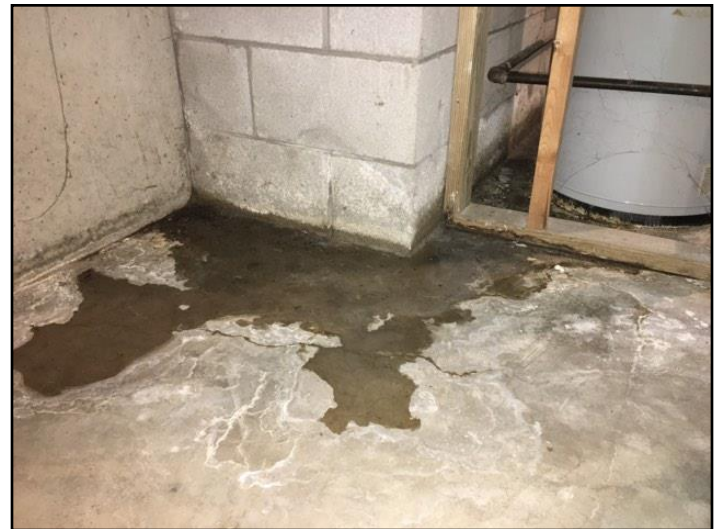
## Basement leakage clues - rot, stains or water marks

Dampness on floor or walls
