# Your Inspection Report

14242 Summerfield Dr  
New Lenox, IL 60451

Saturday, January 16, 2016

Report No. 6673

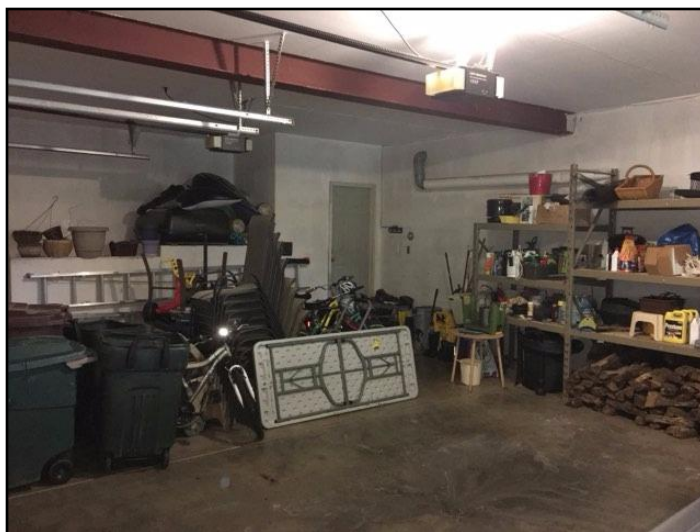
*Storage*

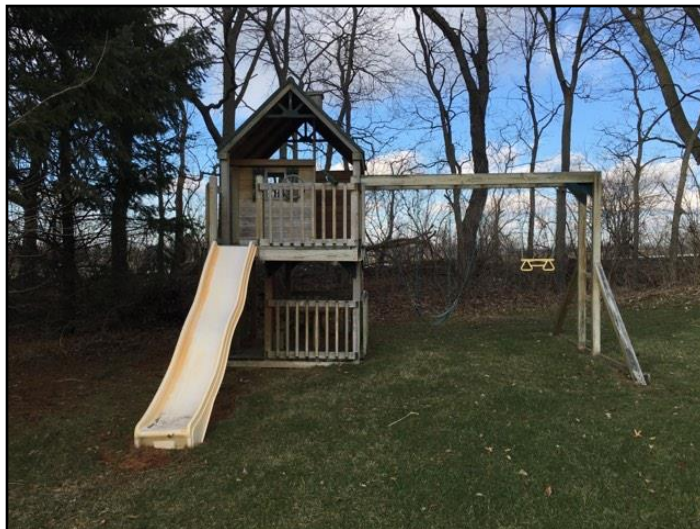
**Inspection prevented by:** • Play apparatus in the yard at the time of the inspection was not inspected. Inspection of play apparatus lies beyond the scope of the General Home Inspection.

*Play apparatus in the yard at the time of...*

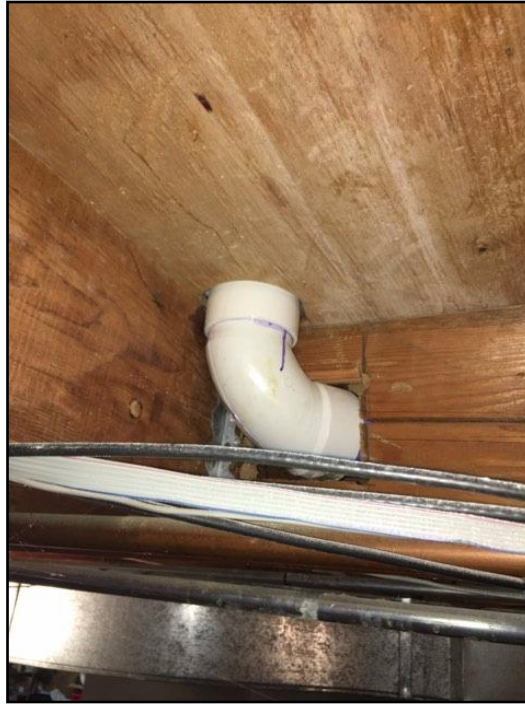
*Notches or holes*

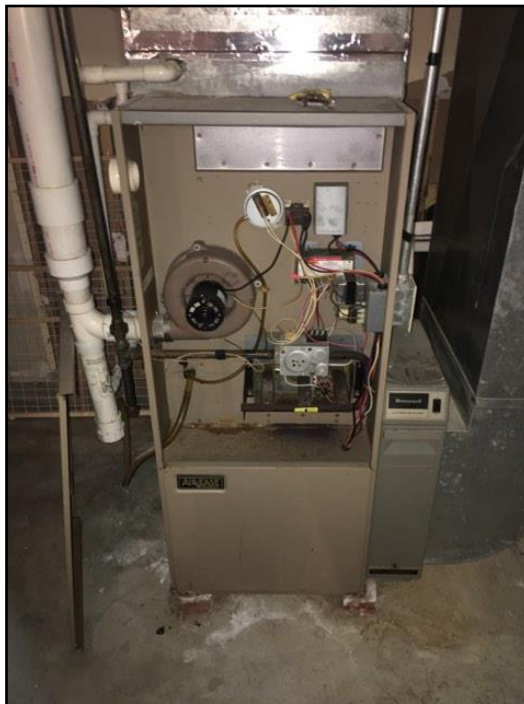
**Condition:** • The estimated age of the heating unit suggests that it is at or beyond it's expected life span. Budgeting for eventual replacement is recommended.

*The estimated age of the heating unit...*

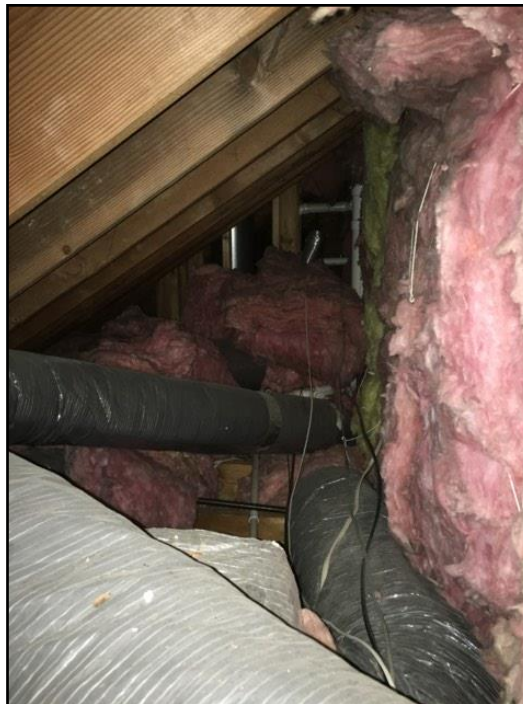
Access to the attic areas (behind drywall) was extremely limited.

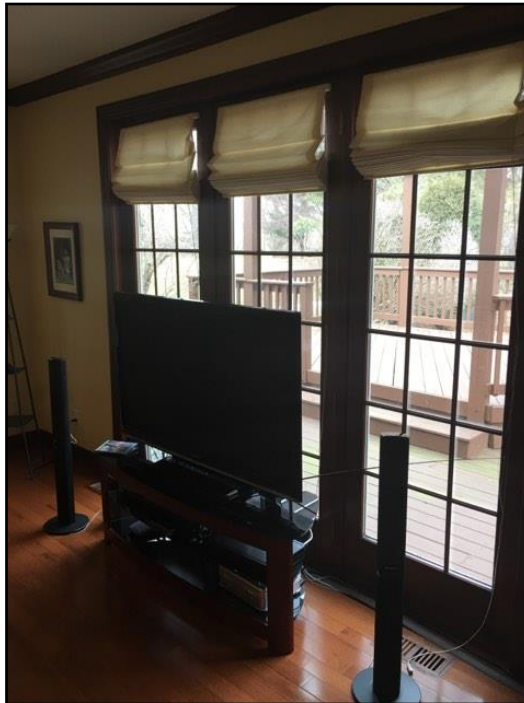
*Family room*

The family room doors could not be operated due to the placement of the TV in front of the doors.

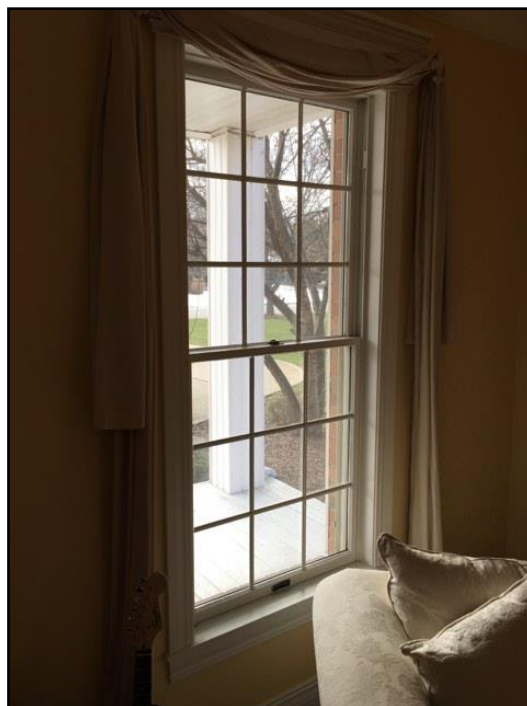
**Condition:** • [Won't stay open](#)

*Won't stay open*

**Task:** Repair
